Technical Service Bulletin

60 Sunroof frame modification

60 22 59 2065731/2 May 6, 2022. Supersedes Technical Service Bulletin Group 60 number 22-58 dated January 8, 2022, for reasons listed below.

Model(s)	Year	VIN Range	Vehicle-Specific Equipment
Q3, Q7, and Q8	2019 – 2023	All	Not Applicable
e-tron quattro	2019 2021 – 2023		
SQ7, SQ8, RS Q8, and e- tron Sportback quattro	2020 – 2023

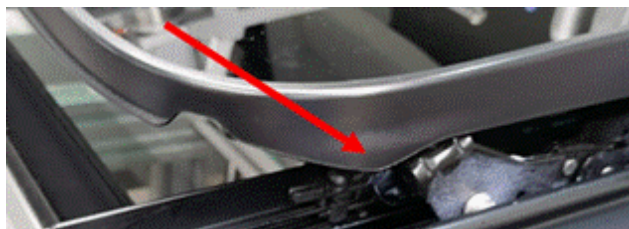
1. If the sunroof frame and/or front sunroof glass panel require replacement the water guidance washer on the sunroof mechanism pivot protrudes to the extent that the rubber "skirt" on the front glass panel also protrudes creating interference between the glass panel and the sunroof opening. This interference can prevent the front glass panel closing sequence from completing.
2. Figure 2 shows the location of the "skirt" protrusion from the water guidance washer.

Figure 1. The front sunroof glass panel side skirt is deformed due to a protruding water guidance washer.

4. Remove the front sunroof glass panel. Using a small pair of diagonal cutters (side cutters) trim away the water guidance washer. The washer must be cut back such that it protrudes no greater than the pivot pin. Perform this operation to both sides.

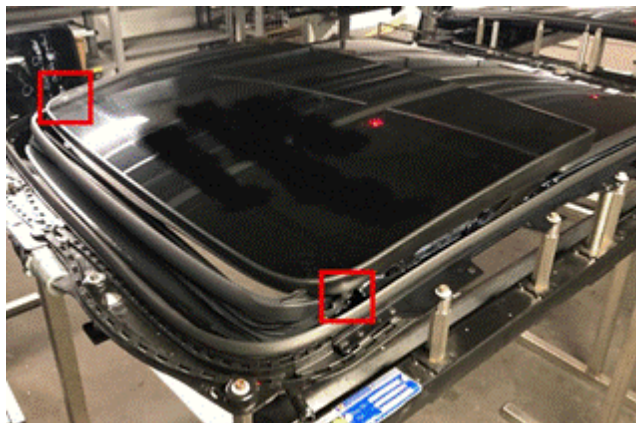
Figure 2. Front sunroof glass panel side skirt protrusion from an unmodified water guidance washer.

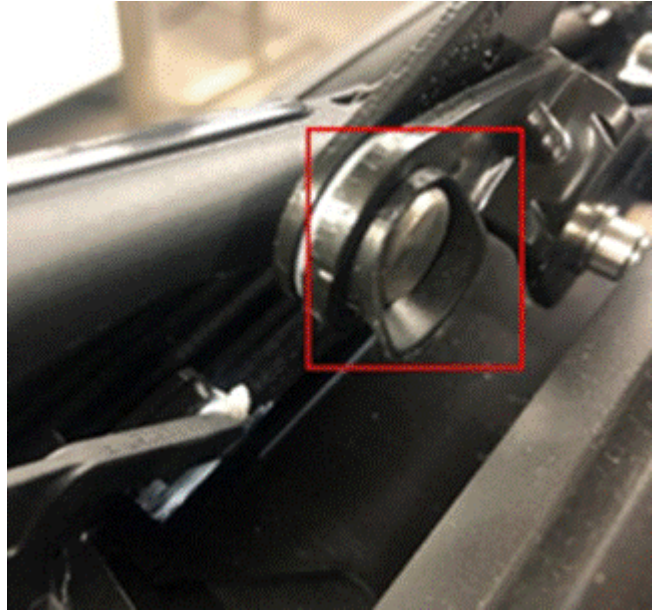
3. Figure 3 shows the water guidance washer with the front sunroof glass panel removed.

Figure 3. Water guidance washer on the front frame mechanism pivot.

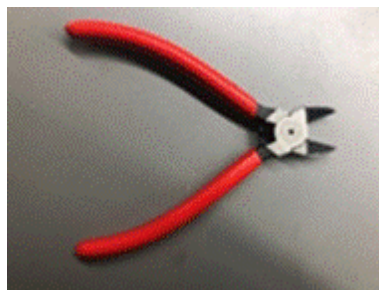
Figure 4. Diagonal cutters (side cutters).

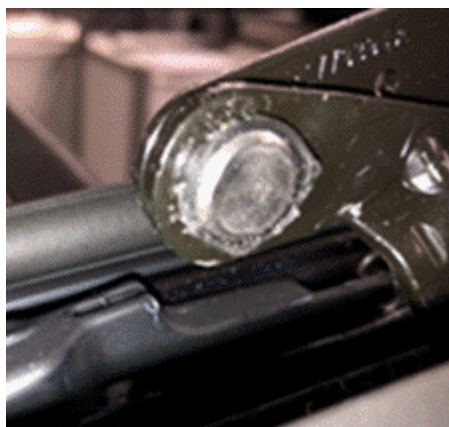
Figure 5. Water guidance washer on the front frame mechanism pivot.

5. Figure 5 shows the removed water guidance washer trimmed below the pivot pin. Since this pivot pin is concealed by the front sunroof glass panel "skirt" it is not necessary to smooth the edges of the cut surfaces.
