PIP5847 Diagnostic Tip: Abnormal Engine Tapping Noise From Cam Carrier Area And Possible Misfire Or Rough Run With DTC P0300

Brand:	Model:	Model Years:	VIN:		Engine:	Transmissions:
			from	to		
Chevrolet	Silverado	2019 - 2022	All	All	2.7 L3B	All
GMC	Sierra	2019 - 2022	All	All	2.7 L3B	All

Involved Region or Country:	North America
Condition:	Abnormal engine tapping noise from Cam Carrier area and possible misfire with DTC P0300
Cause:	Excessive movement in Exhaust Roller Follower roller due to axle pin wear

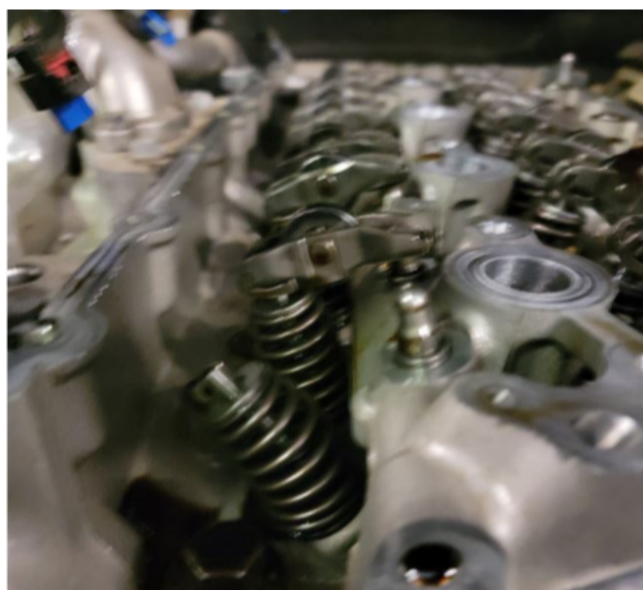
Once the Cam Carrier has been removed inspect each of the Exhaust Follower rollers for increased wear or up and down movement in the roller. The excessive up/down movement is an indication of increased axle pin wear and in worst cases the rollers can come out of position leading to a bent valve or damaged valve stem.

(Picture below showing bent valve due to worn Exhaust Roller Follower)

If a worn Exhaust Roller Follower is found, replace all 8 of the Exhaust Hydraulic Lash adjusters and Exhaust Followers. Also the Exhaust Camshaft should be inspected at this time for damage or premature wear caused by this concern.

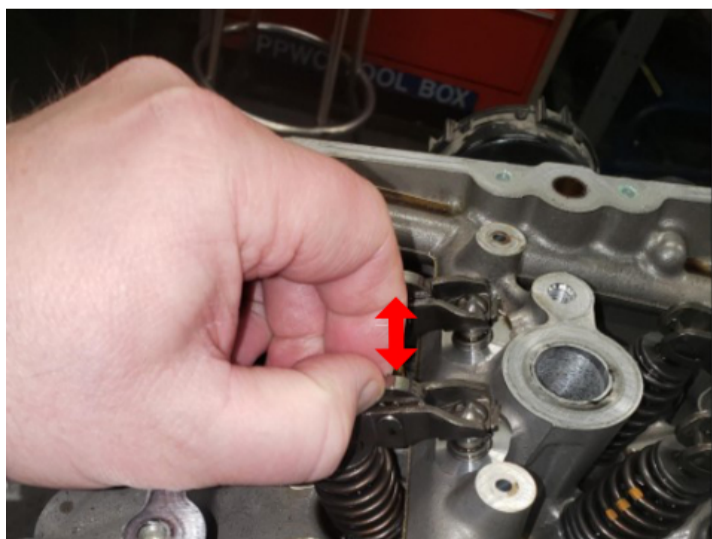
(Picture below shows a typical method used to check for worn roller followers)

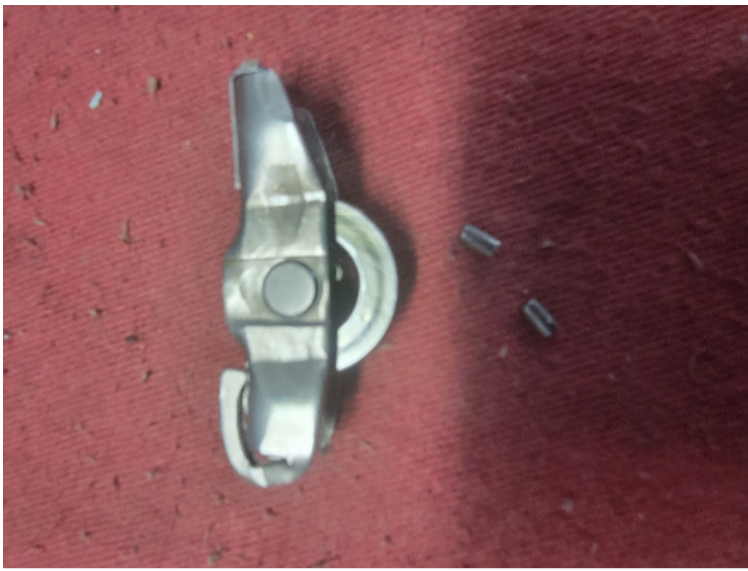
(Picture below shows example of excessive axle pin wear)

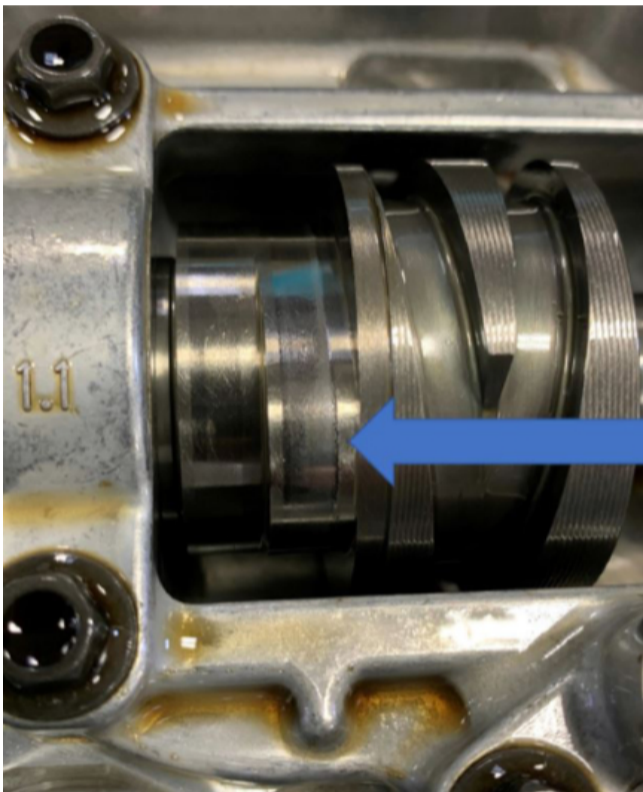
(Blue arrow in picture below showing Exhaust Cam lobe wear due to worn roller follower)
