## Preliminary Information

### PIP5822B MIL Illuminated with DTC P0341 Set

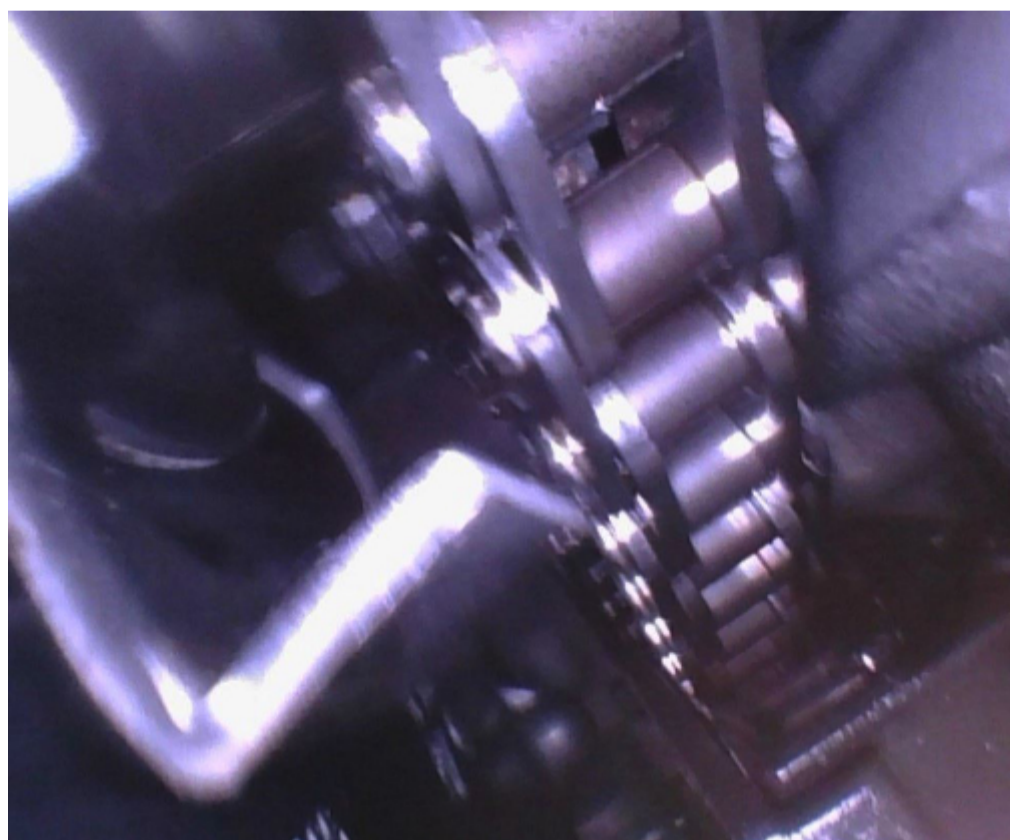
Involved Region or Country:	North America
Condition:	Some customers comment on the MIL being illuminated and the technician may find DTC P0341 set.
Cause:	This may be due to the Camshaft Position Sensor exciter wheel being bent.

Bent cam exciter wheel contacting the timing chain

Perform normal Service Information diagnostics. If that fails to identify the cause of the P0341, remove the camshaft position sensor and use a bore scope to inspect the camshaft position sensor exciter wheel for being bent. If the camshaft position sensor exciter wheel is severely bent and/or making contact with the timing chain, replace the exciter wheel.
