### PIT5396F Diagnostic Tips - Water Leaks

Brand:	Model:	Model Years:	VIN:		Engine:	Transmissions:
			from	to		
Chevrolet	Colorado	2015 - 2022	All	All	All	All
GMC	Canyon	2015 - 2022	All	All	All	All

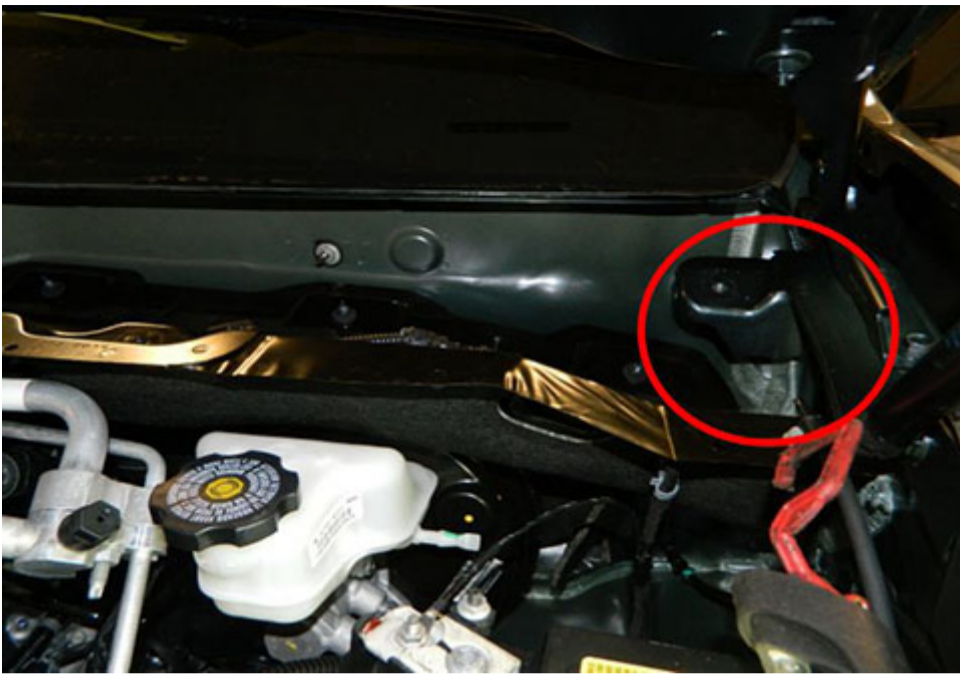
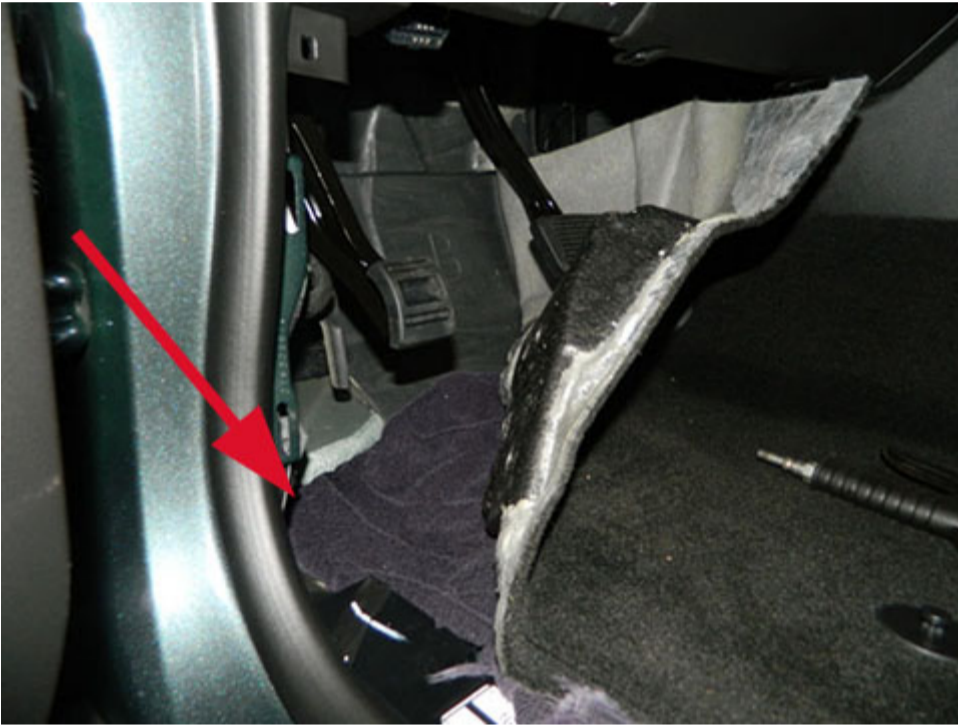
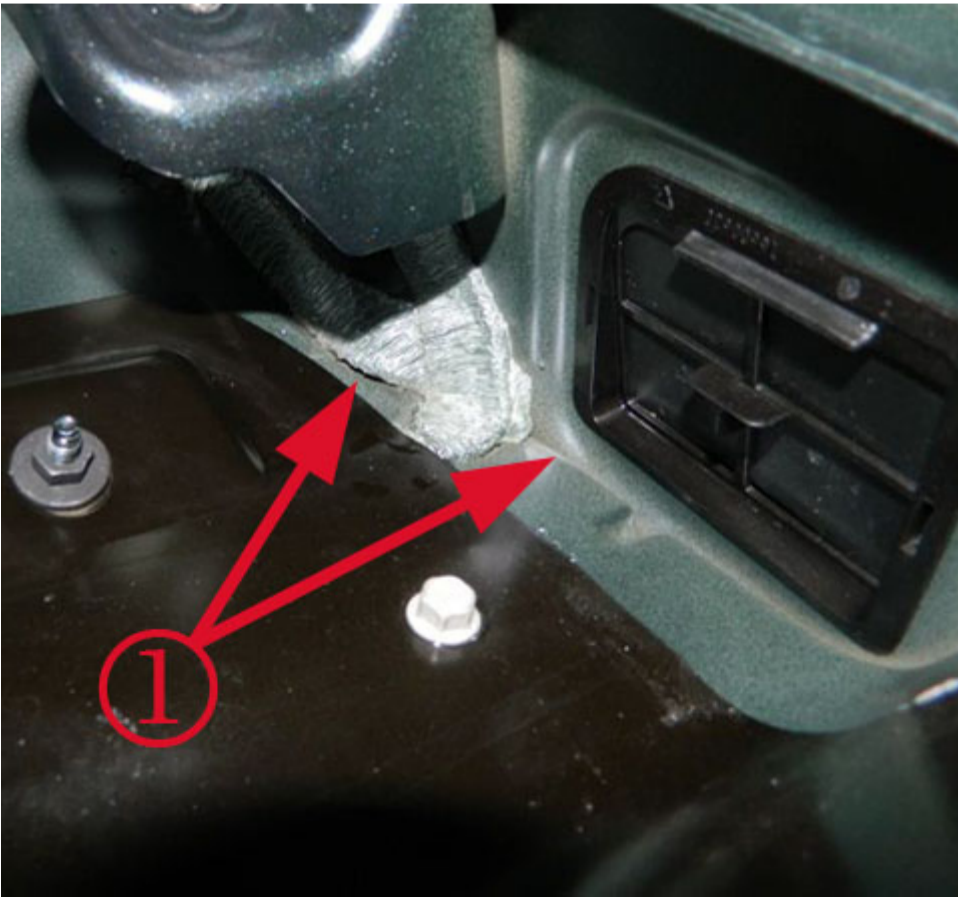
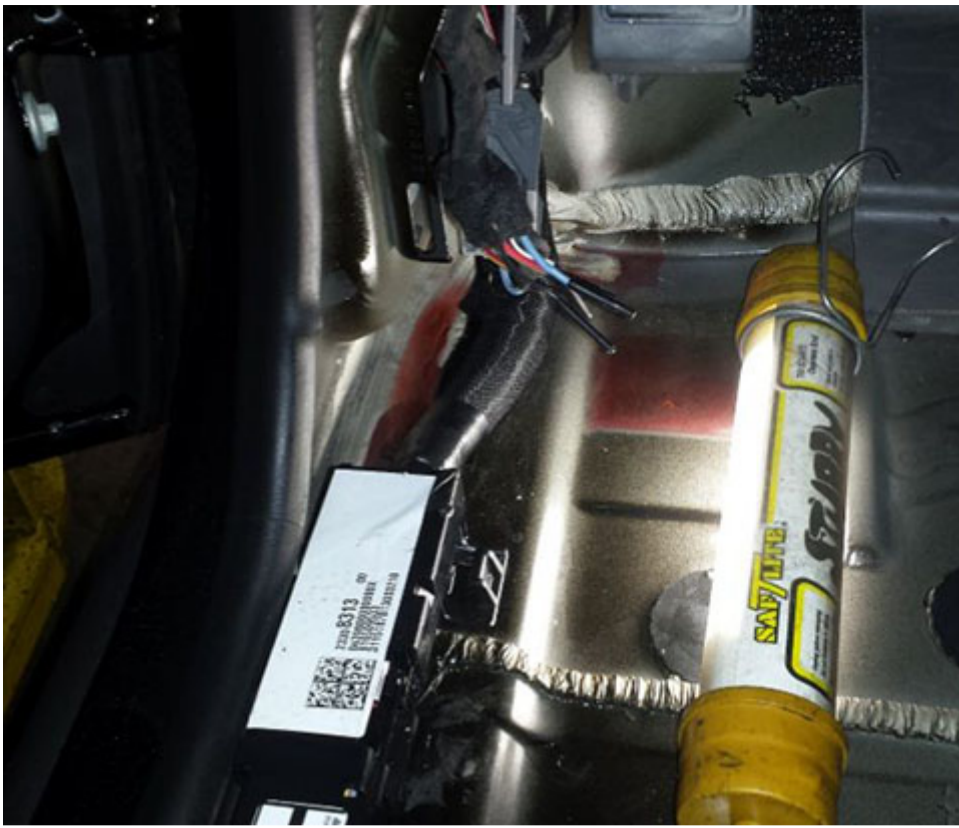
- 5) Cowl seam: May allow water to accumulate on the floor. Water test by cowl drain left and right side. Water may enter from outside cowl area under hood from left and right side add seam sealer.**

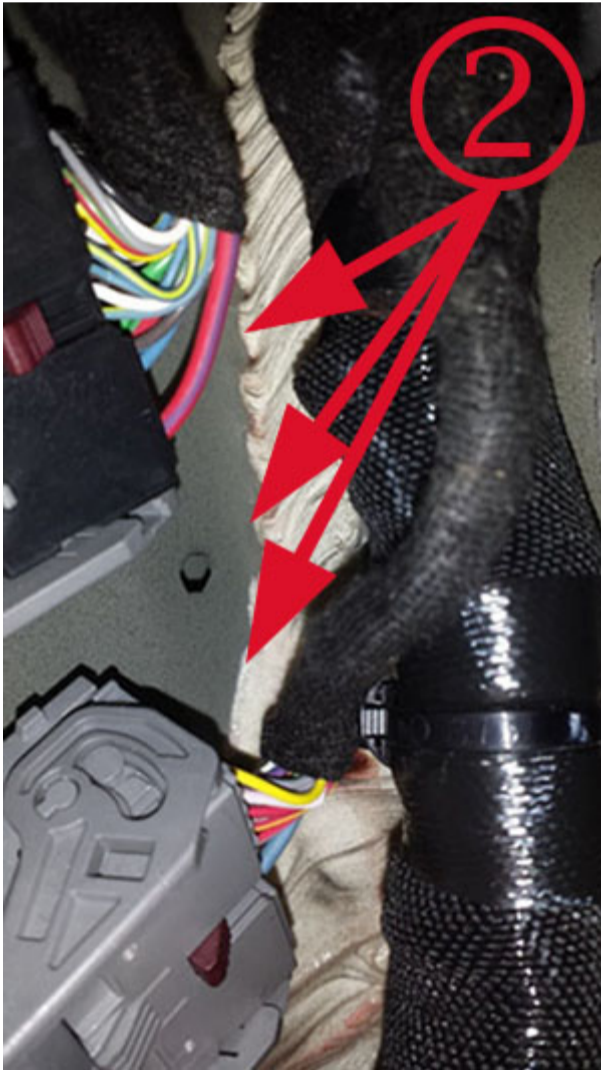
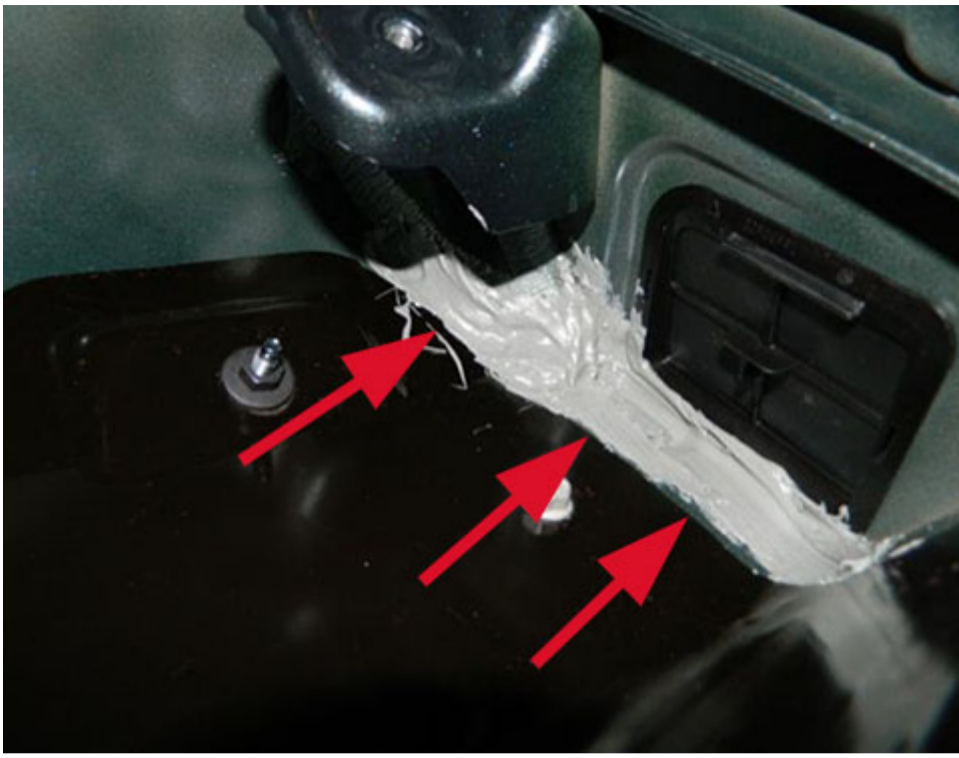
The other area is under dash in the left and right side vertical seams. Reseal as needed
