Preliminary Information

PIP5348D Vibration At Idle In Gear Or Low Speeds Remove Foreign Object Material Debris From Transmission Mount

Models

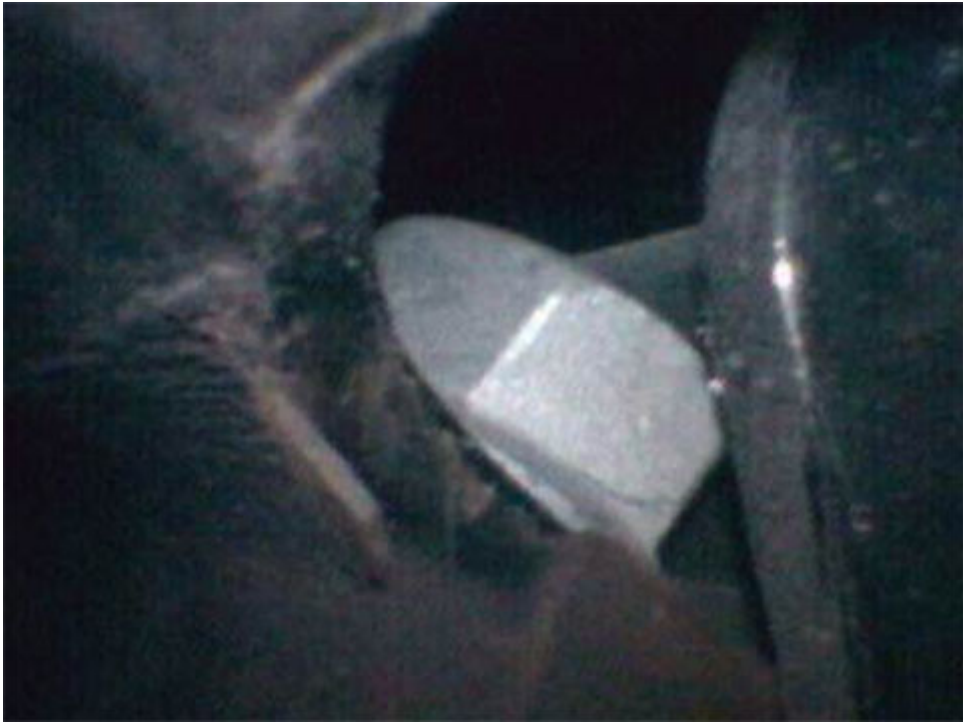
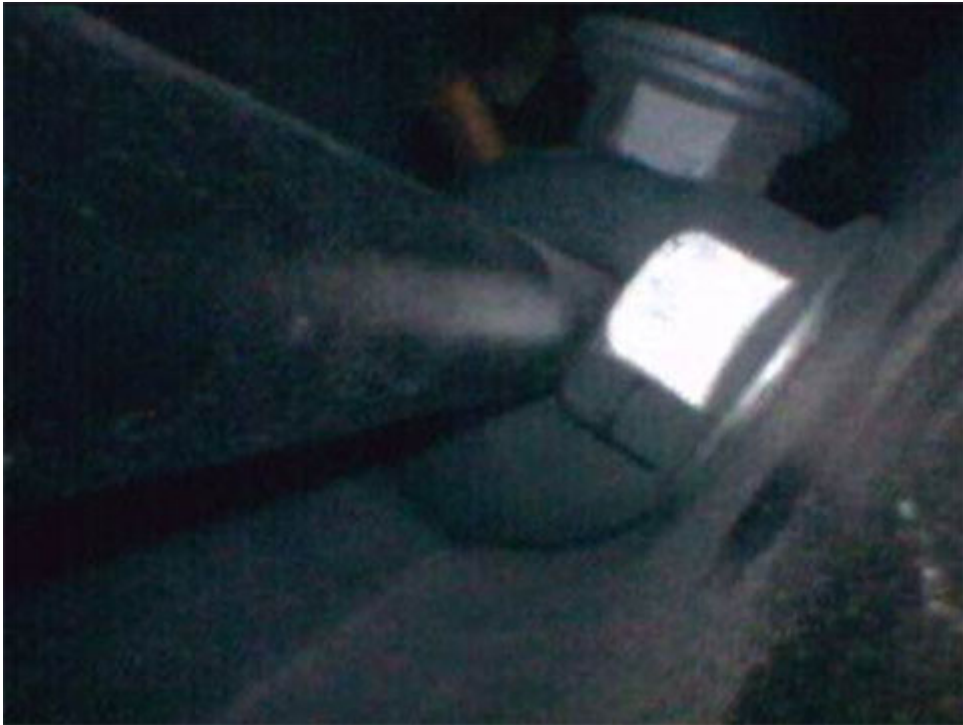
The technician should inspect for a stray nut or debris such as a rock wedged between the rubber and metal portions of the transmission mount.

This debris can be very difficult to find. The technician may have to use a borescope to locate it. See pictures below.

Loosen the transmission mount fasteners and manipulate the mount to allow removal of the stray debris.

Torque all fasteners back to specification.
