PIC6451A Paint Peeling Around the Front Fascia

Brand:	Model:	Model Years:	VIN:		Engine:	Transmissions:
			from	to		
Chevrolet	Corvette Stingray	2020 - 2022	All	All	All	All

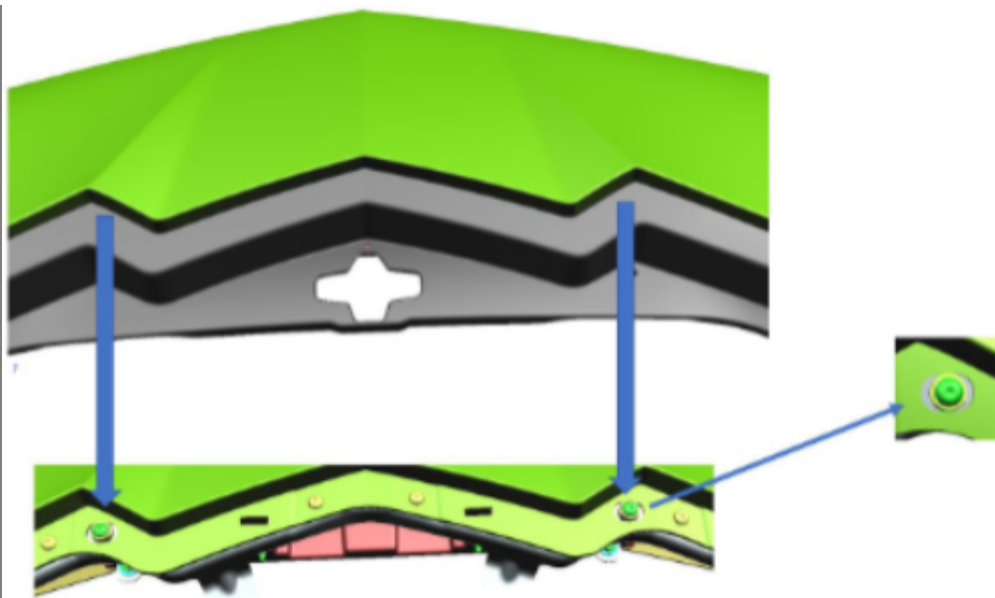
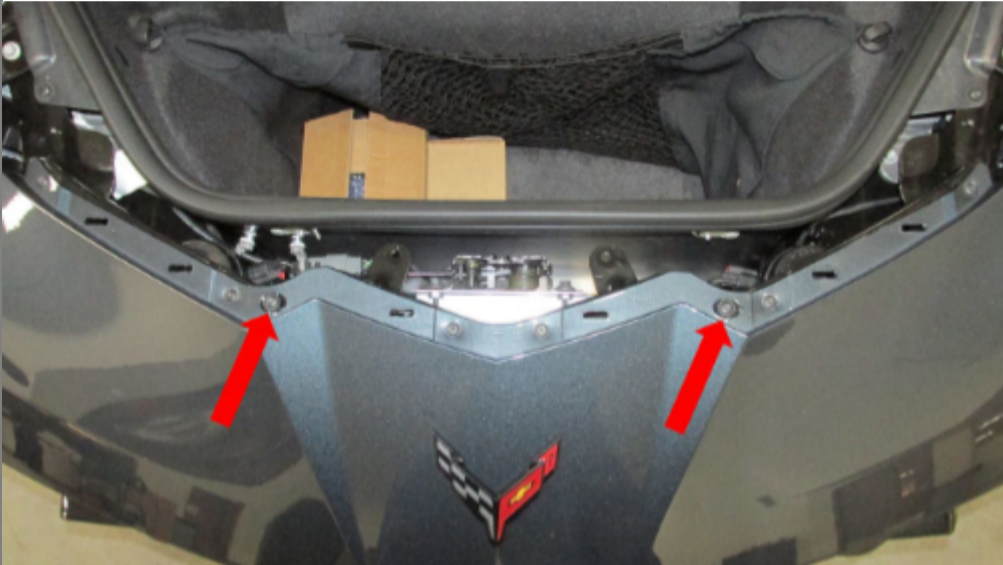
Concern	<p>This concern may be caused by several different issues. Engineering is attempting to gain additional information on this concern. If you have a vehicle that has a paint blemish that appears to be caused by the headlamp capsule on one of these vehicles, please follow the steps below:</p> <ol style="list-style-type: none"> 1) Gain access to the front fascia "locators". To do this, no tools are actually needed and it will take about 1 minute of time. This involves removing several front compartment trim panels by hand that are simply held in place by tension clips. 2) First remove the LH and RH Front Compartment Side Sight Shields 3) Next, remove the Front Compartment Rear Access Cover 4) Finally, remove the Front Compartment Front Sight Shield 5) This will allow access to the front fascia "locators", which will require inspection. 6) Technicians will need to look at these locators to see if they appear centered in the slots. This is a 15 mm locator that is placed in a 22 mm slot. This leaves 3.5 mm of open space, on each side of the locator. <p>Before any repairs are actually made, take several pictures of the concern. Please refer to PIC6346A for some general guidelines on how to take clear photos and send them in to the Technical Assistance Center. In addition to taking clear photos of the concern showing the general area in question, take several, clearly focused close-up photos of the chip in the paint as well. Then, please take a couple photographs of the "Front Fascia Locators" on the vehicle in question. These locators can be seen in the two photos below. The first photo is a computer drawing that illustrates these locators. The second photo is where they can be found on an actual car.</p> <p>NOTE: Regardless if the paint / fascia concern is only on one side of the car or not, please photograph BOTH locators when sending in pictures to TAC.</p>

7) Lastly, create a TAC case for this concern and attach the photos to the DCM case.

NOTE: When attaching the photos to the TAC case, the LH and RH side locators MUST be labeled.
