Preliminary Information

PIT5556A (Inspect Wiring Harness) Multiple Warning Lights / Messages / High Speed Lan / Chassis Expansion Bus / Intermittent Engine Stall at Stops / Service Power Steering / Service Stabilitrak / Service Park Assist / Service Traction Control / Service Suspension / Service Trailer Brake Message / Shift to Park / PRNDL May Not Display Gear

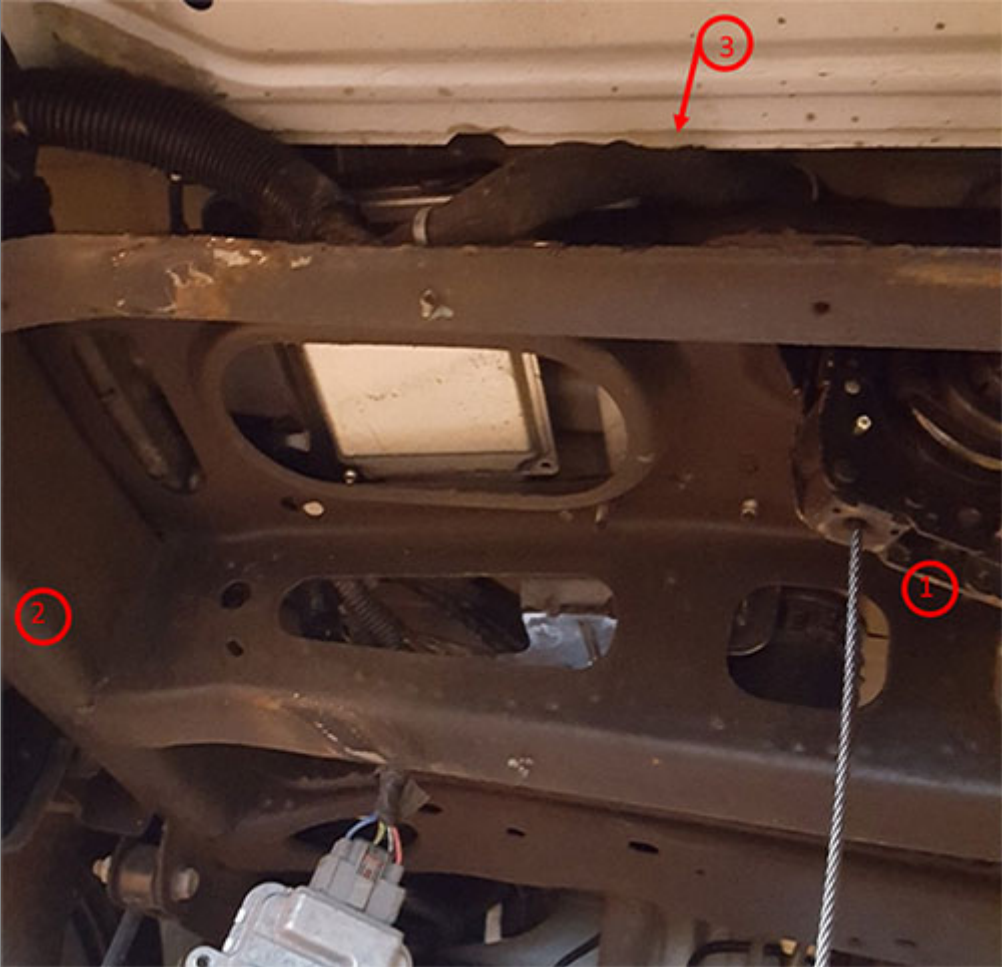
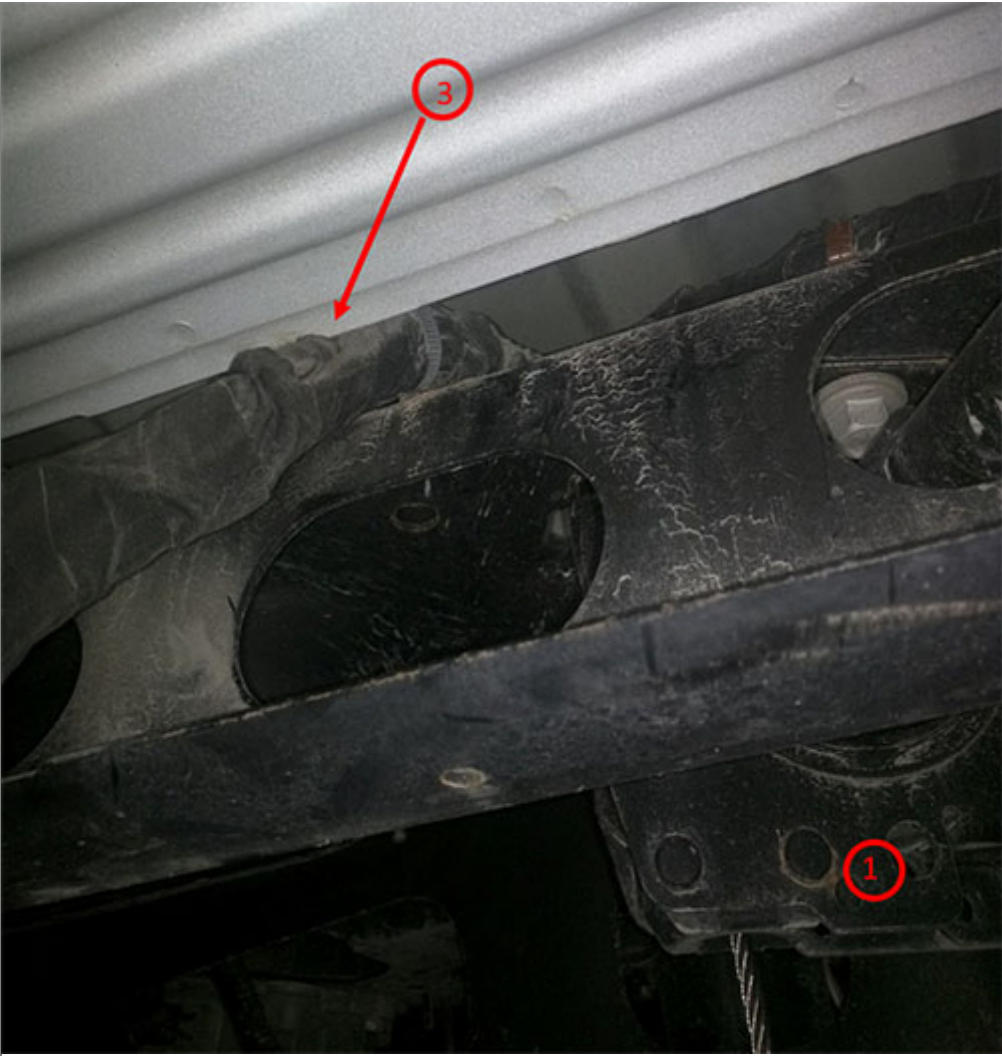
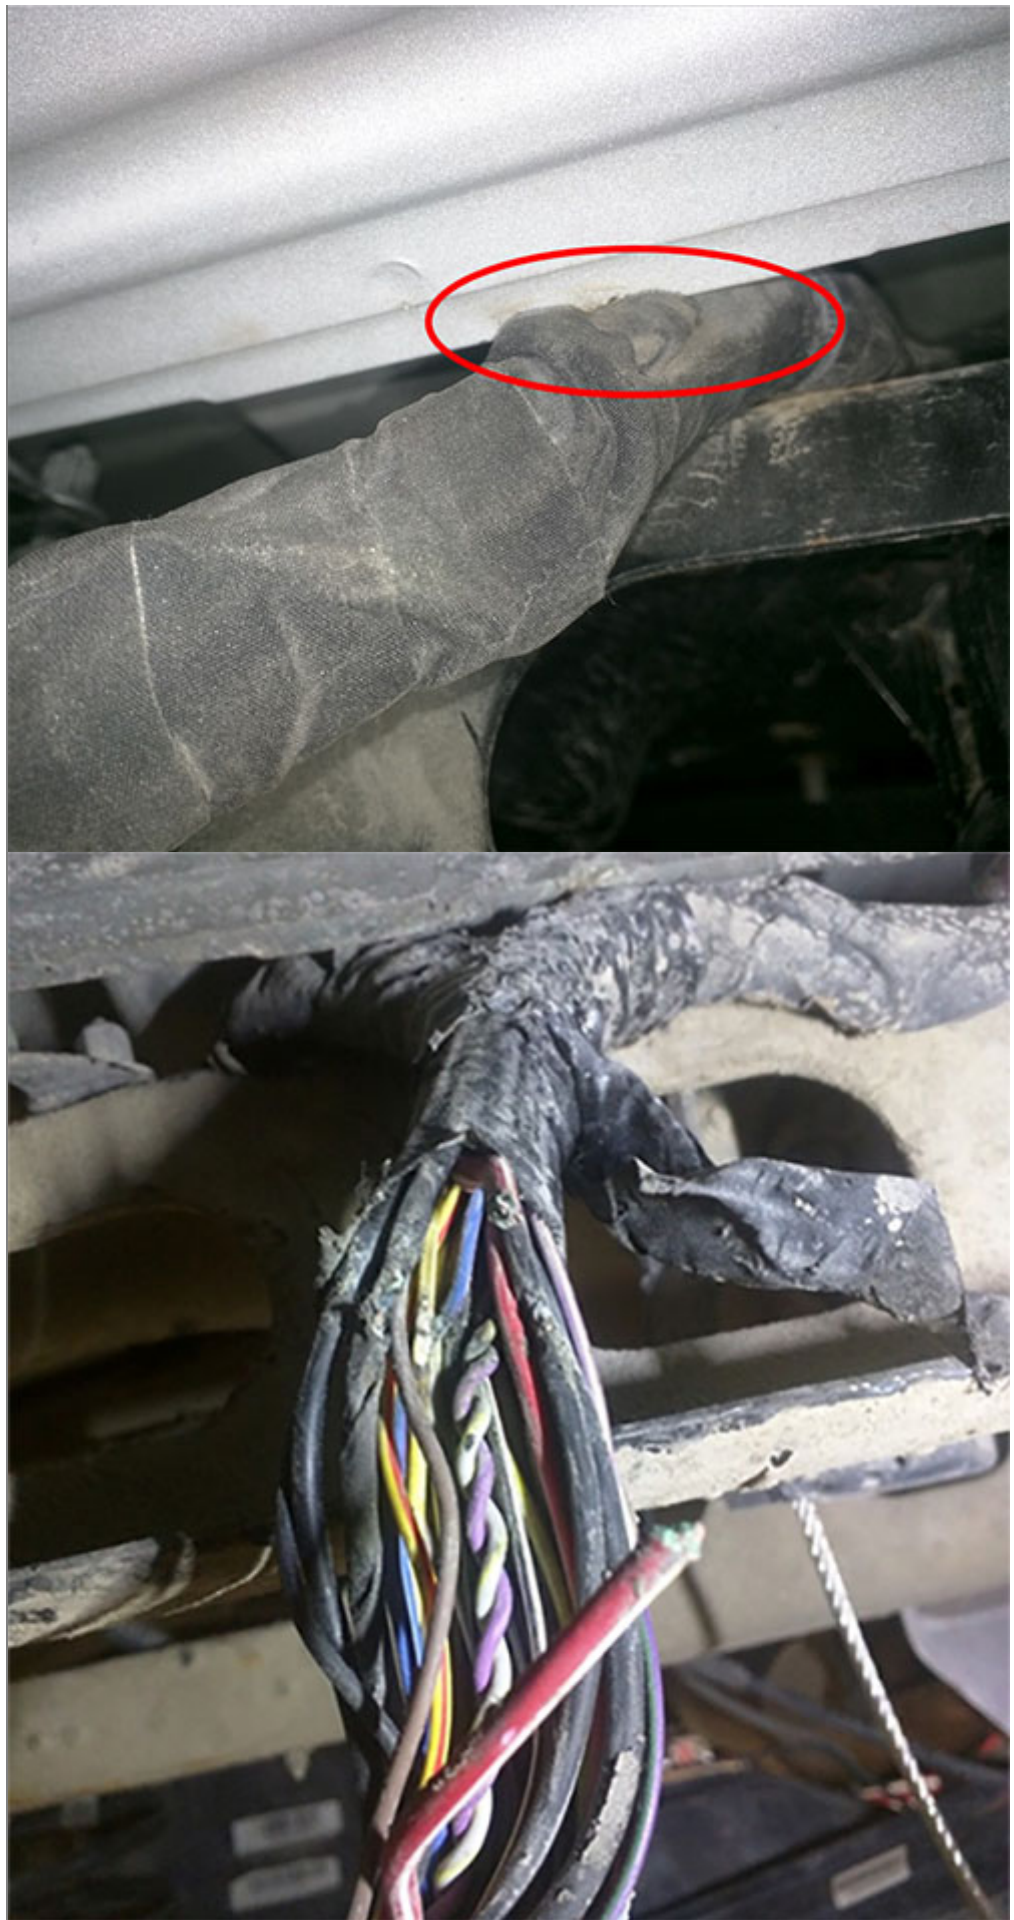
| Cause | <p>If the source of the issue(s) are not found after performing normal SI diagnostics, they could be caused by a shorted chassis harness (3) where it passes between the underbody floor structure and frame cross member above the spare tire, as shown below. Depending on which wire(s) are damaged will determine which vehicle system(s) are affected: Communication Busses High Speed Lan/Chassis Expansion, Electronic Suspension Control, Trailer Brake Control, etc.</p> <p>The spare tire has been removed to access the area.</p> <ol style="list-style-type: none"><li>1. Spare Tire Hoist</li><li>2. Left Rear Frame Rail</li><li>3. Area of Shorted Harness</li></ol> |

Repair the affected wiring as needed. To provide more clearance between the wiring harness and the frame / body, attempt to reshape or flatten the harness in the affected area so it is more of an oval shape. Apply anti abrasion tape to help hold the shape, and, if needed, add additional protection to the harness to prevent any damage from reoccurring.
