Preliminary Information

PIP5849 LUV/LUJ Intermittent P0299 Codes

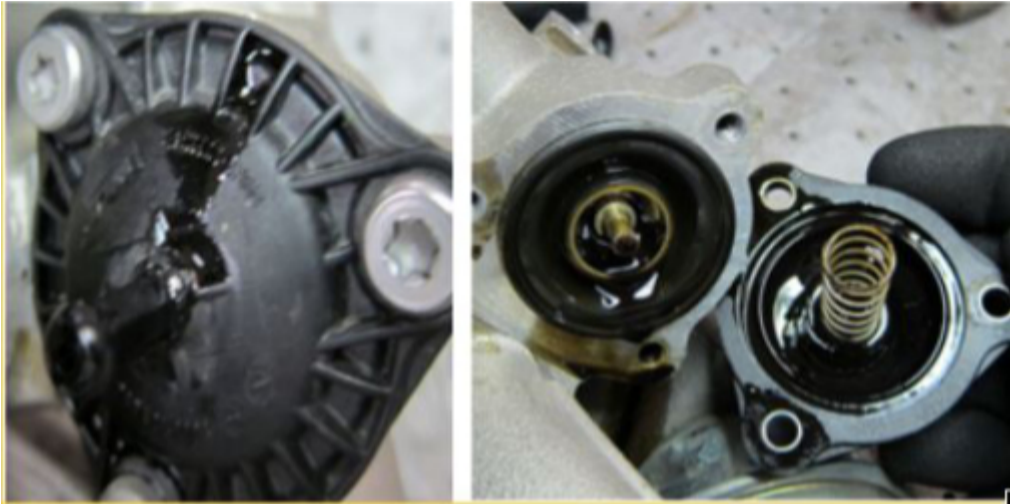
1. Inspect the Charge Air Bypass Valve for oil/water/sludge build-up in the vacuum side port.

2. If found oil/water build-up in the valve port, disassemble, and clean the components. Refer to Charge Air Bypass Valve Replacement in SI. Only if necessary, replace the components (Charge Air Bypass Valve if required).
