Preliminary Information

PIT5886A Tailgate Latch Handle Disengaged From Tailgate

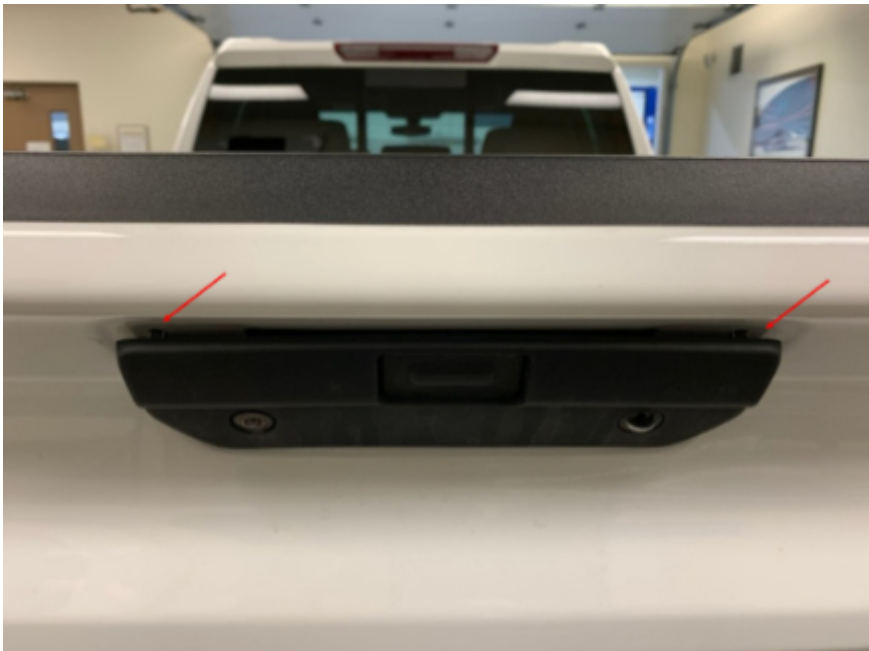
Involved Region or Country	North America
Additional Options (RPO)	QK1 - standard endgate
Condition	Some customers may comment that the tailgate latch handle has disengaged from the tailgate, as shown below.
Cause	The cause of this concern could be forces that are applied to a certain area of the tailgate inner panel being transferred through the standoff brackets (1) to the tailgate handle bracket disengaging the tailgate latch handle, shown below.

To correct this concern, follow the procedure below to remove part of the standoff brackets(1). Removal of the standoff brackets does not hinder the tailgates durability or performance.
