PIT5887A Diagnostic Aid: Intermittent Vehicle Powers Up But Will Not Crank

Brand:	Model:	Model Years:	VIN:		Engine:	Transmissions:
			from	to		
Chevrolet	Colorado	2021 - 2022	All	All	LPG	All
Chevrolet	Equinox	2021 - 2022	All	All	LYNX	All
GMC	Canyon	2021 - 2022	All	All	LPG	All
GMC	Terrain	2021 - 2022	All	All	LYNX	All

Involved Region or Country:	North America
Condition:	Intermittent No Crank. Vehicle Powers Up Normally.
Cause:	Oxidized B+ Nut or Stud On The Starter Solenoid.

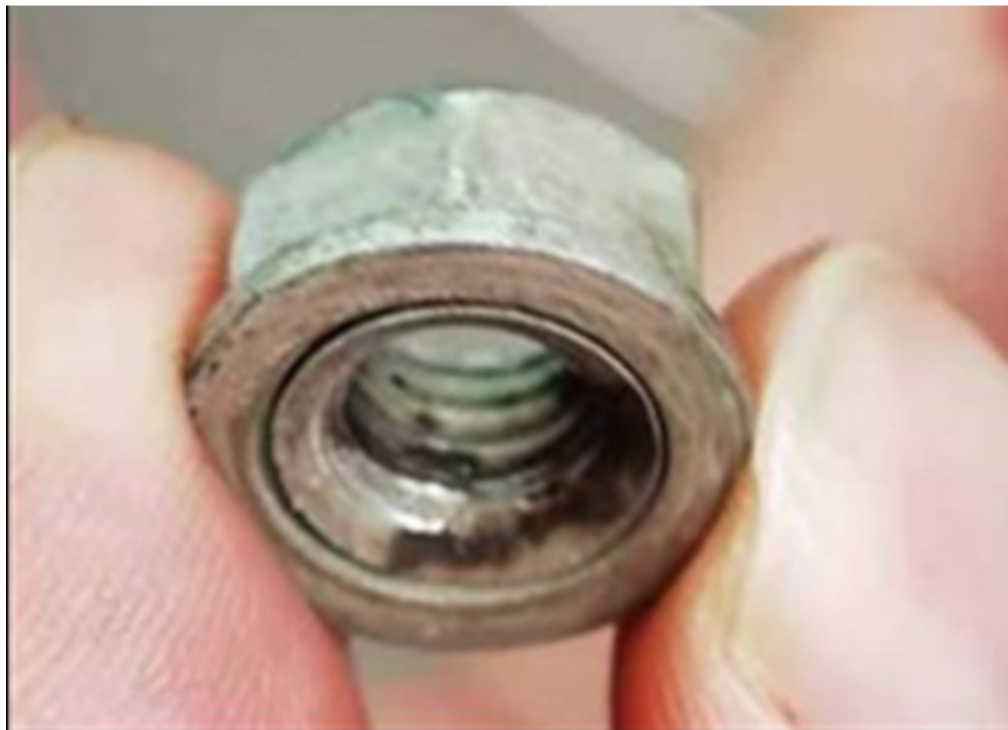
If a vehicle presents with an intermittent power up but no crank concern verify the B CM Power Mode Data shows Crank, The E CM Electrical Data shows active Crank Request and Crank Relay Command. If data is correct, check for power at the B+ terminal at the starter. If present, inspect the B+ stud on the starter for oxidation as shown below.

If it's oxidized as shown in the photos, you should replace the nut and clean the stud terminals and re-check starter function. If this corrects the concern, release the truck. If not, continue with starter diagnosis / replacement.
