Preliminary Information

PIP5681C Exhaust leak, Lean Codes, Rattle Noise, or Catalytic Converter Failure Codes.

Brand:	Model:	Model Years:	VIN:		Engine:	Transmissions:
			from	to		
Buick	Enclave	2018 - 2022	All	All	3.6L LFY	All
Chevrolet	Traverse	2018 - 2022	All	All	3.6L LFY	All

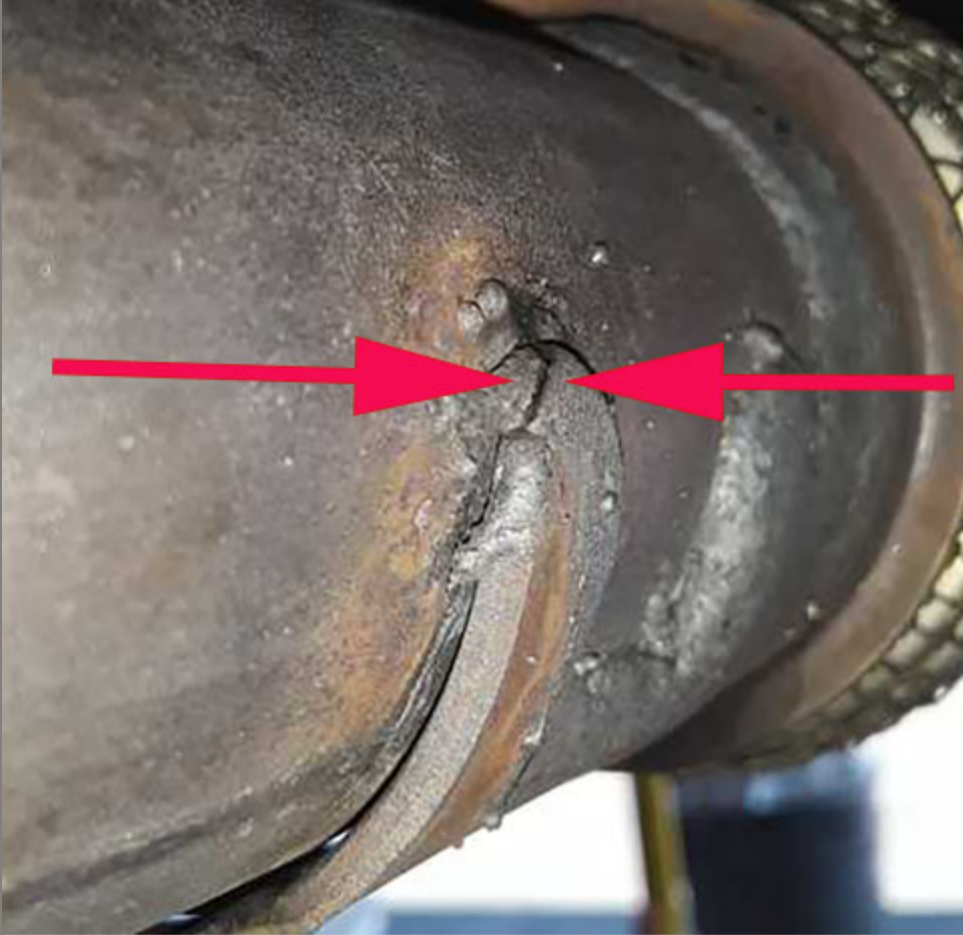
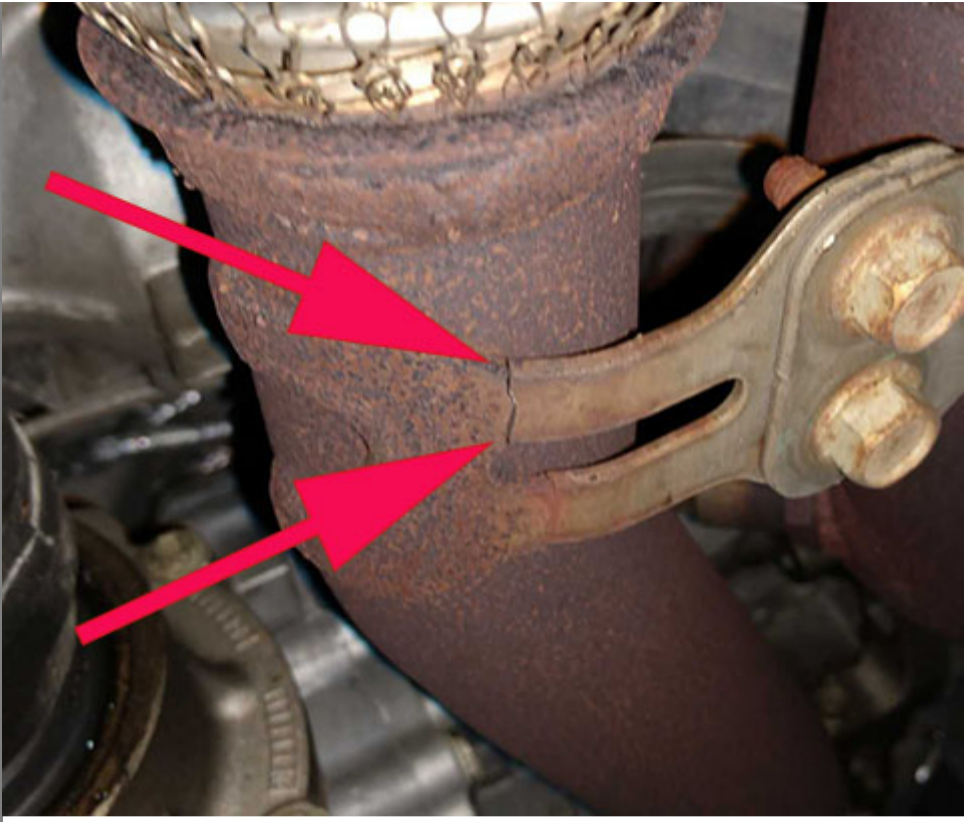
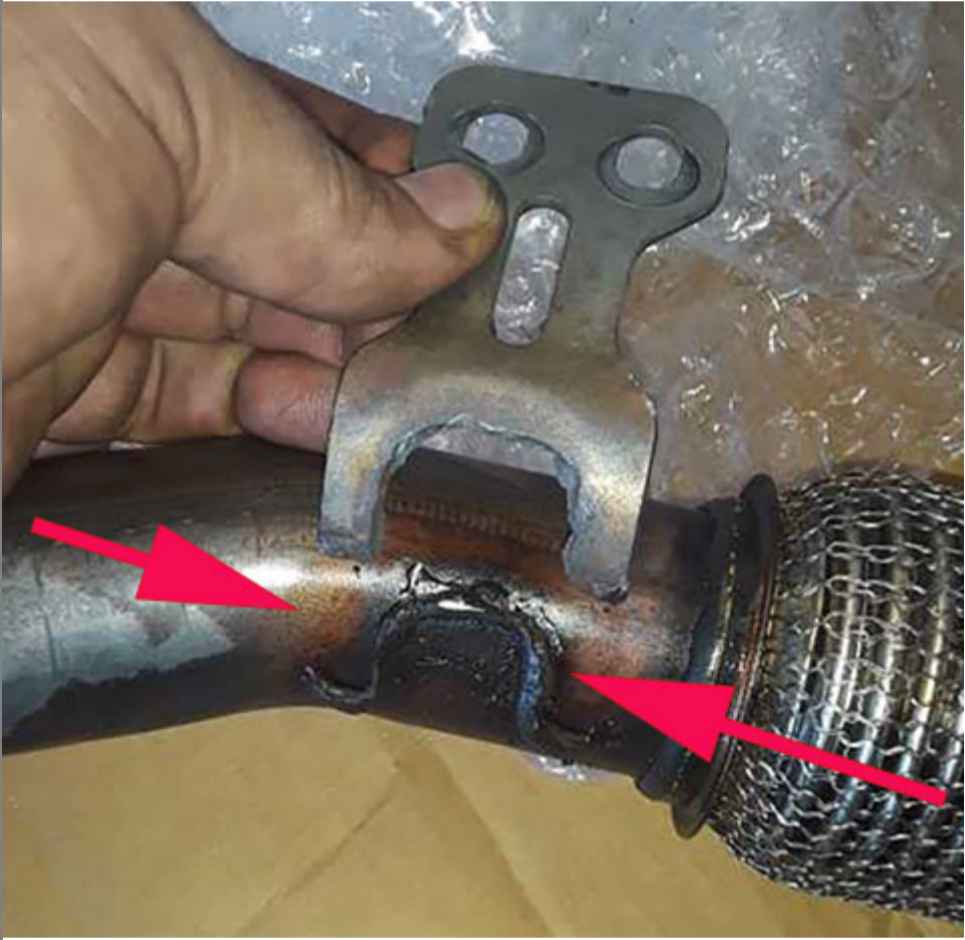
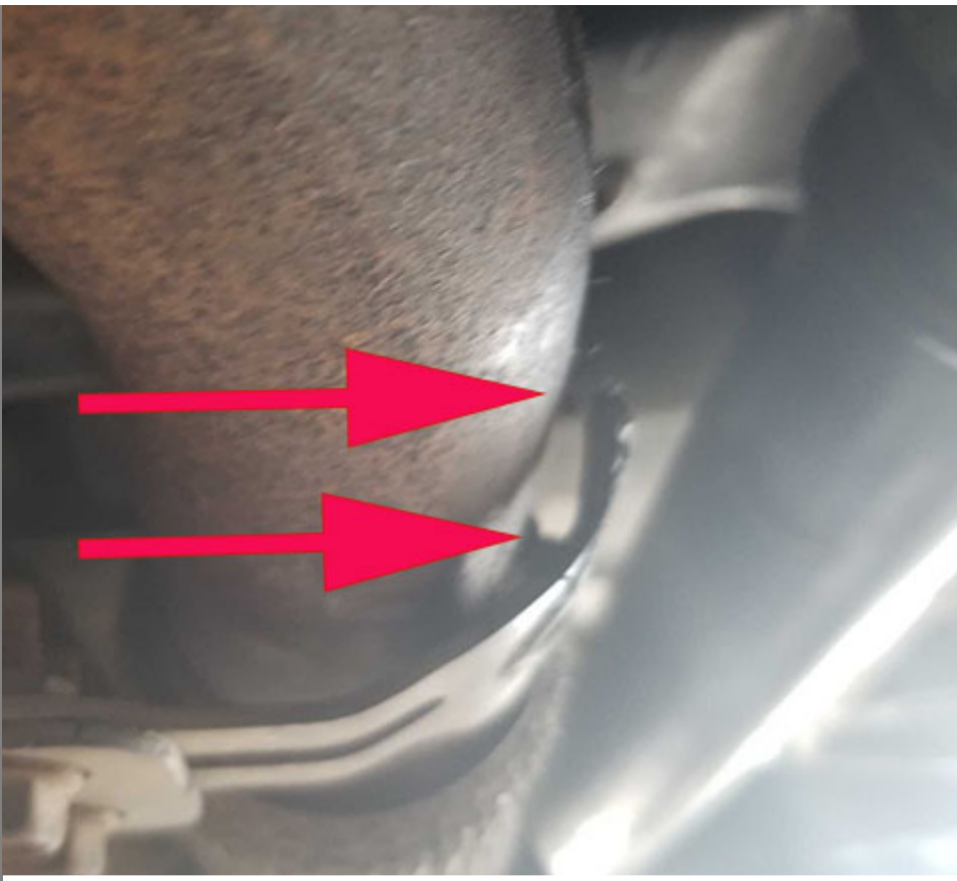
Cause The cause for these concerns could be a broken or poor weld with lack of penetration on the Bank 2 exhaust flex pipe bracket as shown below.
Also this concern has been seen to cause the same type of break on the pipe to the Bank 1 converter which is part of the front muffler assembly.

The correction for this concern is to replace the pipe from the Bank 2 converter to the mid exhaust assembly. Also inspect for damage to the right catalytic converter pipe at the connecting bracket caused by the Bank 2 pipe being broken and replace as needed.

NOTE: This concern does not cause hardware concerns on the catalytic converter and the converter should not be replaced for this.
