2022 Tundra HV Pre-Delivery Service (PDS)

Service Category General

Section Pre-Delivery Service

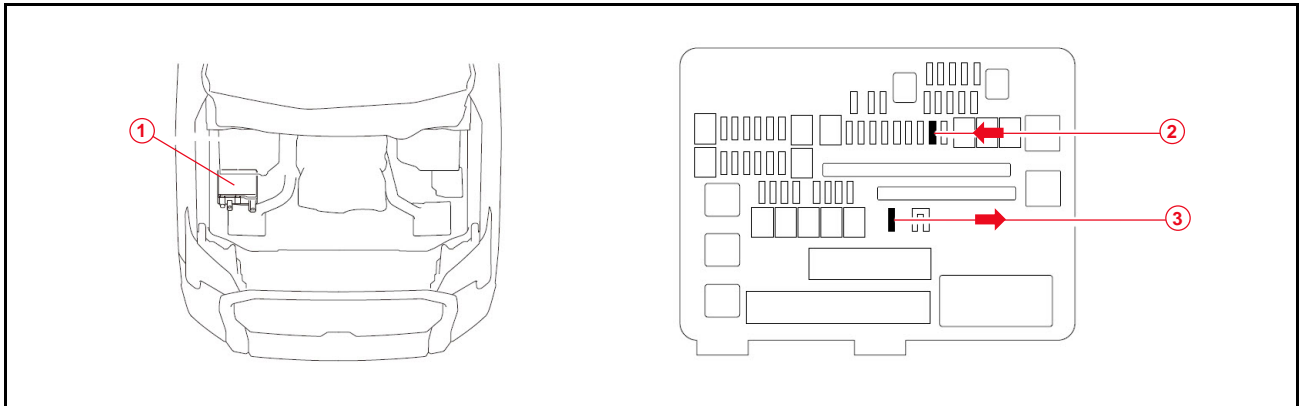
Figure 1.

To minimize battery discharge, the D/C cut fuse (30A) has been removed and is stored in the engine compartment relay block. Install the D/C cut fuse (30A) and confirm ALL related Diagnostic Trouble Codes (DTCs) are cleared.

1	Relay Block
2	Install D/C Cut Fuse (30A)
3	Remove D/C Cut Fuse (30A)
