Aftersales Bulletin

00 16 68 02 00 – Service Action Fuel Tank Feed Line Check

This service action affects Ghost (RR21) and Cullinan (RR31) models produced from November 8th, 2021 to November 12th, 2021.

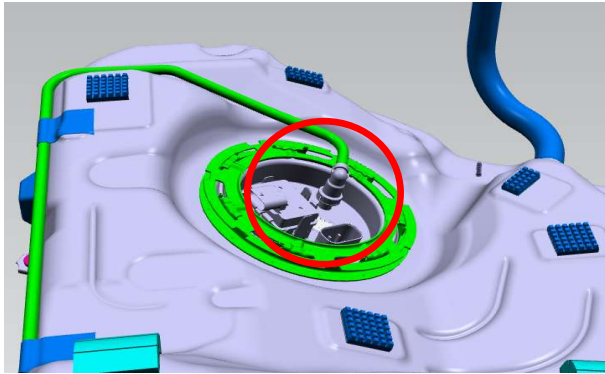
Step 2. Locate the fuel tank feed line connection shown circled in “red” in the picture below.

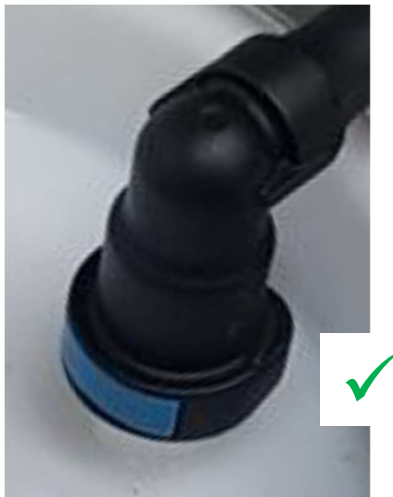
Push-fit connection OK

Locking mechanism properly engaged = fuel tank feed line installed correctly.

No further action is needed. Reinstall the fuel tank following repair instructions.

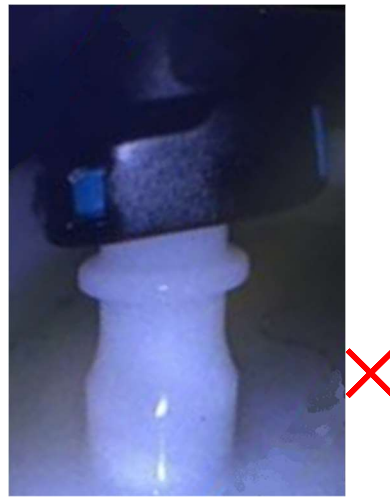
Push-fit connection Not OK

Locking mechanism not properly engaged = fuel tank feed line installed incorrectly.

Properly install fuel tank feed line by pressing or pushing down on it until it is fully seated.
