E-Series	Model Description	Production Date
G22	4 Series Coupe	January, 2021- January, 2022
G82	M4 Coupe	January, 2021- January, 2022

The trunk floor carpet is wet, primarily on the left side.

A crack in the rear window frame panel.

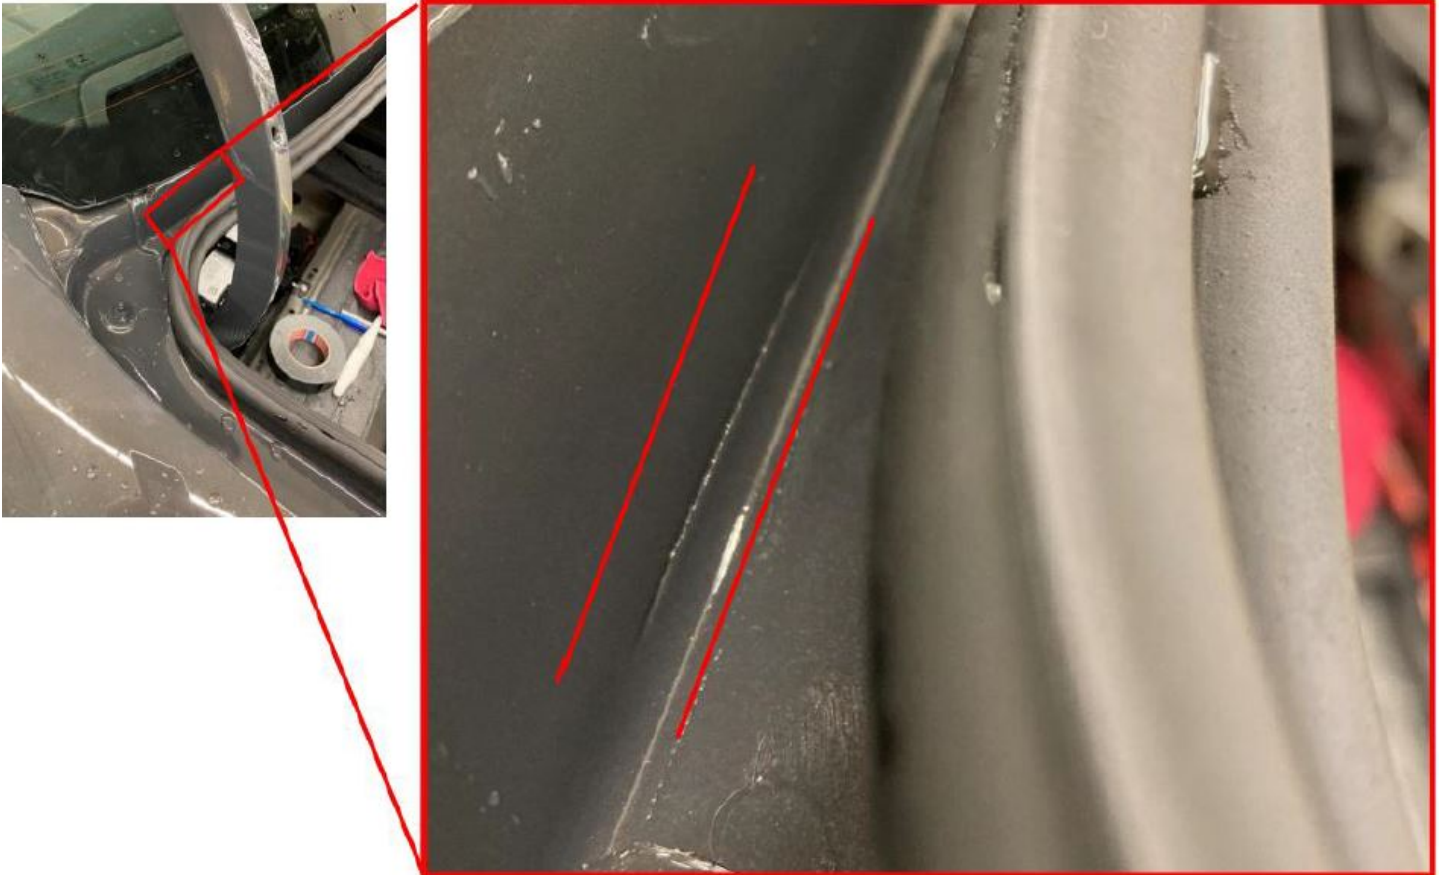
Inspect the area around the lower left corner of the rear window for a crack as shown below:

Repair the crack by welding.

The crack will need to be drilled at both ends and will be welded closed using one of the following methods:

1. MAG (metal active gas) welding with special care not to overheat and expand the crack
2. MIG (metal inert gas) welding using silicone bronze
3. Soft soldering/braze

After repairing the crack, the repaired area will need to be repainted and consequential repairs may apply.
