GROANING NOISE FROM DOORS

This Service Information Bulletin (Revision 1) replaces SI B51 30 19 dated September 2019.

F15 (X5 Sports Activity Vehicle)	F16 (X6 Sports Activity Coupe)	F85 (X5 M Sports Activity Vehicle)	F86 (X6 M Sports Activity Coupe)
F95 (X5 M Sports Activity Vehicle)	F96 (X6 M Sports Activity Coupe)	G05 (X5 Sports Activity Vehicle)	G06 (X6 Sports Activity Coupe)

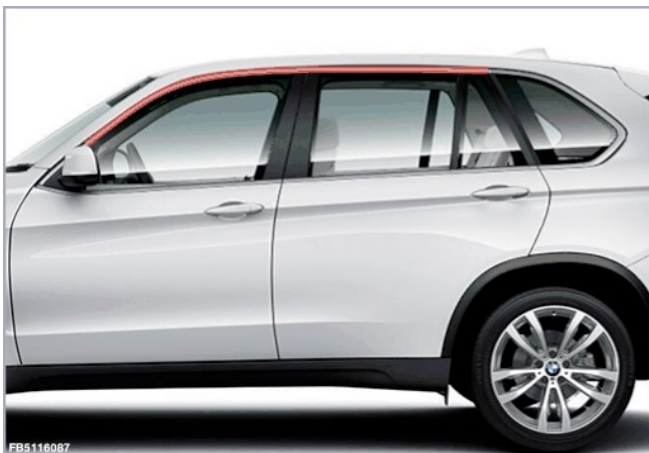
A groaning noise is present from the door frame of any door, most commonly when driving over rough roads or during body flex.

Excessive friction between the window guide and the door opening.

1. Check the door adjustment settings using the ISTA repair instructions applicable to the vehicle model being worked on.

2. Clean the upper door jamb in the area shown (on the body) using silicone remover concentrate 83 12 5 A16 119 of the affected door.
