**SECOND ROW SEAT LEATHER CLOUDY/DISCOLORED**

This Service Information Bulletin (Revision 3) replaces SI B52 02 21 **dated June 2021**.

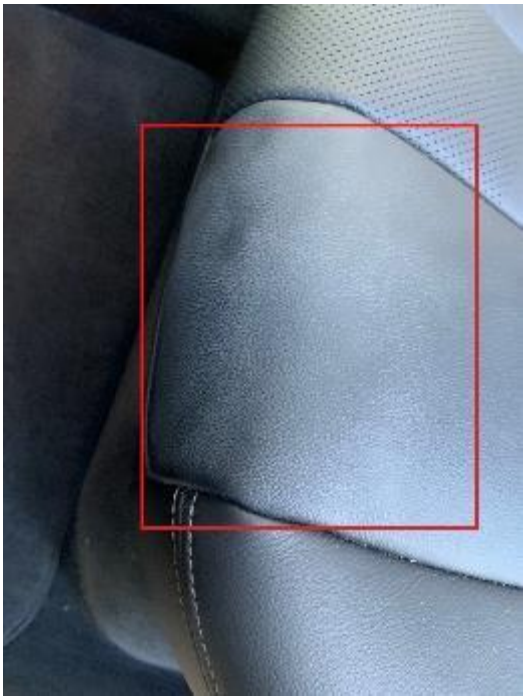
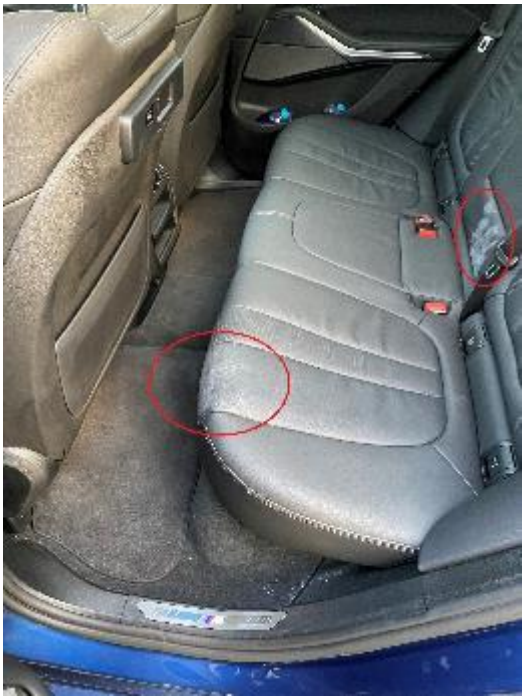
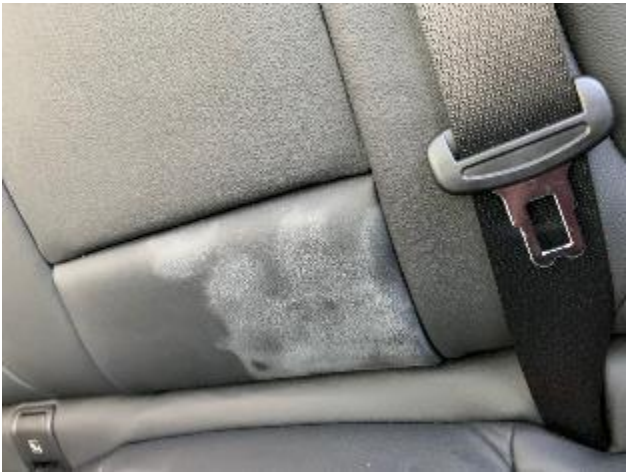
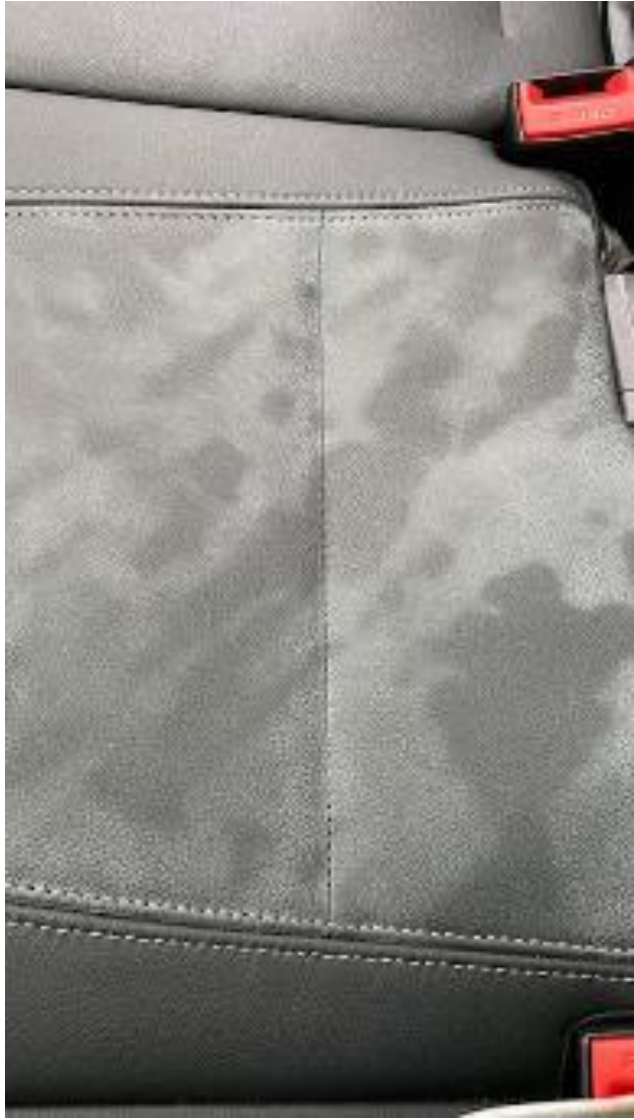
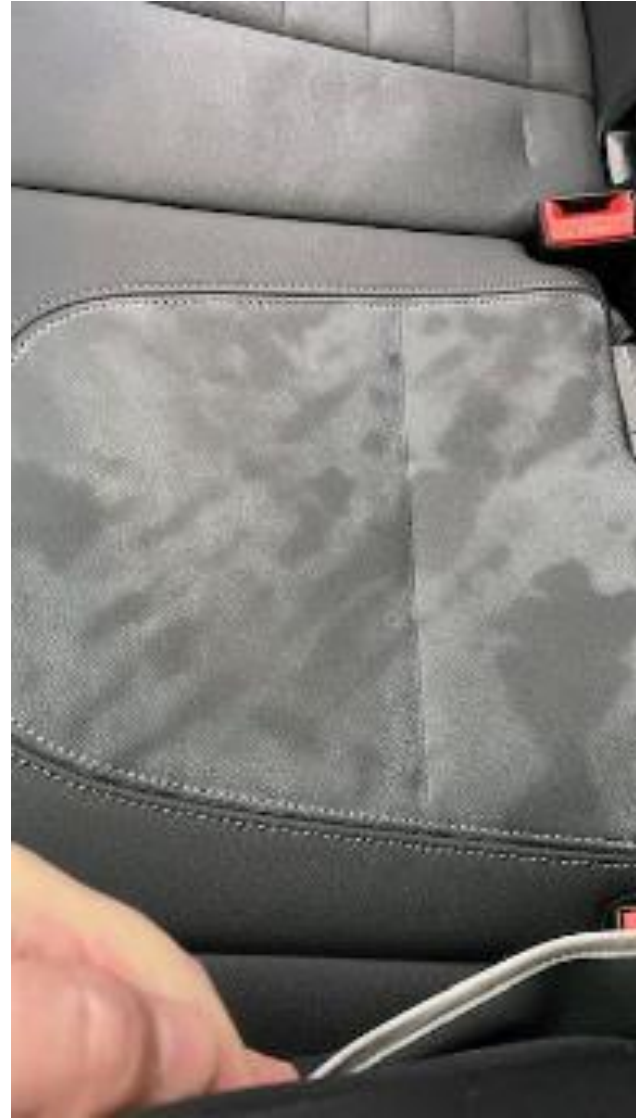
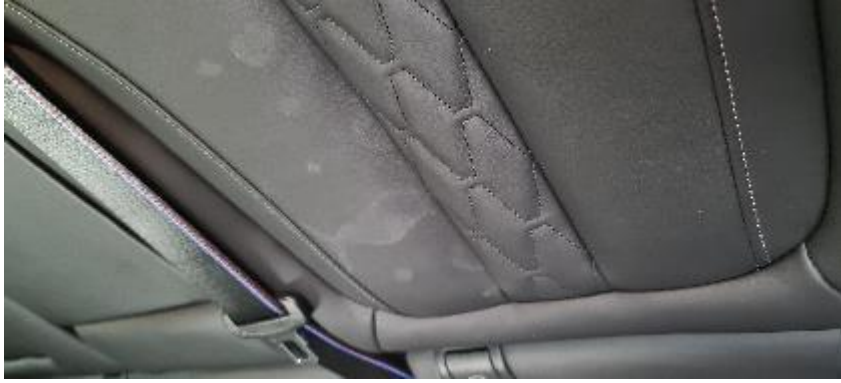
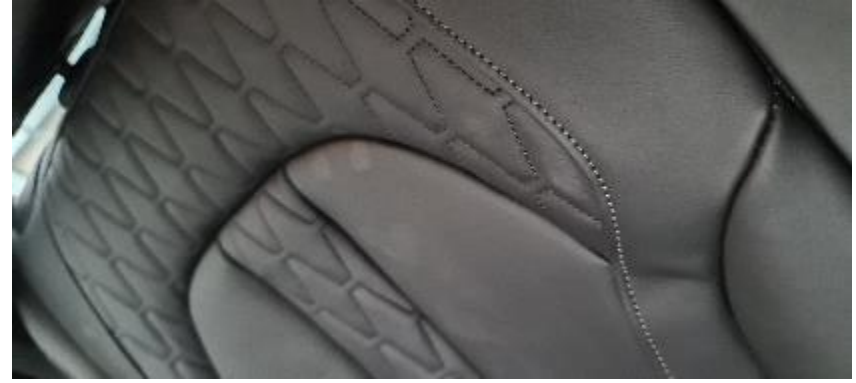
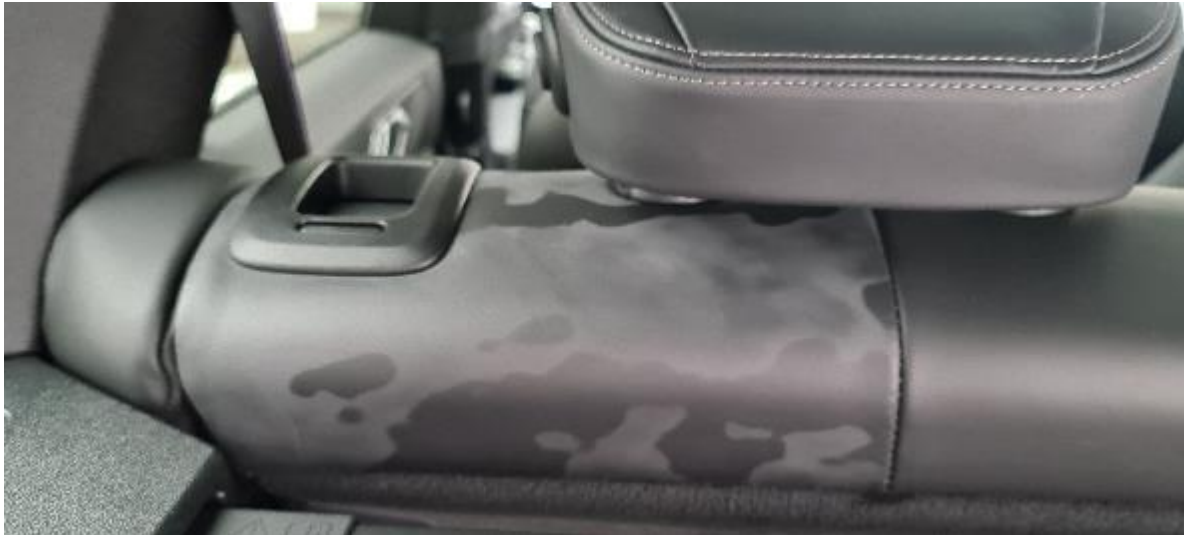
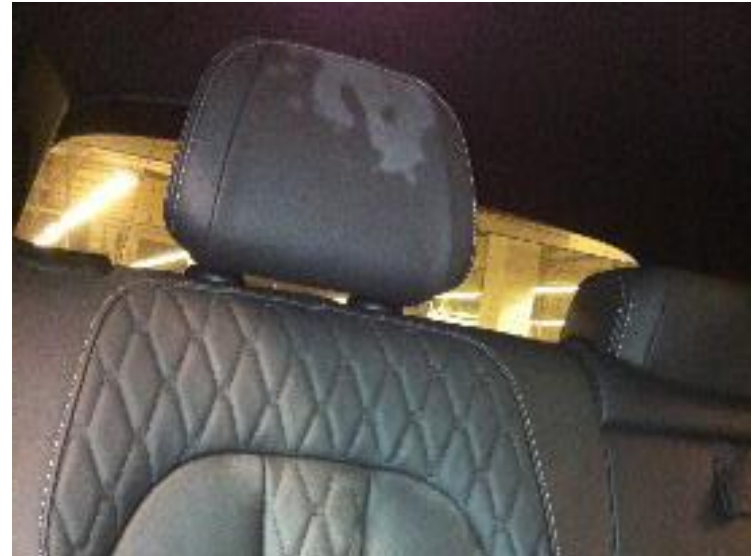
Milky-white stains (discolorations) in the leather are observed in the second-row seat bottom, backrests and/or headrests. Refer to attachment for details.

An unfavorable leather tanning process can result with isolated cases of grease residue accumulating in the second-row seat leather surfaces.

Only for the specific issue identified in the attachment, remove the tanning process-related residue in the second-row seat leather as outlined in the PROCEDURE section below.
