SIB 64 01 21

2022-03-09

WHISTLING NOISE COMING FROM FRESH AIR INLET (ENGINE COMPARTMENT)

This Service Information Bulletin (Revision 4) replaces SI B64 01 21 **dated February 2022**.

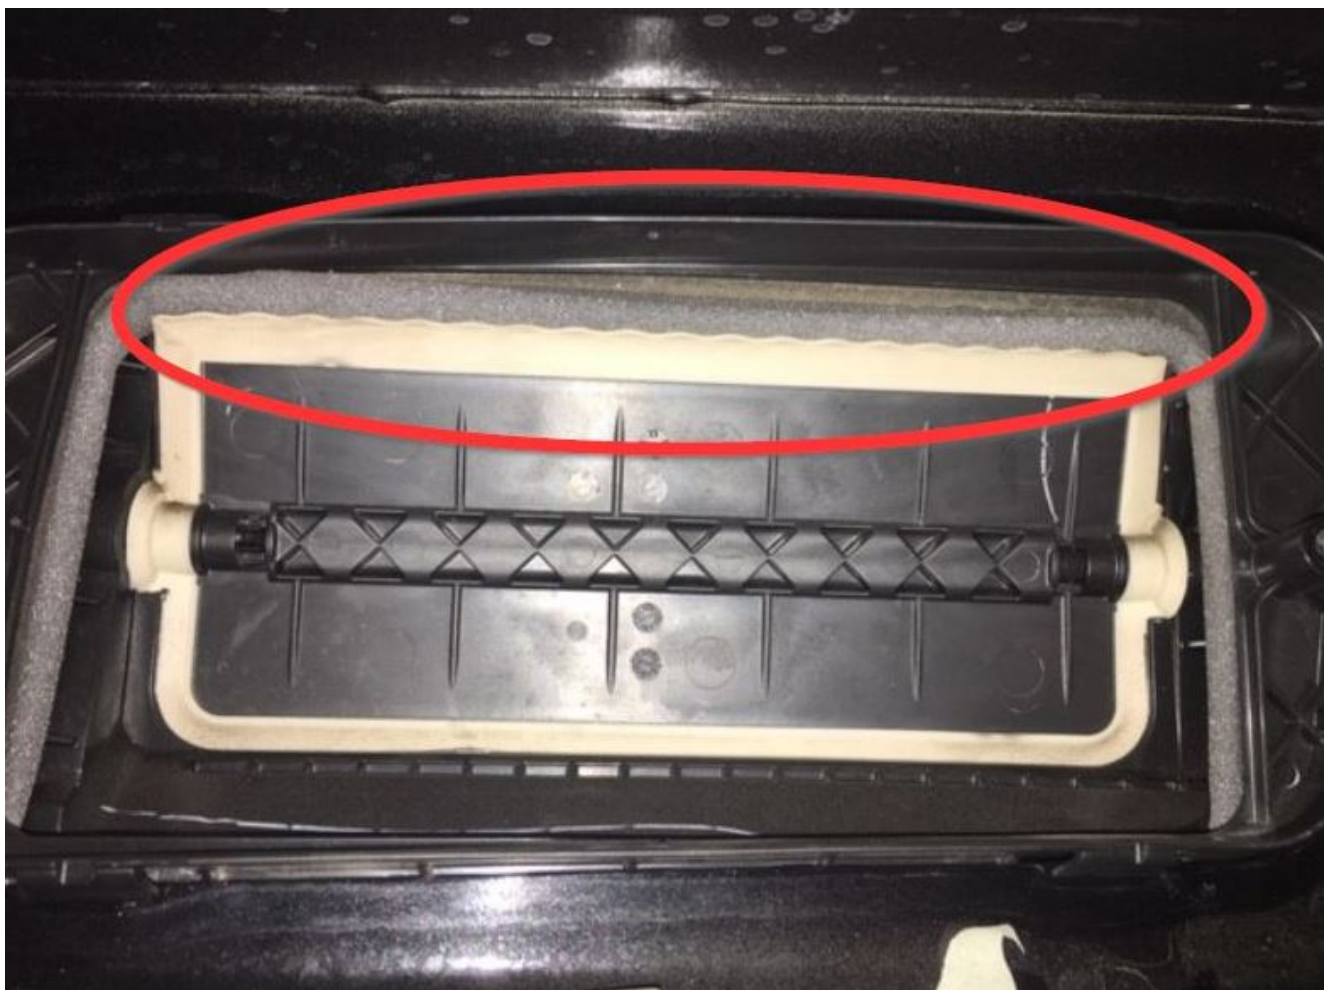
An unfavorably attached foam seal on the sealing frame of the fresh air inlet results in a gap between the foam and the sealing frame (circled). Unintentional air ingress can pass between the seal and the sealing frame.

Inspect the seal between the fresh air inlet and firewall for proper installation. If the seal is mispositioned, seal the gap with Butyl tape.

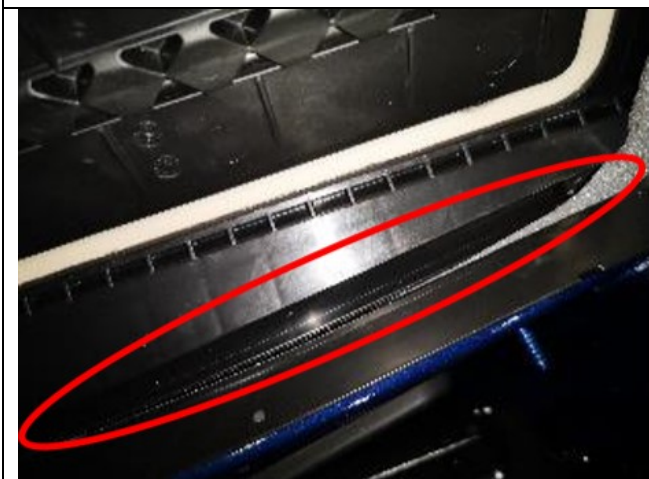
2. Remove the diffuser of the fresh air intake. Once the inlet has been removed, check if the foam material is correctly installed.

A mirror is helpful for checking the lower area of the sealing frame.
