Service Bulletin

Bulletin No.: 22-NA-090

Subject: Information on Lug Nut Stainless Cap Cracking, Rusting and/or Swelling

Brand:	Model:	Model Year:		VIN:		Engine:	Transmission:
		from	to	from	to		
Chevrolet	Silverado 1500	2019	2022				
	Silverado 2500HD/3500HD						
GMC	Sierra 1500						
	Sierra 2500HD/3500HD

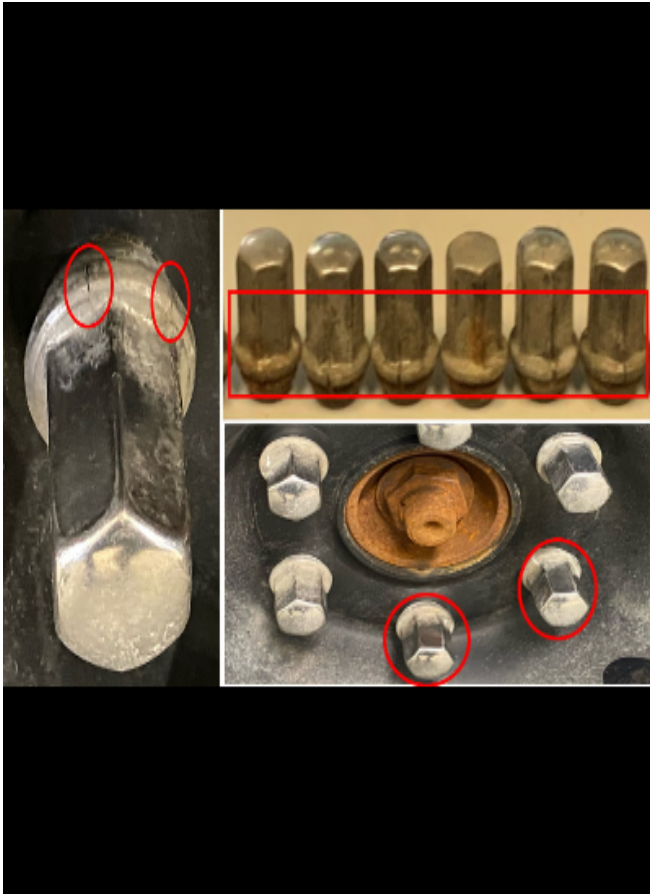
Involved Region or Country	North America, Australia, New Zealand
Condition	Some customers may comment that stainless caps on the lug nuts are cracking, rusting and/or swelling. – Refer to Examples of Damaged Lug Nut Caps section below.
Cause	This condition may be caused by the use of a worn socket/improper fitting socket when removing and installing the two piece style lug nut.
Information	Important: Use a hand torque wrench and deep well socket, alternately and evenly, to tighten the wheel nut to GM Specifications. Refer to <i>Fastener Specifications</i> in the Service Manual.
