Subject: N212350630 - Service Update  
Overhead Console Sets DTC Incorrectly

Models: 2022 Buick Envision

# Service Update

## N212350630 Overhead Console Sets DTC Incorrectly

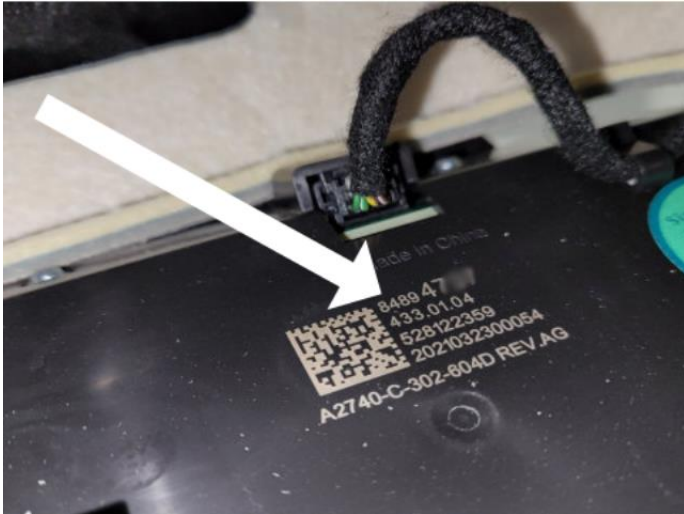
6028952

2. Locate the part number on the roof console. Compare the part number with the table below.

1. Remove the roof console. Refer to *Roof Console Replacement* in SI. Do not disconnect the electrical connector at this time.

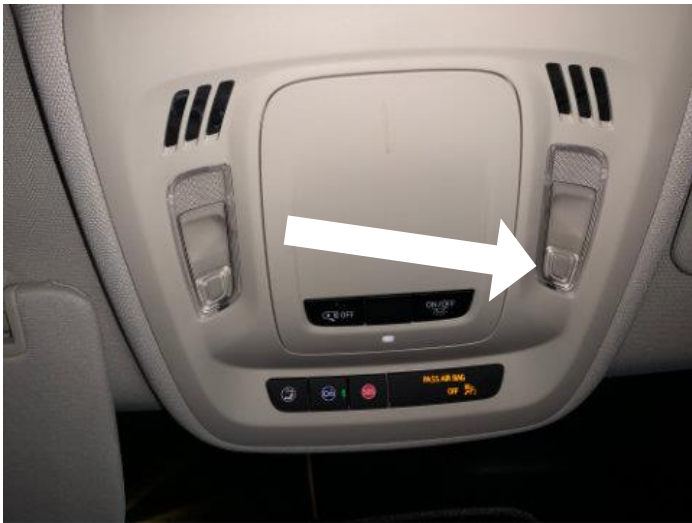
5994572

- Press the RH reading lamp button.
- Confirm the reading lamp illuminates.

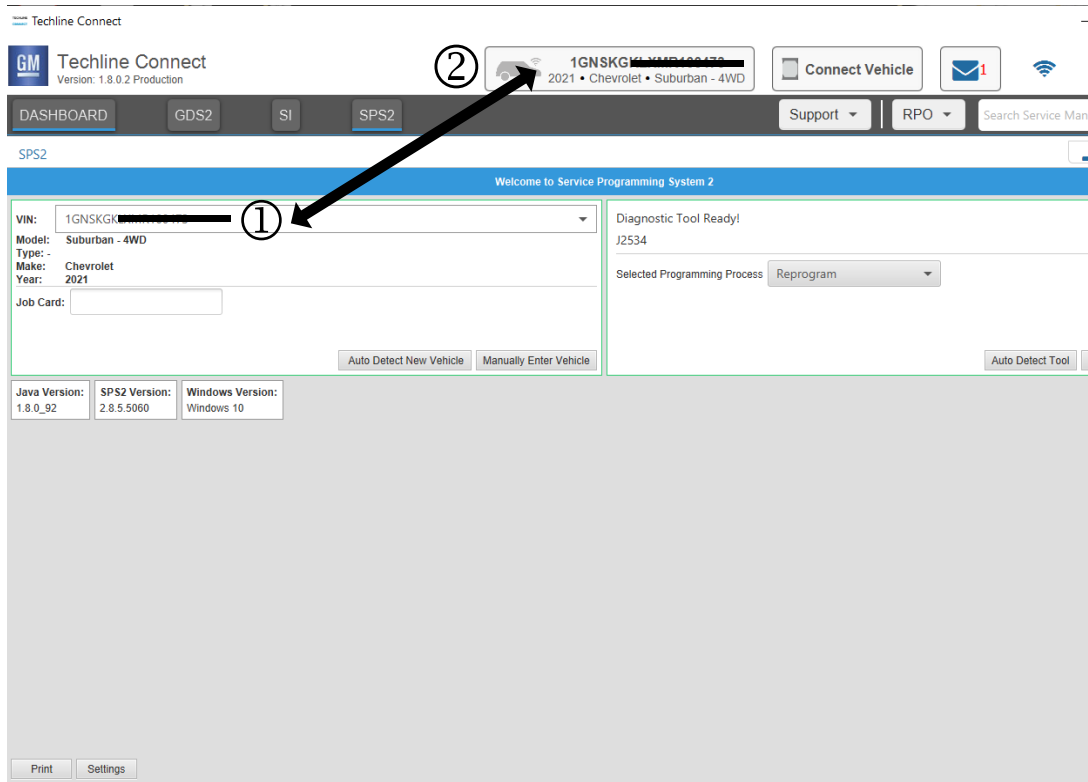
5743643

**Caution:** Be sure the VIN selected in the drop down menu (1) is the same as the vehicle connected (2) before beginning programming.

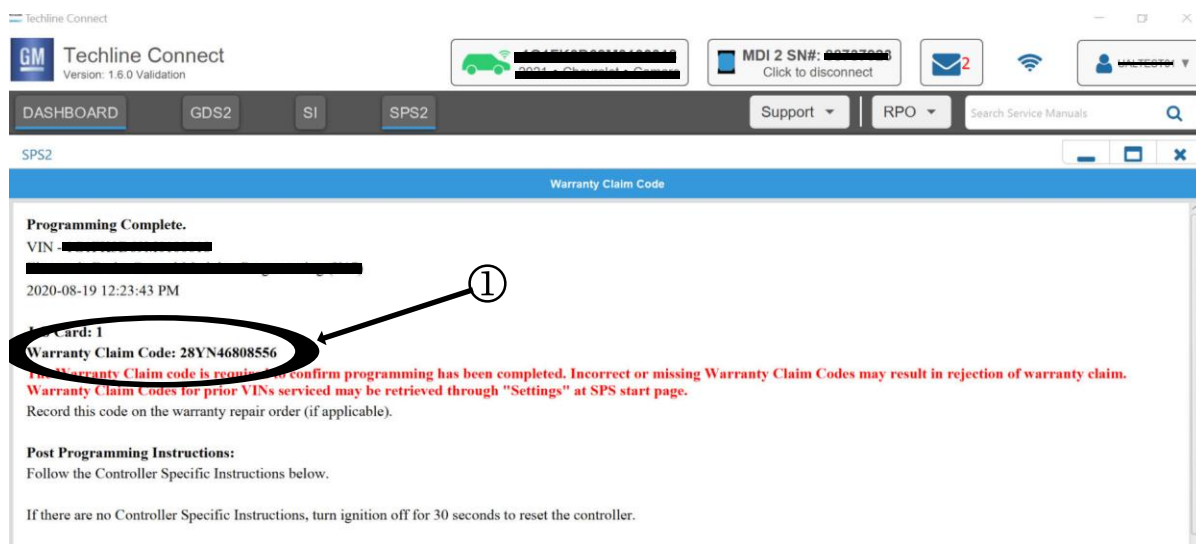
5644478

**Important:** To avoid warranty transaction rejections, you **MUST** record the warranty claim code provided on the Warranty Claim Code (WCC) screen shown above on the job card. Refer to callout 1 above for the location of the WCC on the screen.

5. Reprogram the body control module. Refer to *K9 Body Control Module: Programming and Setup* in SI.

6. Record SPS Warranty Claim Code on job card for warranty transaction submission.
