GLOBAL SAFETY FIELD INVESTIGATIONS
DCS6164
URGENT - DISTRIBUTE IMMEDIATELY

Subject: REVISION: N212350630-01 - Service Update
Overhead Console Sets DTC Incorrectly
Revised Warranty Information

Models: 2022 Buick Envision

N212350630 Overhead Console Sets DTC Incorrectly

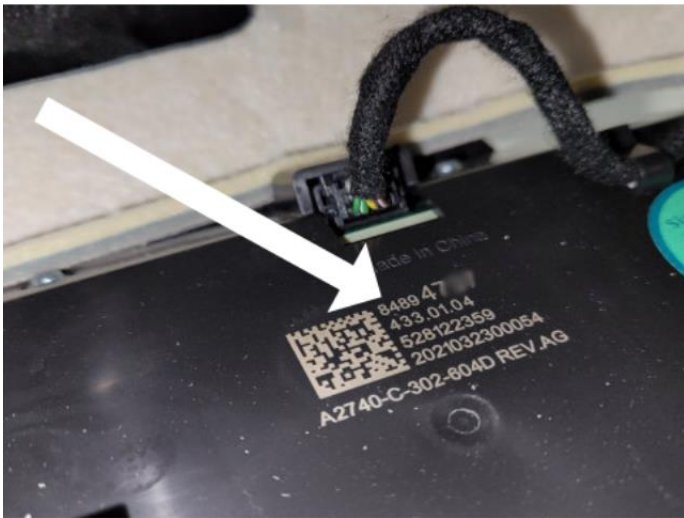
6028952

2. Locate the part number on the roof console. Compare the part number with the table below.

- **If the part number is in the Do Not Replace Column**, reinstall the existing roof console. Refer to *Roof Console Replacement* in SI. No part replacement or programming is required.
 - **If the part number is in the Replace Column**, proceed to step #3.
3. Replace the roof console. Refer to *Roof Console Replacement* in SI.
 4. Verify the function of the roof console front reading lamps as follows:
 - Close all the vehicle doors and allow the courtesy lamps to go off (approximately 20 seconds).
