# Service Update

## N222362400 Incorrect HVAC Control Module Calibration

Release Date: May 2022

Models: 2022 Chevrolet Silverado 1500 LTD  
2022 GMC Sierra 1500 Limited

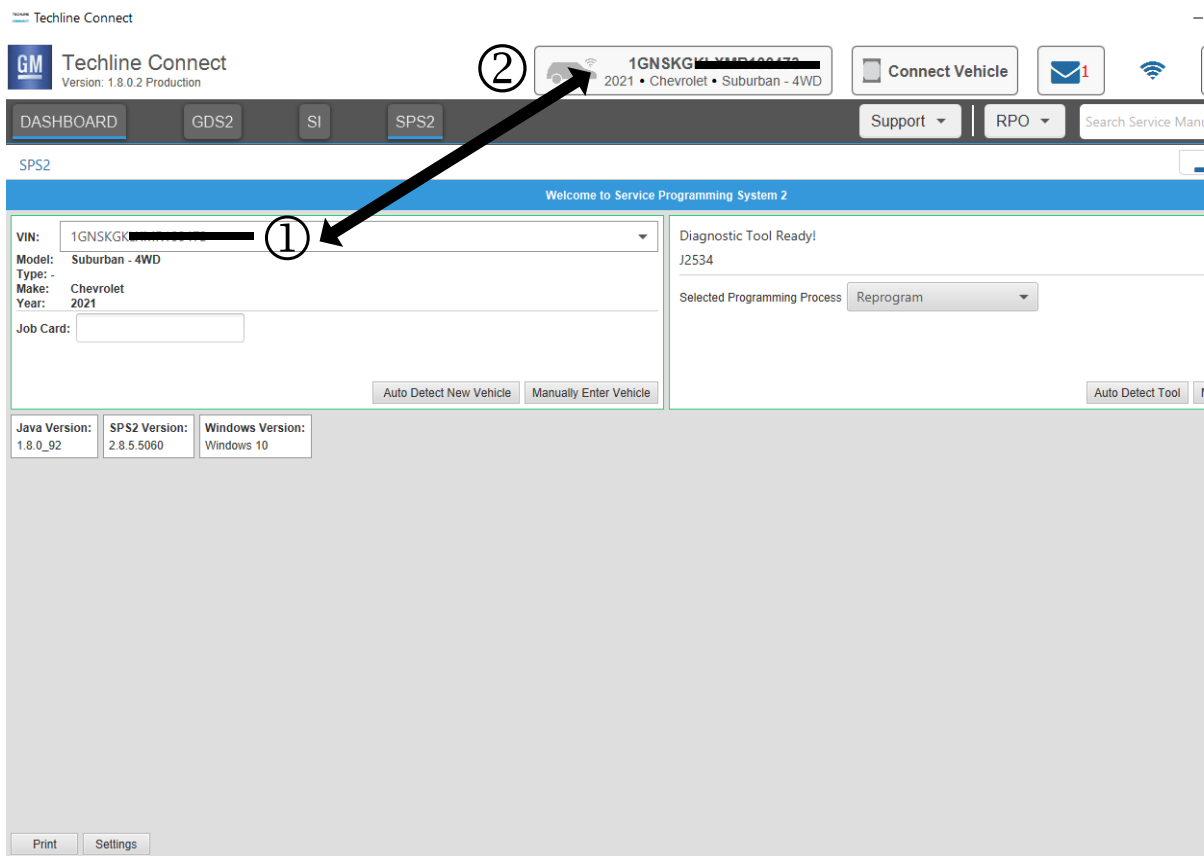
5743643

**Caution:** Be sure the VIN selected in the drop-down menu (1) is the same as the vehicle connected (2) before beginning programming.

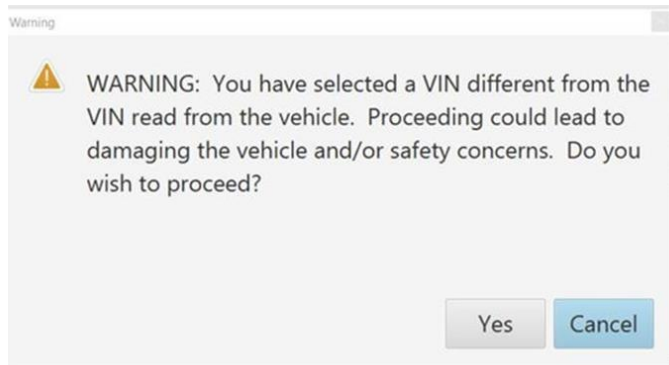
5877000

**Important:** If the vehicle VIN DOES NOT match, the message below will be shown.

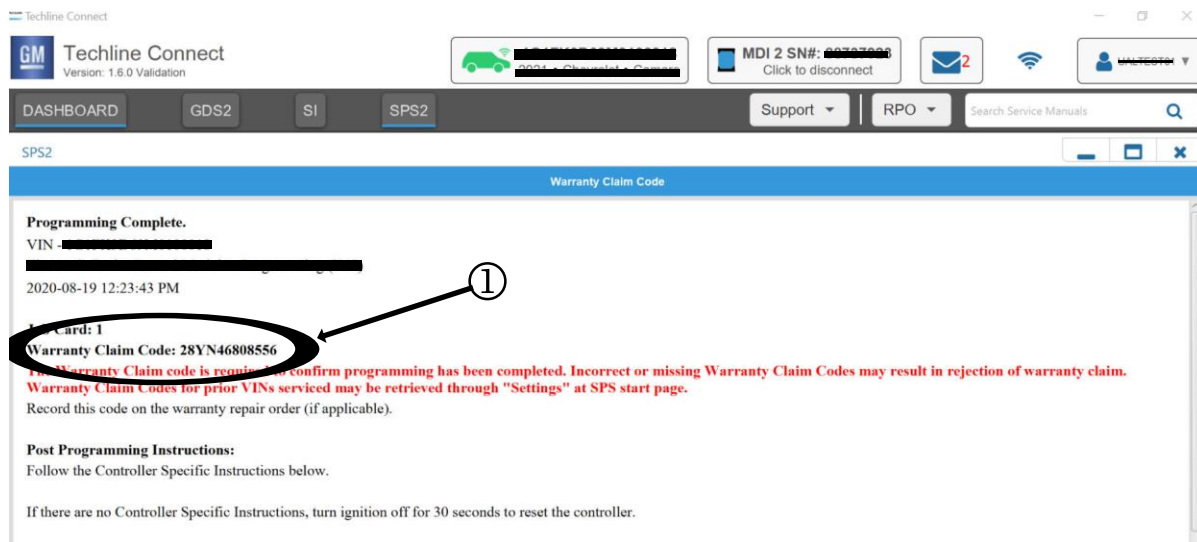
5644478

**Note:** The screenshot above is an example of module programming and may not be indicative of the specific module that is being programmed. Module selection and VIN information have been blacked out.

**Important:** To avoid warranty transaction rejections, you **MUST** record the warranty claim code provided on the Warranty Claim Code (WCC) screen shown above on the job card. Refer to callout 1 above for the location of the WCC on the screen.

- Record SPS Warranty Claim Code on job card for warranty transaction submission.
