Classification:  
AN20-026DReference:  
ITB20-021DDate:  
March 21, 2022

## SOFTWARE UPDATE FOR INFOTAINMENT ISSUES

**APPLIED VEHICLES:** 2020-2021 Q50 (V37)  
2020-2021 Q60 (CV37)  
2020-2021 QX50 (J55)  
2020-2021 QX80 (Z62)

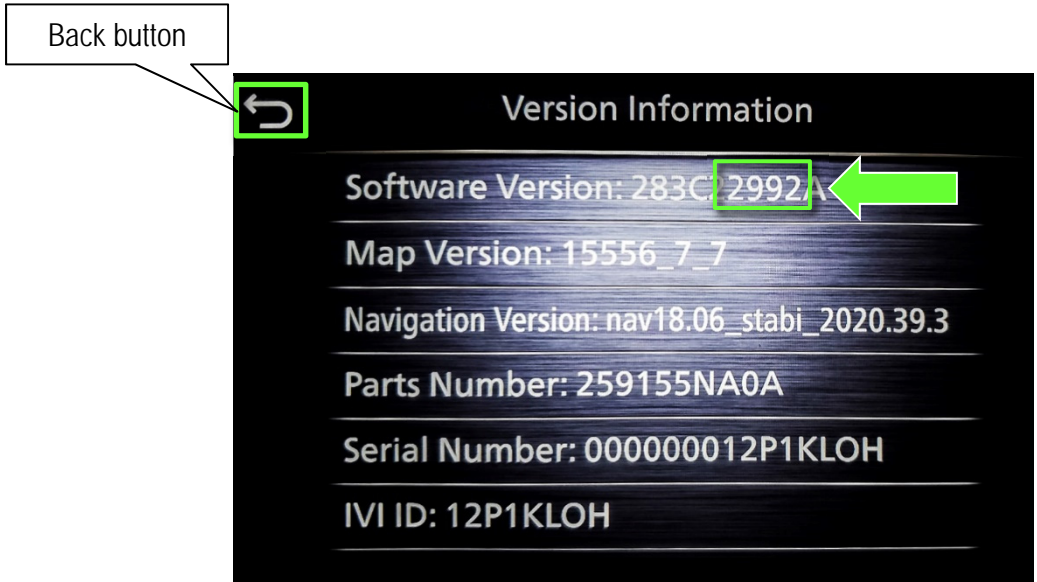
Figure 5

- If the Software Version (digits 6-9 as shown in Figure 5) is **lower** than xxxxx**2992**x, select the back button and continue to step 5 on the next page.
- If the Software Version is xxxxx**2992**x or higher (digits 6-9), select the back button; this bulletin does not apply. Refer to ASIST for further diagnostic information.
