AN22-008

March 31, 2022

CLIENT SATISFACTION INITIATIVE 2020-2021 QX80; INFOTAINMENT SOFTWARE UPDATE AND WIRELESS CARPLAY CONFIGURATION

SERVICE COMM ID #: PC882
APPLIED VEHICLES: 2020-2021 QX80 (Z62)

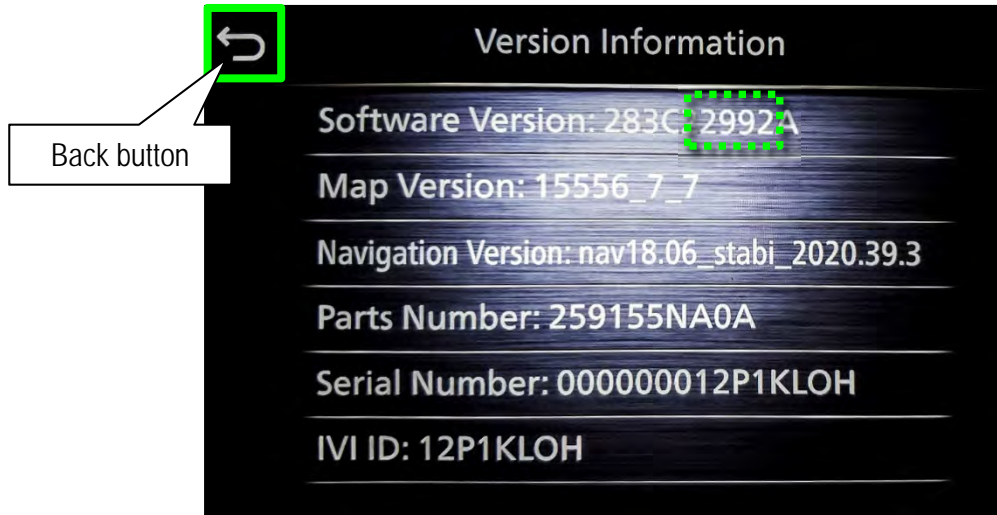
Figure 5

- If the **Software Version** is lower than xxxxx2992x (digits 6-9 as shown in Figure 5), select the back button and proceed to step 5 on page 5.
- If the **Software Version** is xxxxx2992x or higher (digits 6-9), select the back button and skip to step 27 on page 10 to configure the AV control unit.

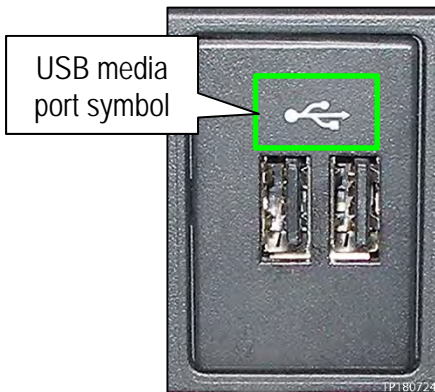
Figure 11

16. Insert the USB drive with the infotainment update-software into the vehicle's USB media port (Figure 11).
HINT: Charging ports are marked in the vehicle with a "lightning bolt" symbol (Figure 12).

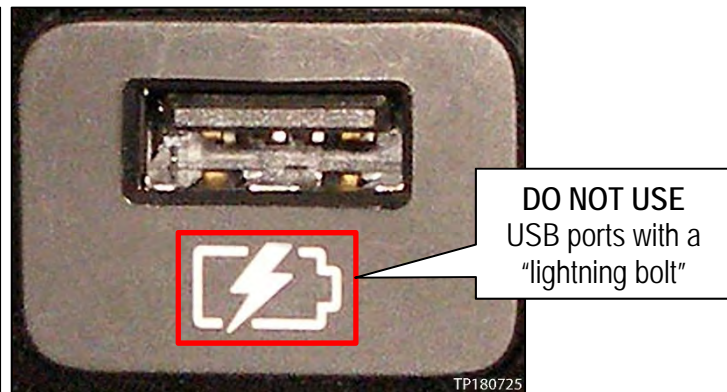
Figure 12

- Do not insert the USB drive into a charging port. If used, the update-software and/or USB drive may become damaged. Only insert the USB drive in a USB media port.
- Do not remove the USB drive during the update to the vehicle until instructed to. If the USB drive is removed during the update, the AV control unit may become damaged.

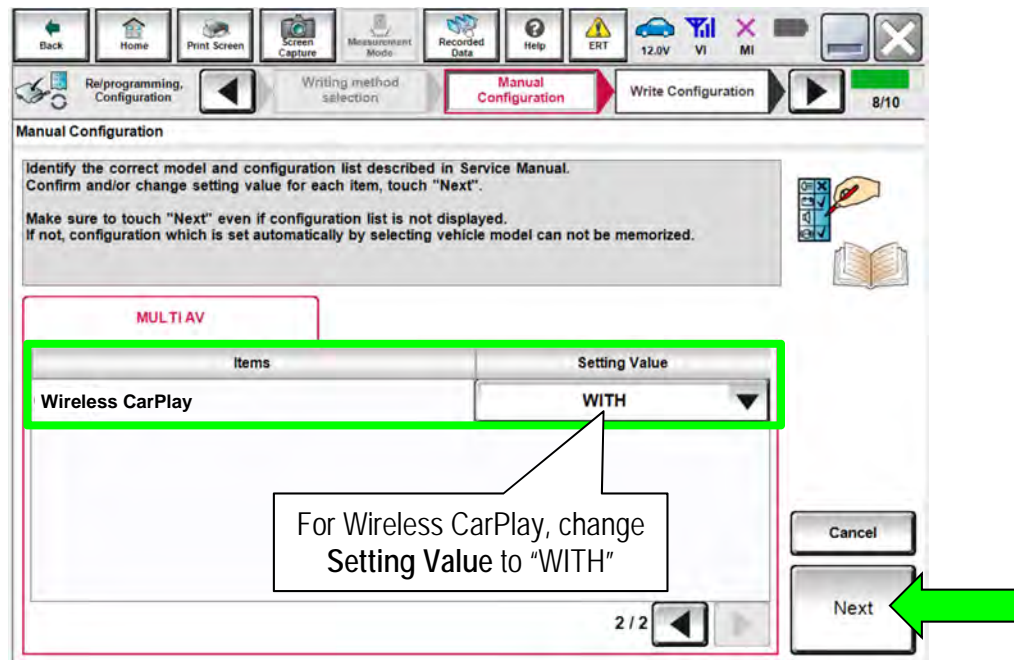
Figure 27

IMPORTANT: The default **Setting Value** for **Wireless CarPlay** is "WITHOUT". Be sure to change this **Setting Value** to "WITH" (Figure 27).

42. Use the drop down menus to select the configuration options that were printed or written down in step 38 on page 14, and then select **Next**.

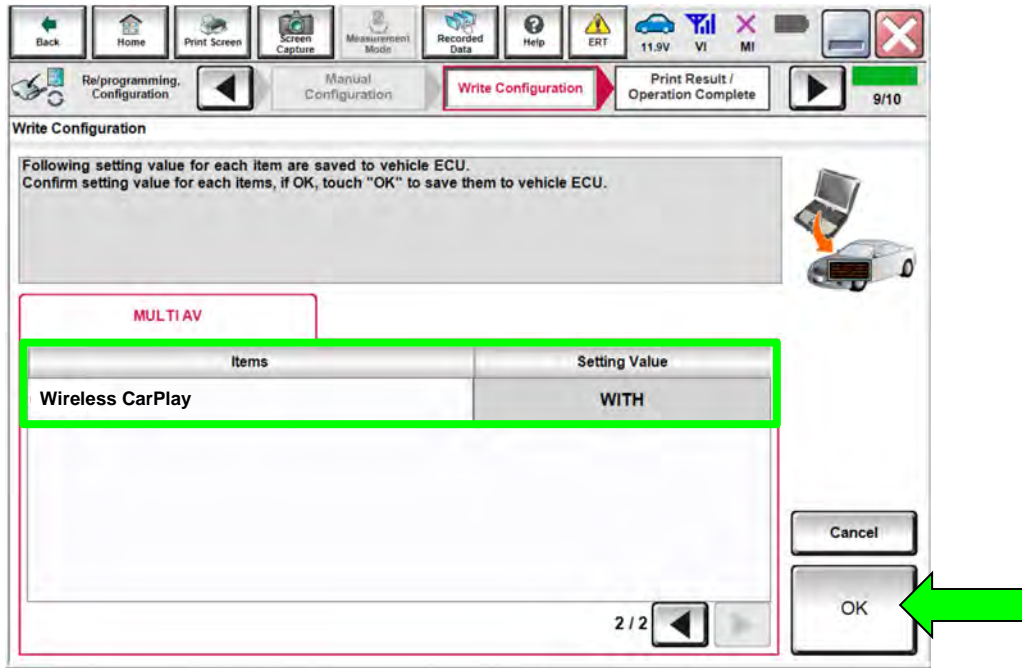
Figure 28

IMPORTANT: Be sure the **Setting Value** for **Wireless CarPlay** is "WITH" before selecting OK.

43. Confirm the configuration displayed is correct, and then select OK.

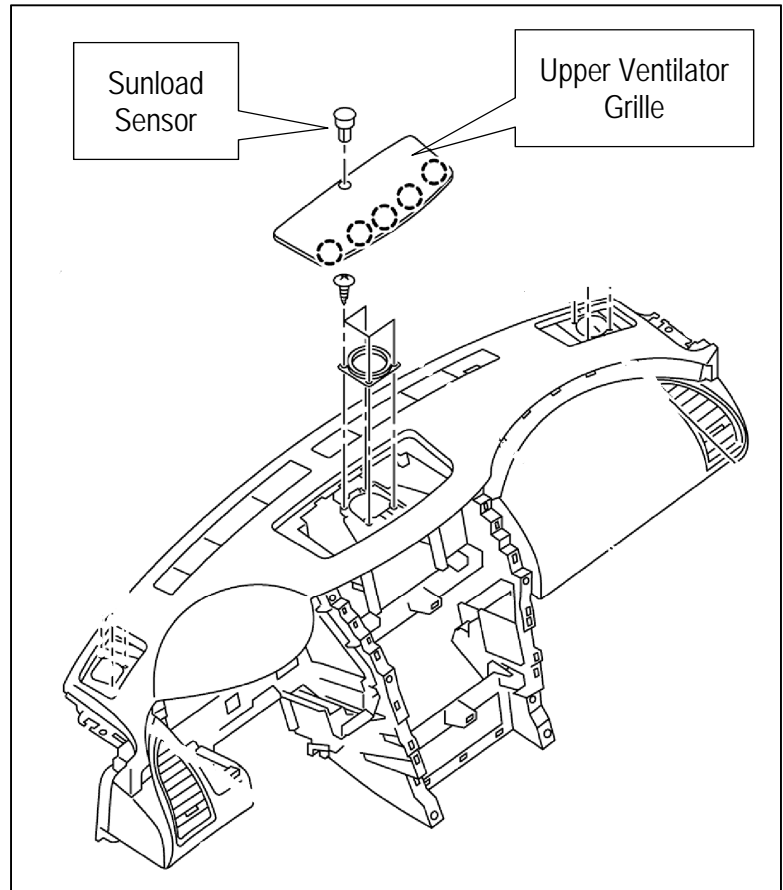
Figure 38

To avoid damage to the Instrument Panel and/or Center Speaker, the Upper Ventilator Grille must be completely removed before performing the next steps. If not removed, damage to the Instrument Panel and/or Center Speaker may occur.

58. Remove the Upper Ventilator Grille.
