SERVICE BULLETIN

Classification:	Reference:	Date:
BT21-022	NTB22-015	March 4, 2022

REAR SLIDING CENTER GLASS SEAL LOOSE OR DETACHED

APPLIED VEHICLES:	2020-2021 Frontier (D40) 2022 Frontier (D41)
APPLIED DATES:	2020-2021 All 2022 Built before September 19, 2021
APPLIED GRADES:	SV with SV Convenience Package Only Pro-X (All) Pro-4X (All)

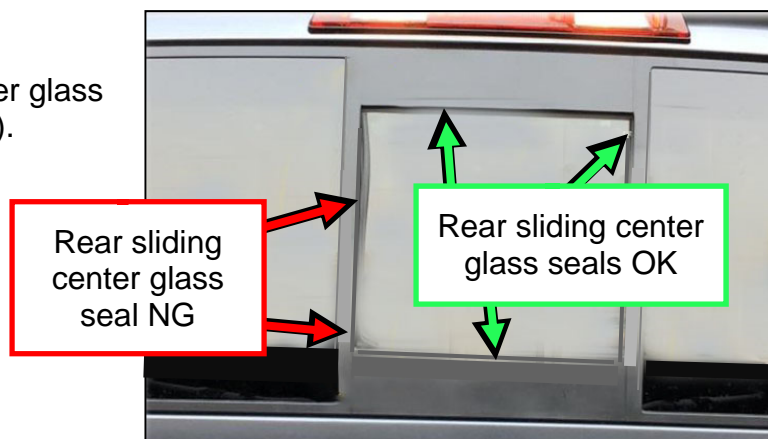
Figure 1

One or more of the rear sliding center glass seals is loose or detached (Figure 1).

Do not replace the complete rear window assembly. Follow the **SERVICE PROCEDURE** in this bulletin to replace any loose or detached rear sliding center glass seals.
