CAMPAIGN BULLETIN Steering Column Dealer Inventory

Reference: PMA04
Date: March 15, 2022

PMA04 – 2021 KICKS STEERING COLUMN

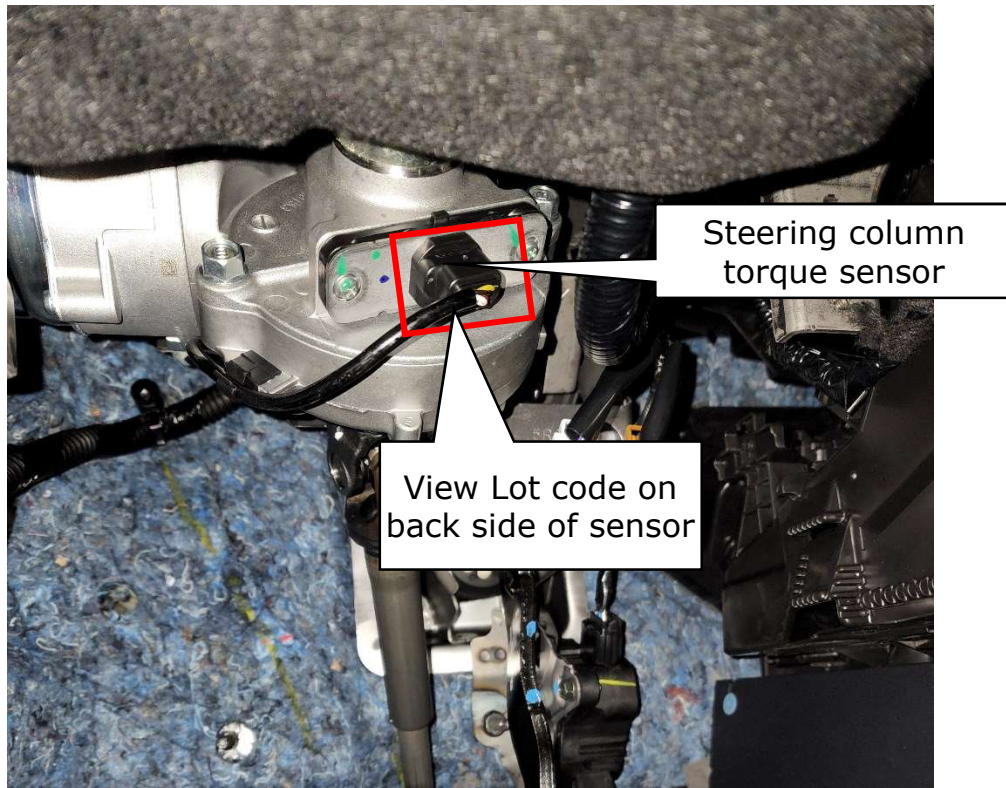
Figure 10

9. Locate the steering column torque sensor. (Figure 10)

- The torque sensor lot code is located on back side of the sensor and is visible by looking upward at the sensor

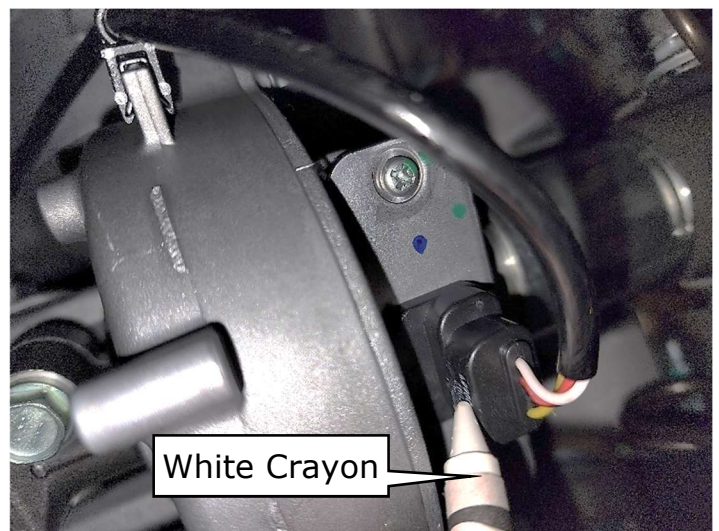
Figure 11

10. Highlight the lot code of the steering column torque sensor. (Figure 11)

- Using a white crayon, with light pressure rub the crayon over the lot code until the lot code is legible

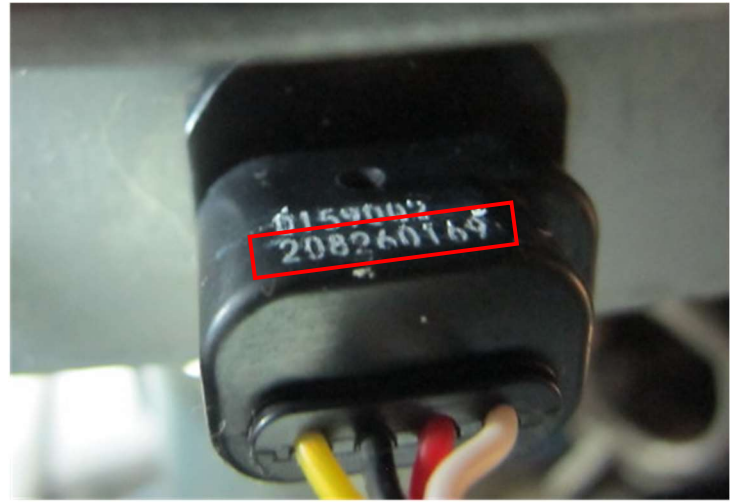
Figure 12

11. Document the lower line of the lot code on the repair order. (Figure 12)

12. Review the first (5) five digits of the lot code obtained in Step 11.

- **Do the first (5) five digits of the lot code match one of the sets of numbers below?**

21624	21625	21626
21627	21628

- If the first (5) five digits of the lot code **matches** one of the above sets of numbers, replace the steering column assembly. Refer to the ESM for removal and replacement instructions. **STEERING - STEERING SYSTEM - REMOVAL AND INSTALLATION - STEERING COLUMN – Removal and installation**
- If the first (5) five digits do **NOT** match the below lot codes, no action is necessary, reassemble the vehicle in reverse order. Be sure to replace the LH knee air bag bolts with new parts during reassembly.
 - Torque knee air bag bolts to 10.8 N•m (1.1 kg-m, **8 ft-lb**)
 - Torque battery terminals to 5.5 N•m (0.56 kg-m, **49 in-lb**)
