MAS002980 (MSC 22-08)

Campaign 487
FROM Maserati TSO
TO Maserati Network

Service Campaign 487 MC20 - Water infiltration through door wiring area

DATE: April 1, 2022

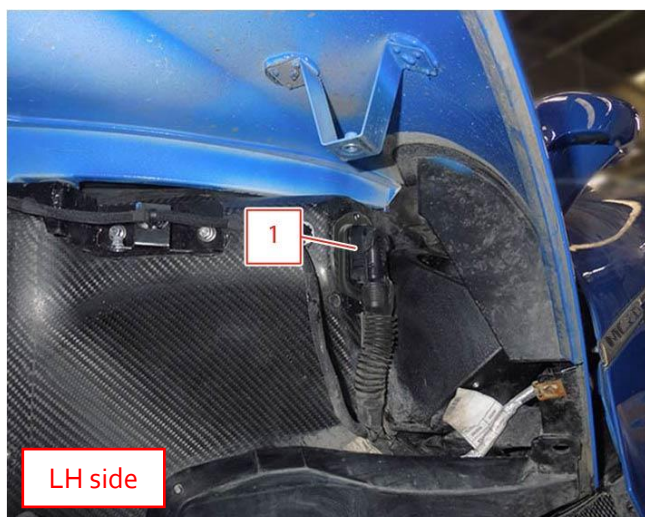
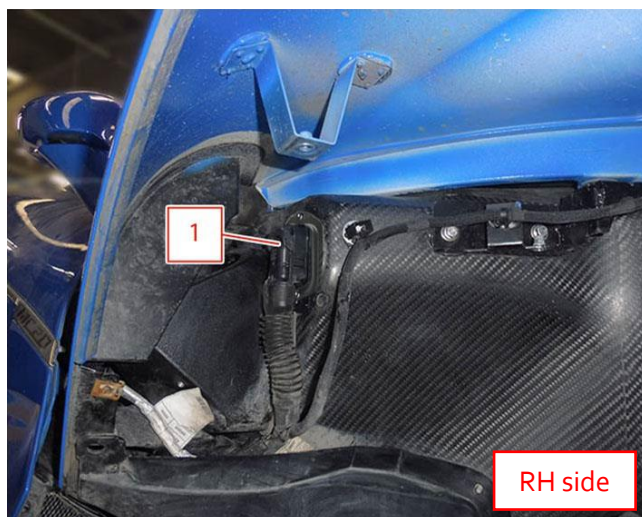
This possible infiltration is caused by a poor coupling between the aluminium bracket of the door connector and the carbon fiber of the monocoque body, which could be uneven in the coupling area.

8. The job must be carried out on the DTB (Door to Body) connectors (1) inside the front wheel arches:
