## Service Campaign 488 M161 MY21-22 - Potential Maserati Logo Detachment

DATE: April 5 2022

Maserati Levante (M161) MY21-22 vehicles are involved in a Service Campaign to prevent the detachment of the front hood Maserati EMBLEM.

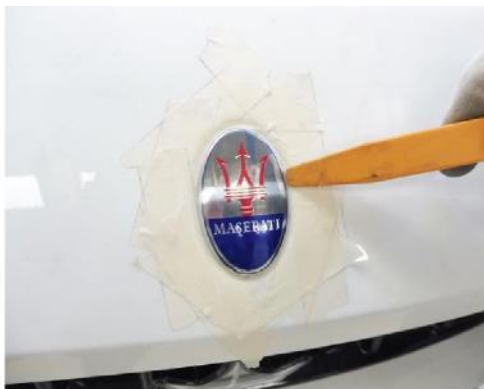
1. Always check in ModisCS+ to see if the vehicle is involved in this campaign and if the campaign has not been previously performed.
2. Protect the area around the EMBLEM with masking tape.
3. Check if the Maserati EMBLEM can be easily detached from its holder using a suction cup or a suitable Teflon wedge. May need to apply little force for the inspection.

- If the inspection is GOOD and the EMBLEM adhesion is strong. The inspection procedure is finished.
- If the inspection is NO GOOD and the EMBLEM is loose and detaches from the holder. Proceed with
