TECHNICAL SERVICE BULLETIN

3.0L, 6.7L - Illuminated MIL With Various Reductant System Related DTCs

22-2191

16 May 2022

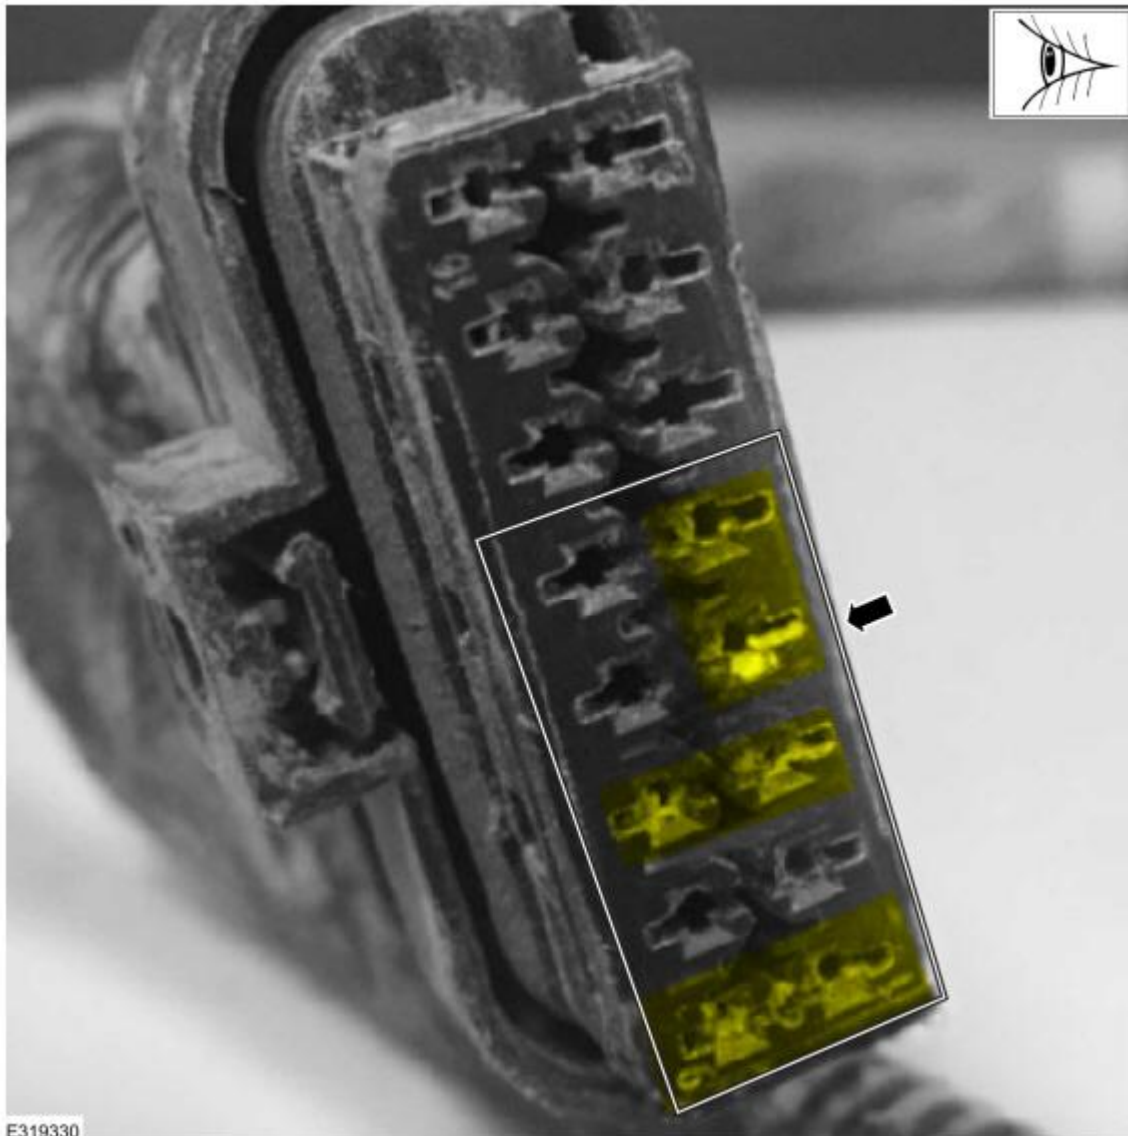
Figure 1

- Visible green corrosion on multiple terminals on the harness side of connector C3613. (Figure 1)

- If there is corrosion or discoloration on the red ductant tank harness connector only and not on the red ductant pump/heater assembly, only replace the red ductant tank harness.

- If there are signs of corrosion or discoloration on the red ductant pump/heater assembly, replace both the red ductant tank harness and the red ductant pump/heater assembly. Refer to WSM, Section 303-08.

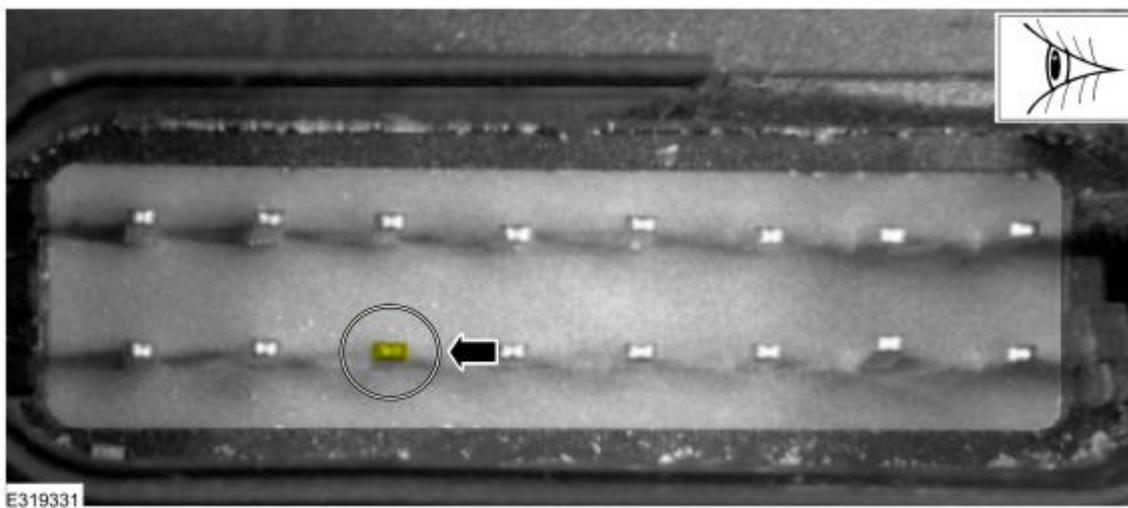
Figure 2

- Corroded pins on the reductant pump/heater assembly at connector C3613. (Figure 2)

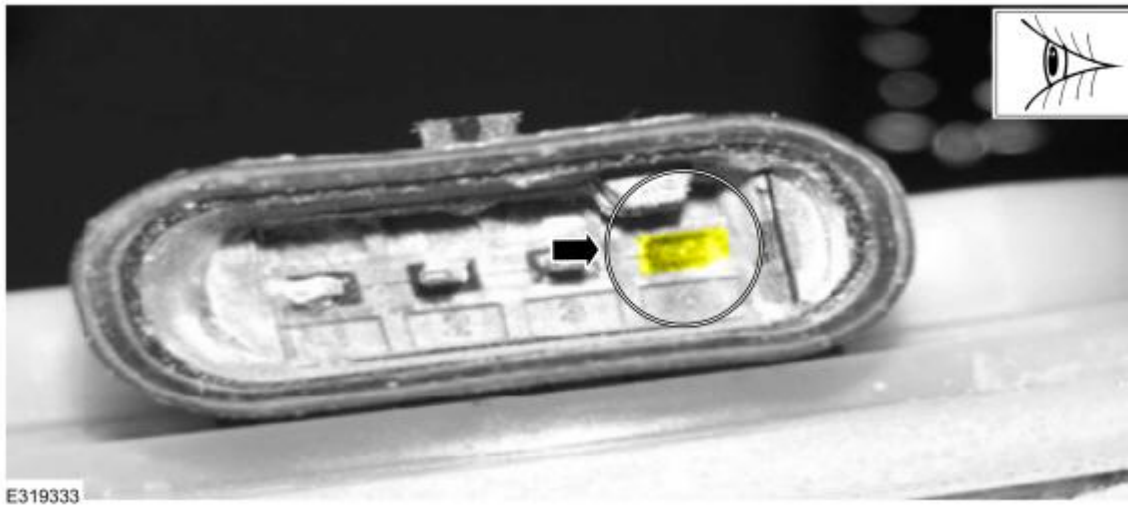
Figure 3

- Visible green corrosion on the reductant level sensor/quality module side of connector C4851/C3610. (Figure 3)

- If there are signs of corrosion or discoloration on the red ductant level sensor/quality module, replace both the red ductant tank harness and the red ductant tank (red ductant level sensor/quality module built in).

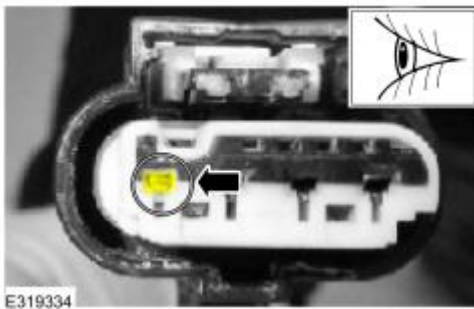
Figure 4

- Visible green corrosion on the harness side of connector C4851/C3610. (Figure 4)

- If there is corrosion or discoloration on the red ductant tank harness connector only and not the red ductant level sensor/quality module, only replace the red ductant tank harness.
