## Technical Service Bulletin

Transaction No: 2034898/22

01-18-13 - MIL ON DTC P0401, P2002 or P240F Exhaust Gas Recirculation Flow Insufficient

Release date: 5/16/2022

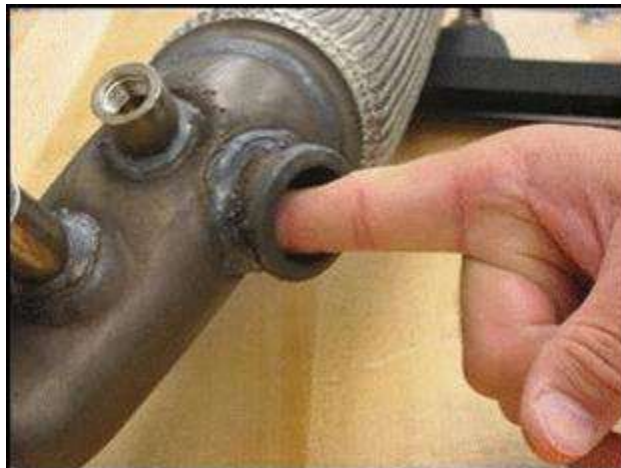
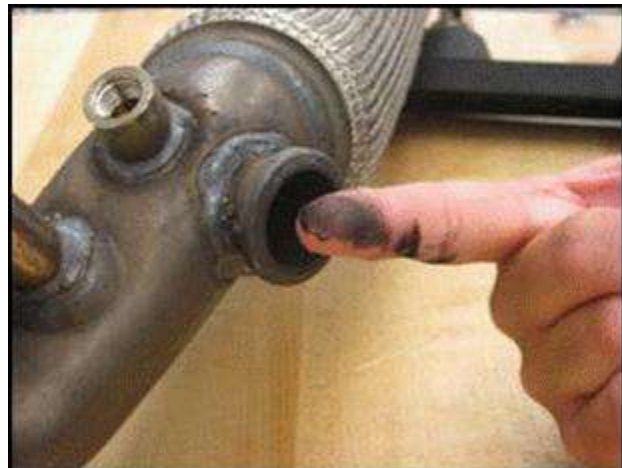
- Remove the EGR filter from the Diesel Particulate Filter (DPF) and swipe the inside of the exhaust pipe at the EGR filter connection point using a clean cloth or your finger. See figures 1 and 2 below.

If your finger or the cloth comes out with black soot:

- Replace the DPF & EGR filter together. **The engine must be running correctly with no faults stored to perform the next steps.**
- **Read out 01 ECM control module OBD Basic Settings block 67 with engine at idle and at operating temperature. If the MAF actual value is equal to or greater than 540 mg/h, proceed to smoke testing below (there is likely a leak within the intake system). If the value is less than 540 mg/h, proceed to inspection of the snow flap and air filter (TSB attachment). There is no need to smoke test.**
- **Smoke test the charge air system for leaks if MAF value is 540 or greater (see procedure below).**
