Service Bulletin

Date: **24 January 2022**

Subject: **Reprogramming of E-Shock GPS Module code 8000C9312 (E5 version)**

Product: **All E5 models equipped with GPS modules code 8000C9312**

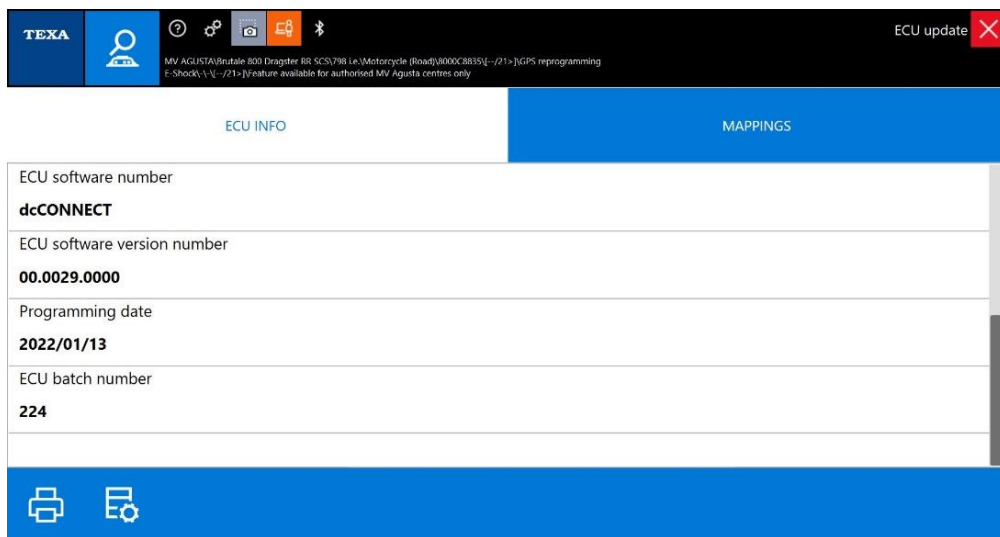
If the software version "v0.29" is already present, no further operations are necessary.
 If other software versions are present, proceed with the update following the procedure indicated below.
