Niro HEV (DE HEV)

Niro PHEV (DE PHEV)

730

RANDOM MISFIRES/OVERHEATING DUE TO LOW COOLANT

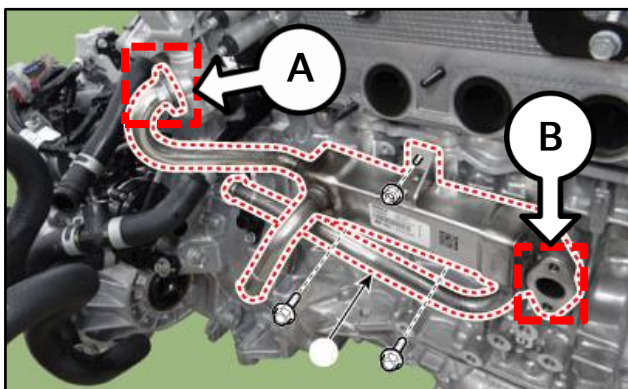
1. Loosen the pipe leading to the cooler at the EGR Valve (A).
2. Next loosen the two (2) 10mm nuts on the lower RH (passenger) side of the EGR Cooler (B).
3. Watch for any coolant that comes out of the EGR Cooler.
 - If coolant leaks from the flange when loosened (B), **replace the EGR Cooler.**
 - Bleed the system and confirm the cooling system has no additional leaks and no engine hesitation.
 - If **no** coolant is found when the flange is loosened, continue with additional diagnostics per the applicable shop manual. (Do not replace the EGR Cooler.)

Note: The marked indicated location is the lowest point that coolant should sit in the EGR system.
