SERVICE BULLETIN

Reference number:	SB-41-1636	Issued: 07 April, 2022
Subject:	DBX Vehicle Lifting Process	
Applicable to:	All Dealers	
Model:	DBX	
Distribute to:	After Sales Manager Executive Manager Service Manager Sales Manager	Warranty Staff Technician(s) Parts Staff

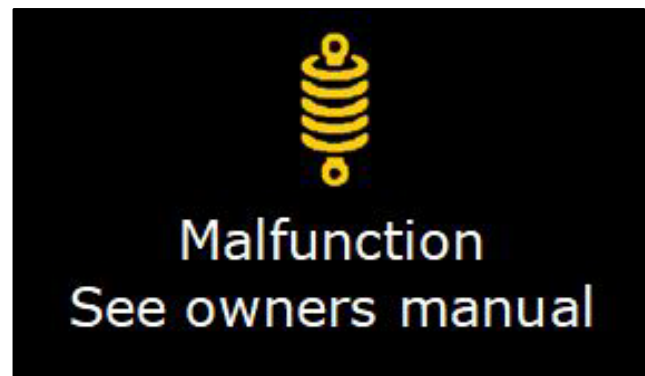
Figure 1

Aston Martin has found that when a DBX is lifted on a 2-post lift or a jack with the ignition set to on, this can cause the Diagnostic Trouble Codes (DTC's) that follow:

- C158A-33 (U57) Air Damping Module (ADM) - Signal Has too Many Transitions / Events.
Note: Vehicle level too high or too low for high vehicle speed.
- C1588-31 (U57) Air Damping Module (ADM) - No Signal.
Note: Down-levelling speed on front axle too low.

The warning message in (Figure 1) will also show in the instrument cluster.

To prevent this issue, you must switch the ignition off before you lift the vehicle on a 2-post lift or a jack.

1. To clear the warning message in Figure 1, set the ignition to on, but do not start the engine.
2. Connect the Vehicle Communication Interface (VCI) to the vehicle by using the Diagnostic Link Cable (DLC).
3. Click the "DTC/OBD" button (refer to Figure 2).
