STAR ONLINE PUBLICATION

Case Number: S2123000059 Rev A

Symptom/Vehicle Issue: Water Leak At Headliner Near Driver Microphone

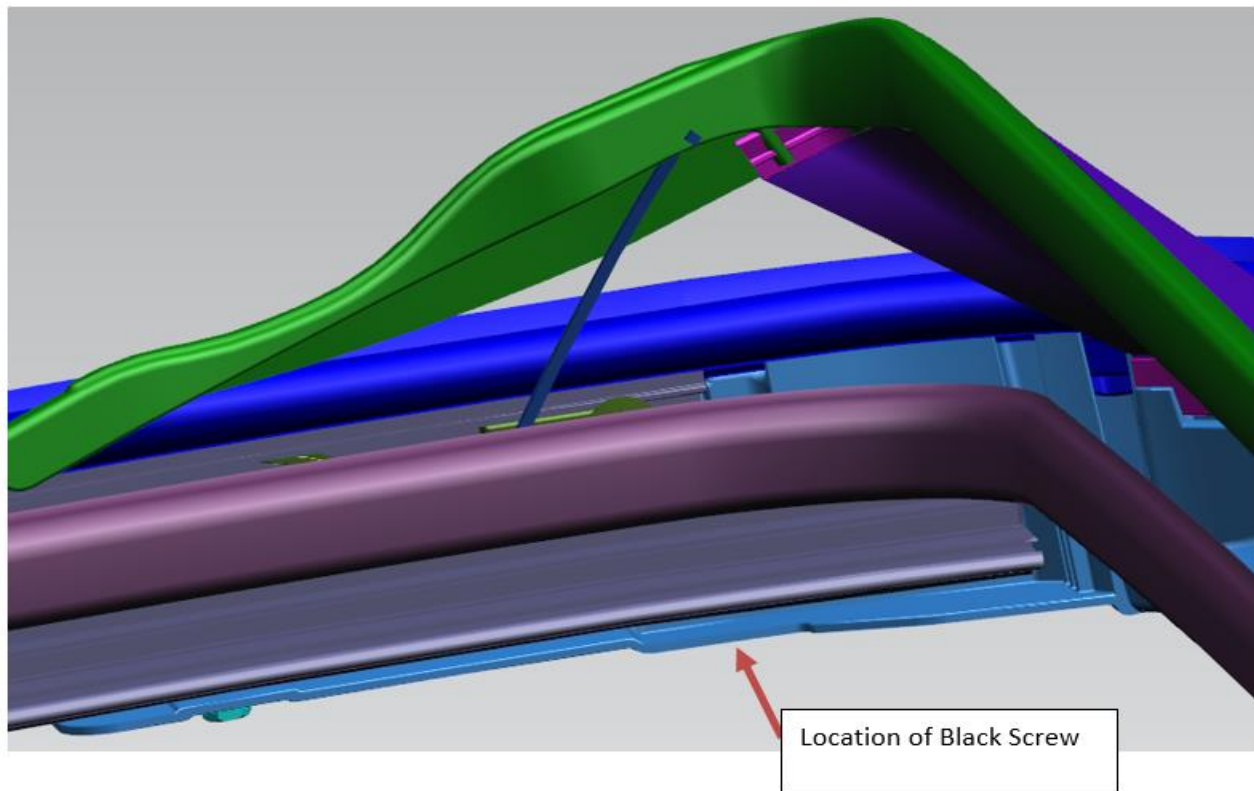
Discussion: Water found in the microphone area may be due to a loose fastener on the sunroof frame. Fig 2 shows the approximate area of the screw. Perform a water test at the screw location to verify the leak is from this location. Use a cup or bottle to apply the water to the top side of the screw area (drain trough) while looking for water entering below the headliner from this location. It will be necessary to pull the headliner down and use a light to inspect for water. If water is found coming into the vehicle proceed with the below information.

Driver front corner of dual pane sunroof frame viewed from the center of the sunroof opening

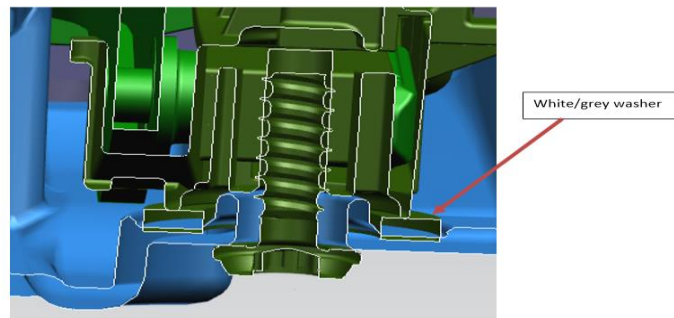
Fig 3

Locate the screw in Fig 3. The screw is in the drain trough forward of the air deflector spring. Lower the headliner (not necessary to remove headliner) to gain access to the screw head T25 size. Refer to 23 - Body / Sunroof, Dual Pane / SUNROOF, Dual Pane / Removal and Installation for further information.

Cross section of black screw joint
