## STAR On-Line Case

**Case Number:** S2209000002

**Release Date:** March 2022

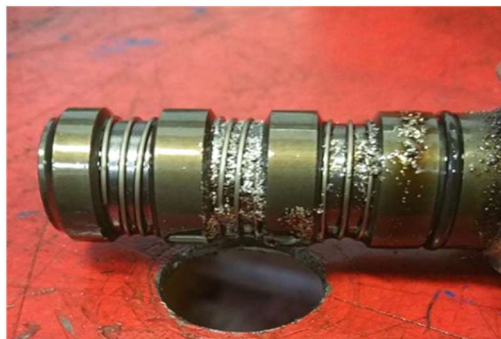
Pic 1

**Diagnosis:** If an internal engine problem is identified, further inspection should be performed before attempting repair. Removal of the Oil Control Valve (OCV) for the Variable Valve Timing (VVT) system should be performed to inspect for debris at the filter screens.

**Repair Procedure:** Remove the OCV per the service procedure found in TechCONNECT and inspect the screens for metal debris. If debris is found (Pic 1), engine replacement is required. Note: Warranty Pre-Authorization requirements may apply.
