STAR ONLINE PUBLICATION

Case Number: S2208000063

Symptom/Vehicle Issue: Loss of power steering assist. U0131 Lost Communication With Electric Power Steering Control Module

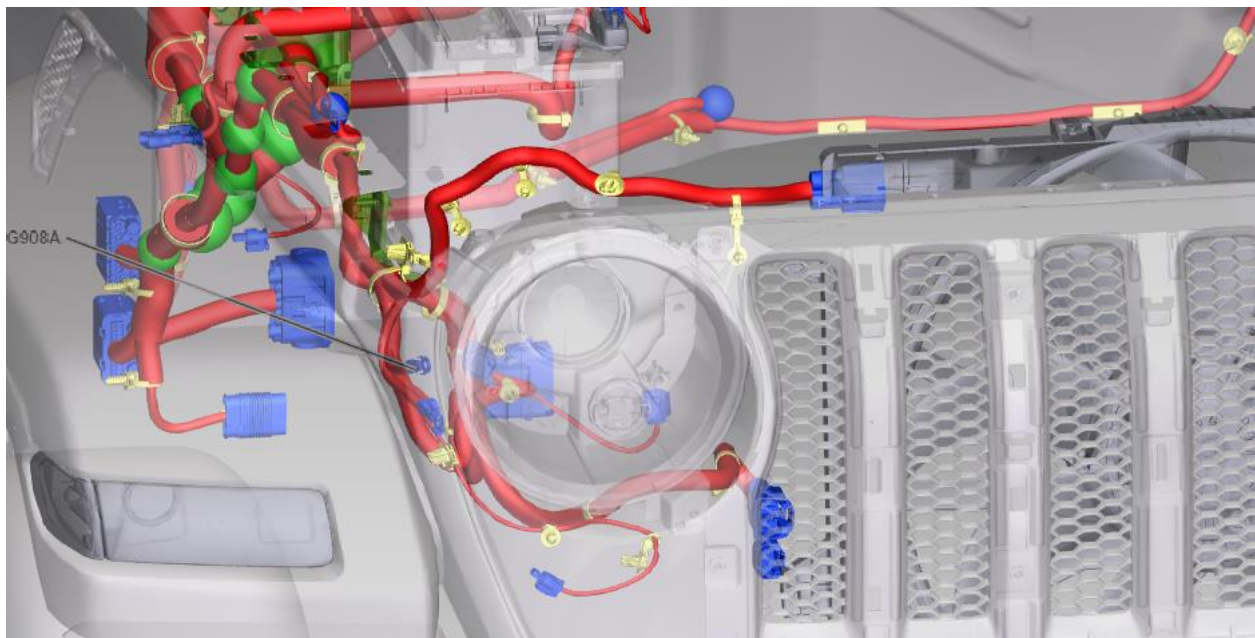
Discussion: The customer may experience a lack of power steering assist. Upon scanning the vehicles for DTC's you may find U0131 - Lost Communication With Electric Power Steering Control Module. This may be caused by the ground wire not being fully welded/secured to the ground eyelet.

Diagnosis: Inspect the G908A ground located behind the passenger side headlight. Determine if the ground eyelet is properly secured to the ground wire.

Repair Procedure: It is recommended to spot solder the ground wire onto the eyelet terminal.
