STAR ONLINE PUBLICATION

Case Number: S2108000137 REV. A

Symptom/Vehicle Issue: (CEL) Check Engine Lamp, (ABS) Anti-Lock Brake System, And (TCS) Traction Control System Lamps On

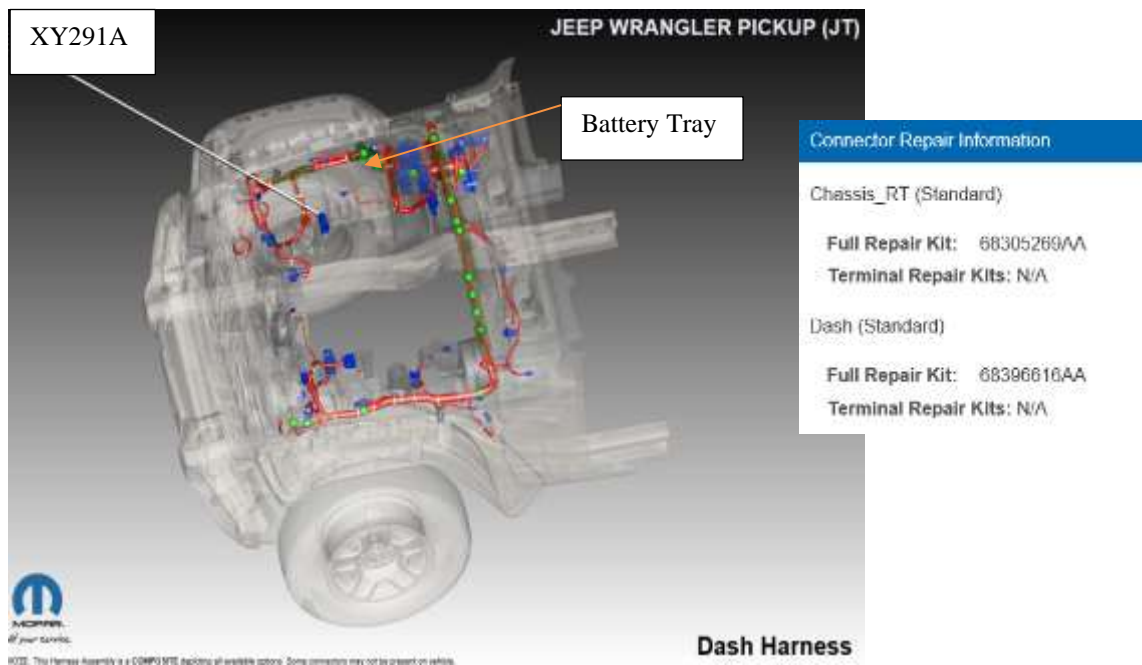
Customer Complaint/Technician Observation: Owner complains the ABS and TCS and CEL warning lamps are on. Technician observed multiple DTC's relating to wheel speed sensors setting as stored or active for the right front, left and or right rear, C0034-1D, C0037-1D, C003A-1D, C0034-1D.

Repair Procedure: Inspect the XY291A, 34-way black connector looking for spread and or damaged terminals for the involved wheel speed sensor circuits. Use the appropriate terminal connector repair kit as needed to repair.

If no conditions identified at the inline connector, inspect the harness as it routes to and near the battery tray. Inspect the harness for any signs of contact areas at the battery tray, repair any harness damage per harness repair guidelines and isolate the harness as needed from the suspect contact points.
