## UPDATE FROM WARRANTY OPERATIONS

## 2021 JL/JT (Wrangler/Gladiator) Tire Pressure Monitor Sensors

TSB 22-003-21 was published on September 29, 2021 to summarize the effect of the changes:

Tire Pressure Monitoring (TPM) Mid-Year Change

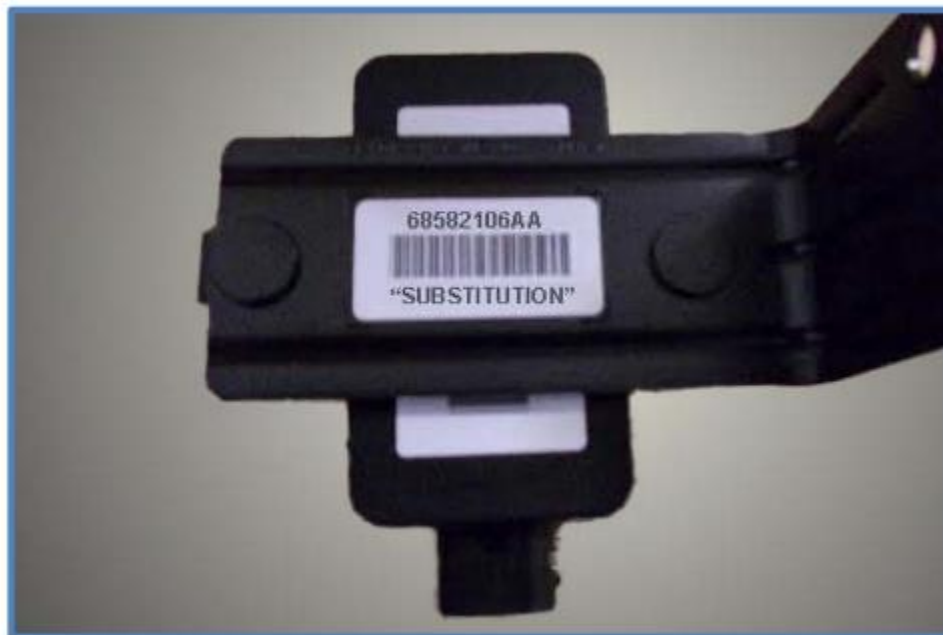
Frequency Hub (RFH). As a consequence, this mid-cycle action leaves the original wiring harness in place. Even though the RFH has now taken the responsibility of monitoring TPMS signals, there are still functional wires going to the TPM module connector. To address the harness issue, an empty box has been installed to plug into the harness. This was done to prevent corrosion or other damage to the wiring harness and connector pins. To help aid in identification a label has been placed on the empty TPM modules stating they are just a “Substitution” module.

**Figure 16: TPM module labeled as “Substitution”**

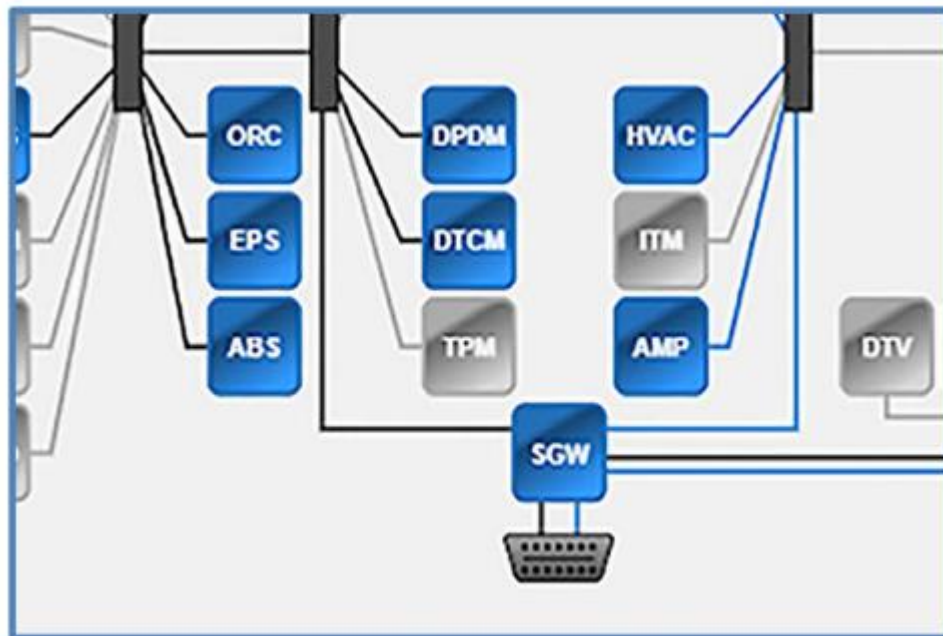
Technicians diagnosing a TPMS fault may be confused when the vehicle topology shows a grayed out TPMS module. Due to this new implementation, the TPMS module on the wiTECH topology is still there but is grayed out to indicate that it is not accessible. This means that you need to go through the RFH to access TPMS data. On vehicle topology for vehicles that have a

functional TPM module, the module will display as normal and will be accessible through wiTECH. As mentioned earlier, even though the RFH has now taken the responsibility of monitoring TPMS signals, there are still functional wires going to the "Substitution" TPM module. These can still create faults in the vehicle even though they are not used for TPMS functions. Some common faults include communication faults, shorts or low resistance faults. As always, refer to Service Library as well as TSBs and Star Publications for the latest information regarding service and diagnostic procedures.

**Figure 17: TPMS module grayed out**

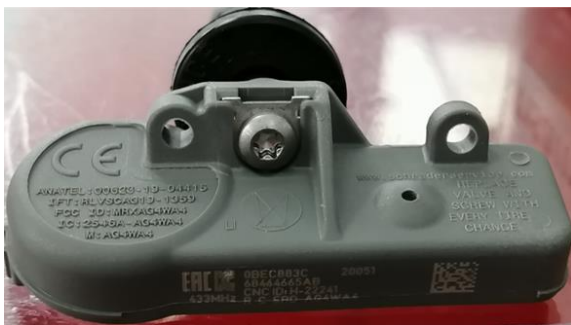
Old Sensor prior to June 7, 2021

Returning the incorrect sensor from the vehicle will result in a chargeback of the complete claim.

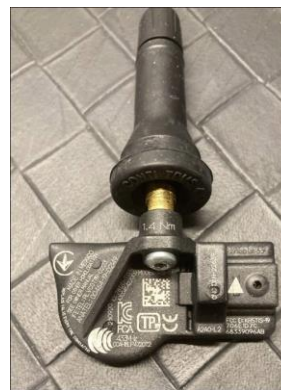
The revised functionality also requires the use of a redesigned tire pressure sensor that is not backwards compatible. So be sure to consult Star Parts prior to installing and/or replacing these sensors.

New Sensor after June 7, 2021
