NUMBER: 08-039-22

UBQ, UEQ, UFQ, UBN, UEN And UFN Radio Enhancements

This bulletin involves inspecting the software level and updating the software to S21D.5.

2022 (WS) Grand Wagoneer/Wagoneer

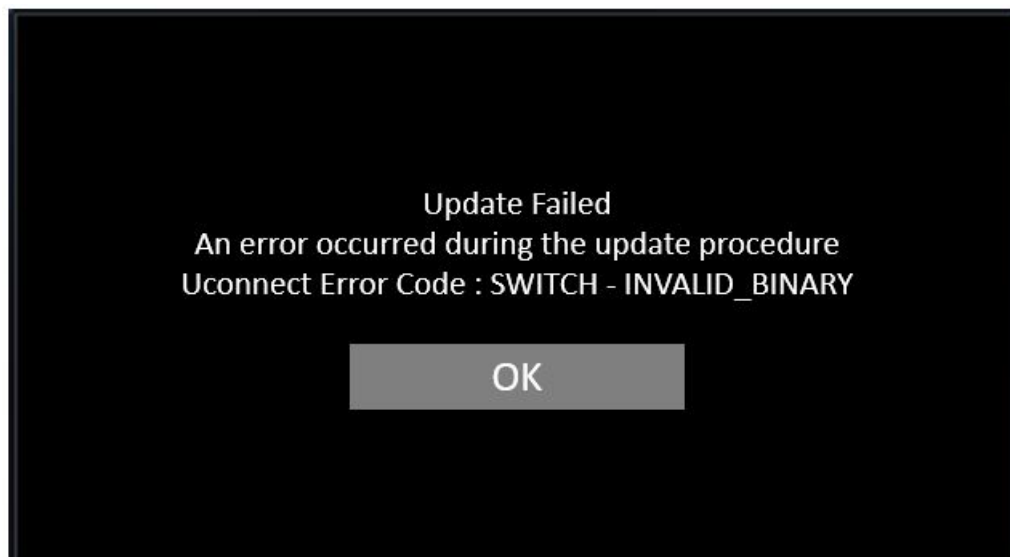
Fig. 5
Error Message

- Do Not** turn off the ignition at this point. The update is still in process, wait until the radio restarts and the home screen is displayed. This should take around five minutes.
- Sometimes the radio will display an error pop up " Invalid_Binary_Switch " after successful radio update. Please ignore this error message and press "OK" to continue (Fig. 5) .
