NUMBER: 08-062-22

GROUP: 08 - Electrical

DATE: March 18, 2022

UBD UED UBC Radio Enhancements

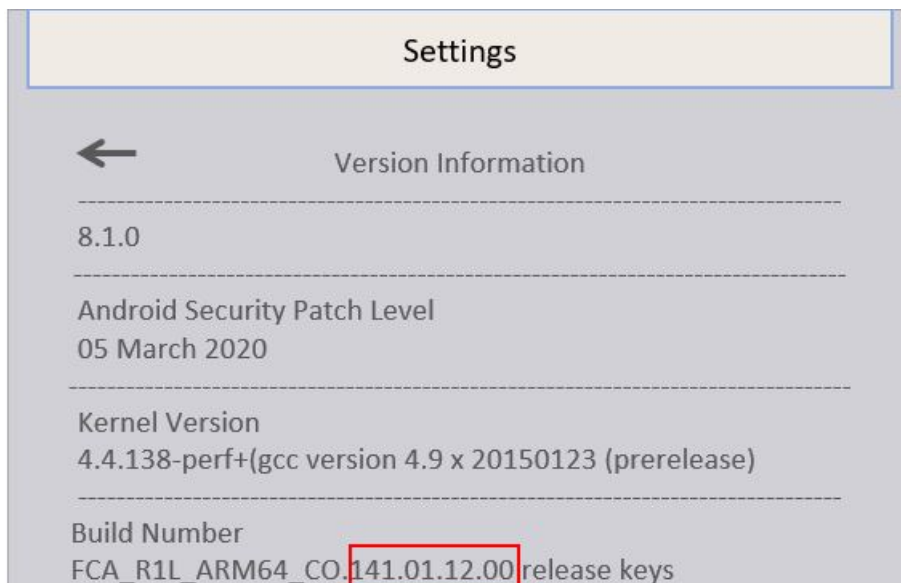
Fig. 1
Radio Software Level Screen

1. On the radio display screen go into "Vehicle Settings".
2. Select "System Information".
3. Select "Version Information".
4. Under the "Build Number", radio software version is listed. For example, the software version here is 141.01.12.00 (Fig. 1) .

- YES>>> The software version is below 141.01.12.00. Proceed to [Step 1](#) of the repair procedure below.
- NO>>> If the software version is at or above 141.01.12.00, the radio is already at updated software. This bulletin has been completed, Use inspection LOP (18-60-02-9R) to close the active RSU.
