**NUMBER:** 18-056-22

Flash: Powertrain Control Module (PCM) Updates

This bulletin involves reprogramming the Engine Control Module/Powertrain Control Module (ECM/PCM) with the latest available software.

2019	(DD)	RAM 3500 Cab Chassis
2019	(DP)	RAM 4500/5500 Cab Chassis

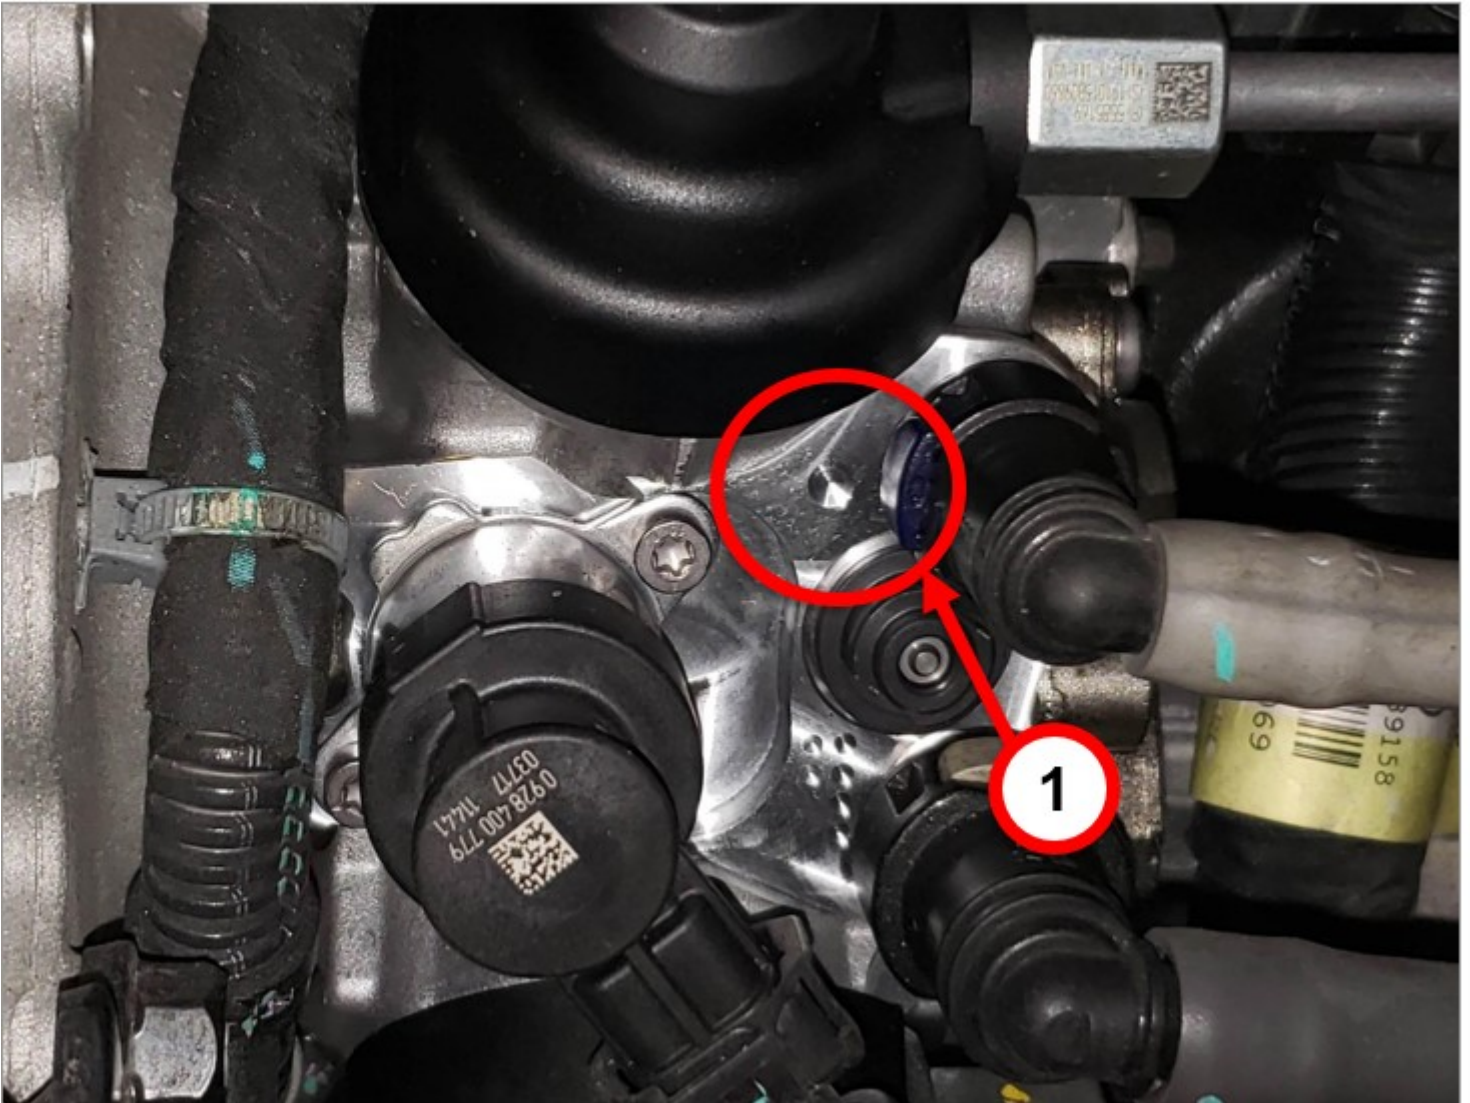
**Fig. 1**  
**New Style Symmetrical Cam Design Pump**

1. Inspect the fuel injection pump to see which pump the vehicle has:
  - Vehicles with the new style Symmetrical Cam design pump will have one large single dot embossed in the pump housing (Fig. 1) .
  - For vehicles equipped with a Symmetrical Cam pump, choose the calibration labeled Symmetric Cam, or Sym Cam.

1 - One large Single Dot on Housing.

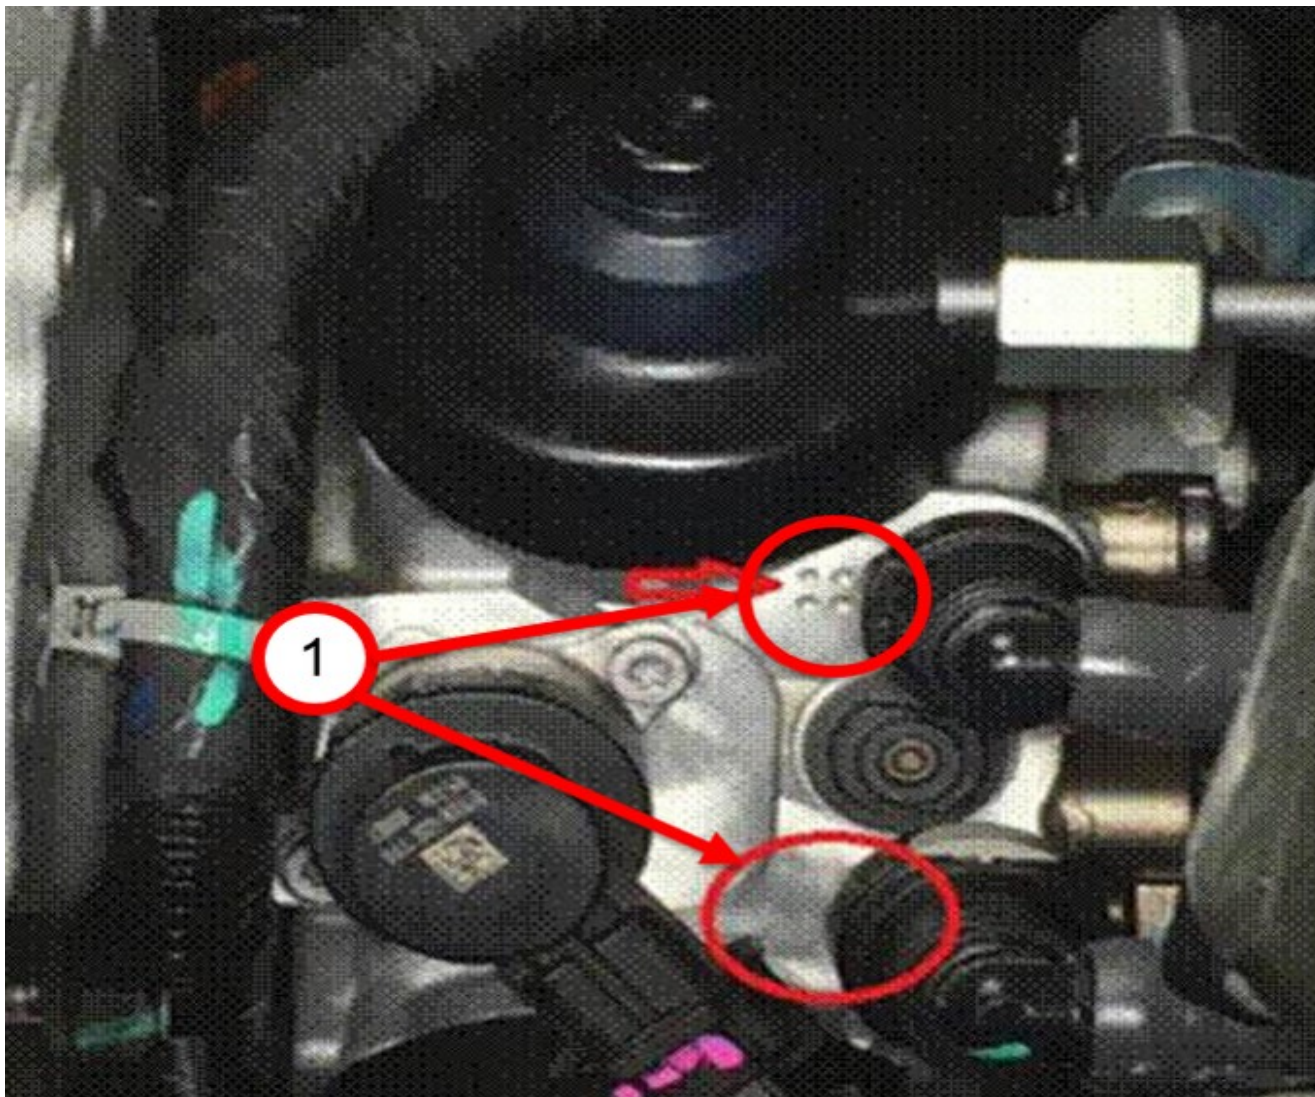
Fig. 2

- Vehicles with the old style Asymmetrical Cam design will have multiple small dots or no dots embossed in the pump housing (Fig. 2) .
- For vehicles with an Asymmetrical Cam pump, choose the calibration labeled Asymmetric Cam or Asym Cam.

Old Style Asymmetrical Cam Design Pump

1 - Multiple Small Dots or No Dots Embossed In The Pump Housing.
