E-Series	Model Description
F39	X2 Sports Activity Coupe
F44	2 Series Gran Coupe
F48	X1 Sports Activity Vehicle

Customer complains of musty odor or damp front footwell carpet.

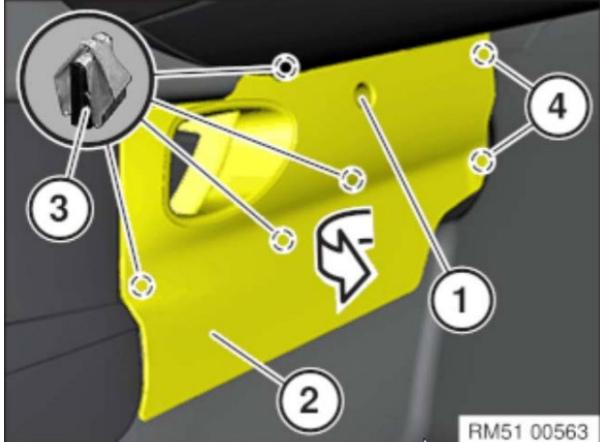
Locate IHKA housing A/C condensate drain by removing passenger side console foot well trim.

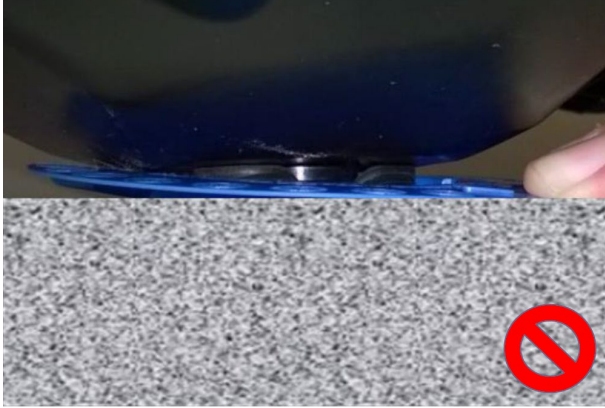
<ol style="list-style-type: none"> 2. If drain is twisted or deformed it must be replaced.

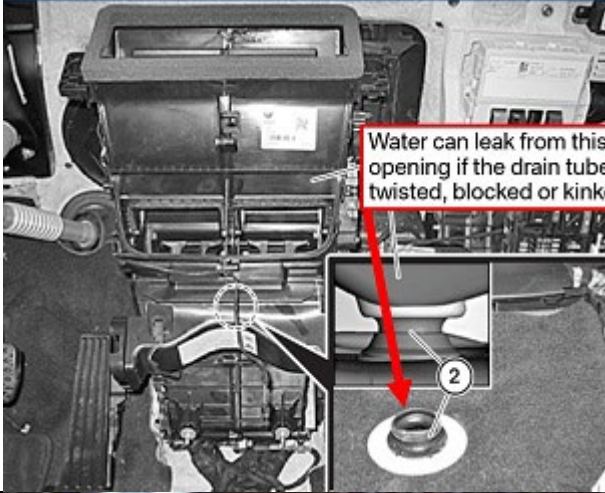
- The condensate drain hose is blocked by the heat shield
- The condensate drain hose is not attached properly to the housing
- The condensate drain hose was damaged during installation

<p>3. This close up shows drain incorrectly installed.</p>

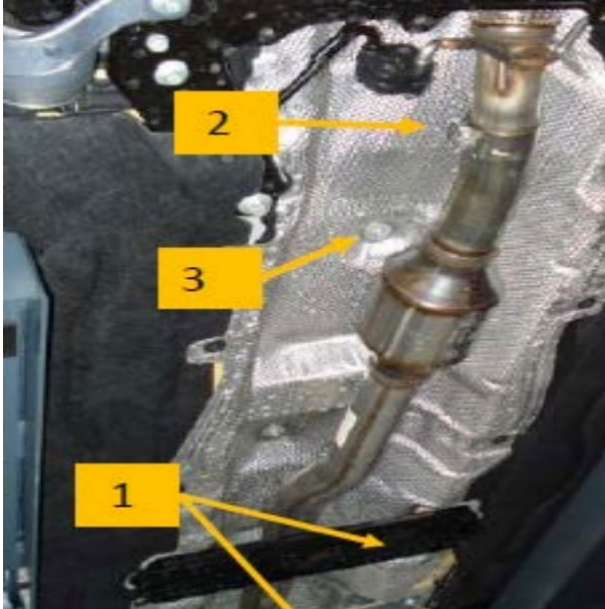
<p>4. Water leaks can occur in these areas causing the molding smell from carpet.</p>
