E-Series	Model Description	Production Date	Affected Option Code
G01	X3 Sports Activity Vehicle (SAV)	From Start of Production	All US vehicles are equipped with Knee Air Bags as standard equipment
G02	X4 Sports Activity Coupe (SAC)		
F97	X3 M SAV		
F98	X4 M SAC

A check control message for the restraint system appears. In the instrument cluster, the red air bag warning light lights up permanently.

The wiring harness going to the knee air bag may be rubbing against the support tube of the instrument panel.

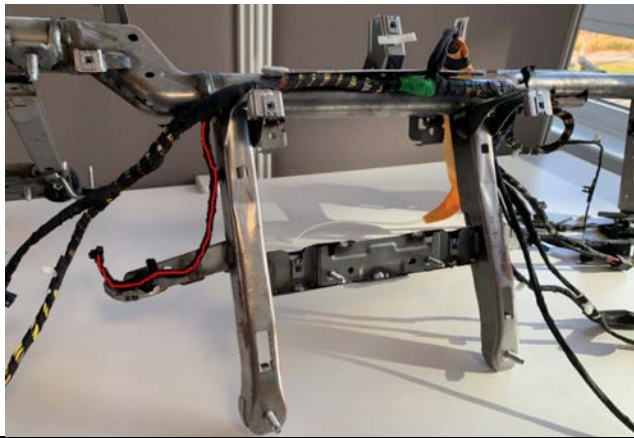
Drivers knee air bag harness route. Wrap the last 34 centimeters back towards the wiring harness with an abrasion-resistant fabric tape (part number 61 13 6 925 452).
--	---

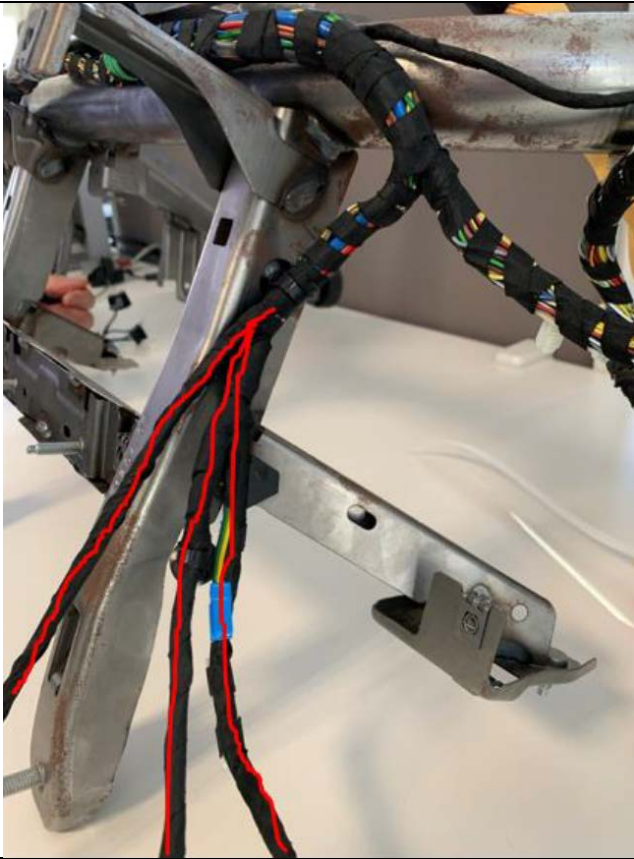
Passenger side air bag harness route.
Wrap the 3 harnesses shows in red on the passenger's side with an abrasion-resistant fabric tape (part number: **61 13 6 925 452**).
