Knee Air Bag Check Control Message G05 variants

E-Series	Model Description	Production Date	Affected Option Code
G05	X5 Sports Activity Vehicle (SAV)	From Start of Production	All US vehicles are equipped with Knee Air Bags as standard equipment
G06	X6 Sports Activity Coupe (SAC)		
G07	X7 SAV		
F95	X5 M SAV		
F96	X6 M SAC

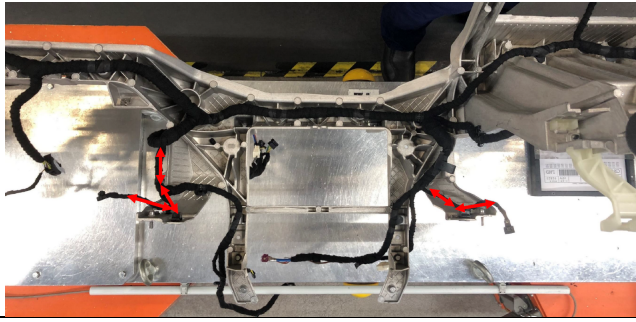
The wiring harness going to the knee air bag may be rubbing against the support tube of the instrument panel.

<p>1. Cover the 4 points on the support tube (the surface or the edge inside the oval circle) with felt tape (Felt tape part number 54 34 7 248 700).</p> <p>If metal residue or welding residue are visible on the support tube, they must be removed. Glue the felt generously to the support tube or the edge.</p>
	<p>2. Wrap the harness of the knee airbag on the driver's</p>
