E-Series	Model Description	Production Date	Affected Option Code
F95	X5 M Sports Activity Vehicle	From November 25th, 2021, to March 5th, 2022	5AU – Driving Assistant Professional & 5AR – Traffic Jam Assistant
F96	X6 M Sports Activity Coupe

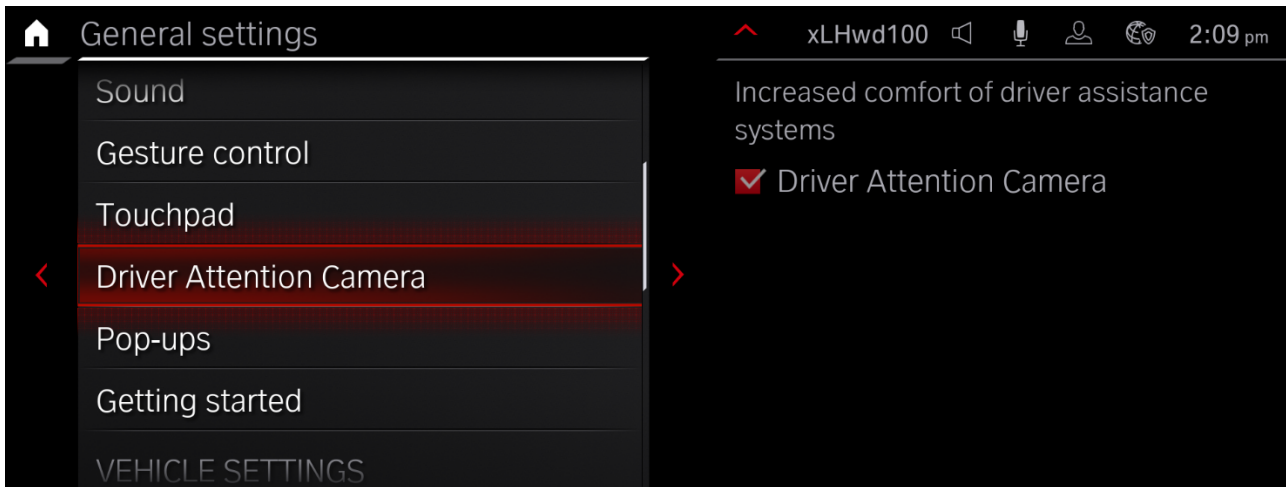
The Driver Attention Camera (DCS) setting is missing or greyed out. The setting can normally be found under General settings, Driver Attention Camera.

Software error in the Head unit.

Based on a customer complaint, program the vehicle.

4. Program the vehicle using ISTA 4.33.3x or higher (released February 2022).
