# Service Bulletin

Bulletin No.: 16-NA-222

**Subject:** Information for Engine Concerns Resulting from Lack of Scheduled Maintenance, Improper Service or Aftermarket Calibrations

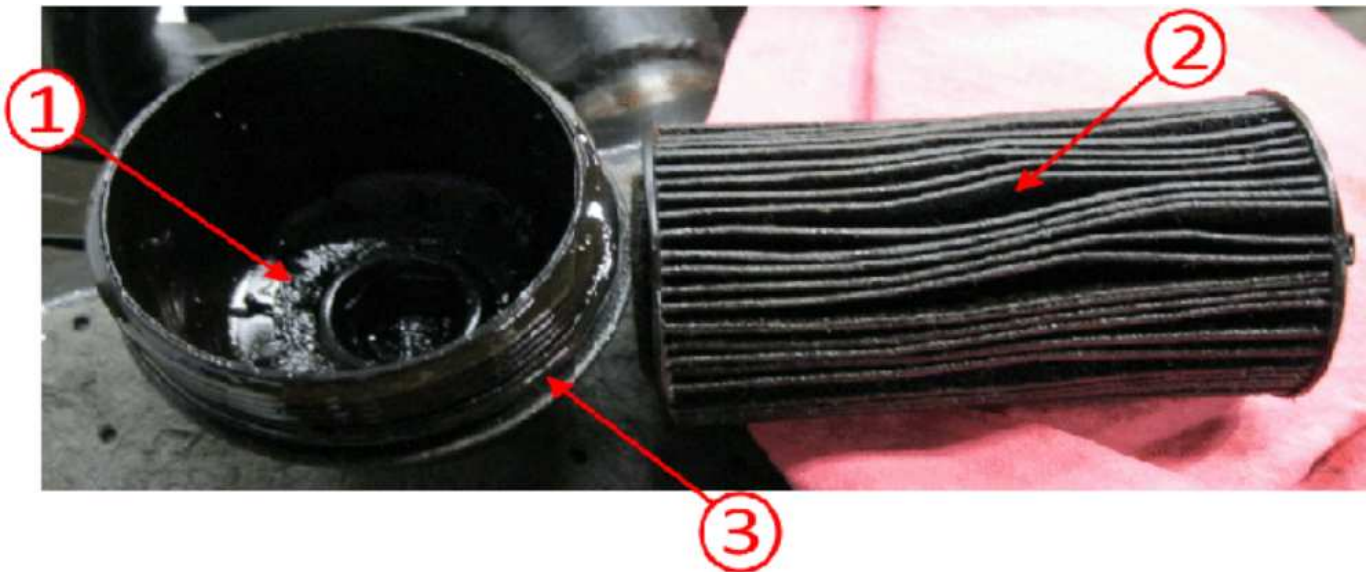
4543496

Oil filter blocked by debris and oil sludge.

- On vehicles equipped with an oil filter cartridge, inspect the cap (1) for sludge.
- Oil filter pleats (2) with heavy debris or sludge.
- Damage, holes, tears, improper installation, or missing seals (3).

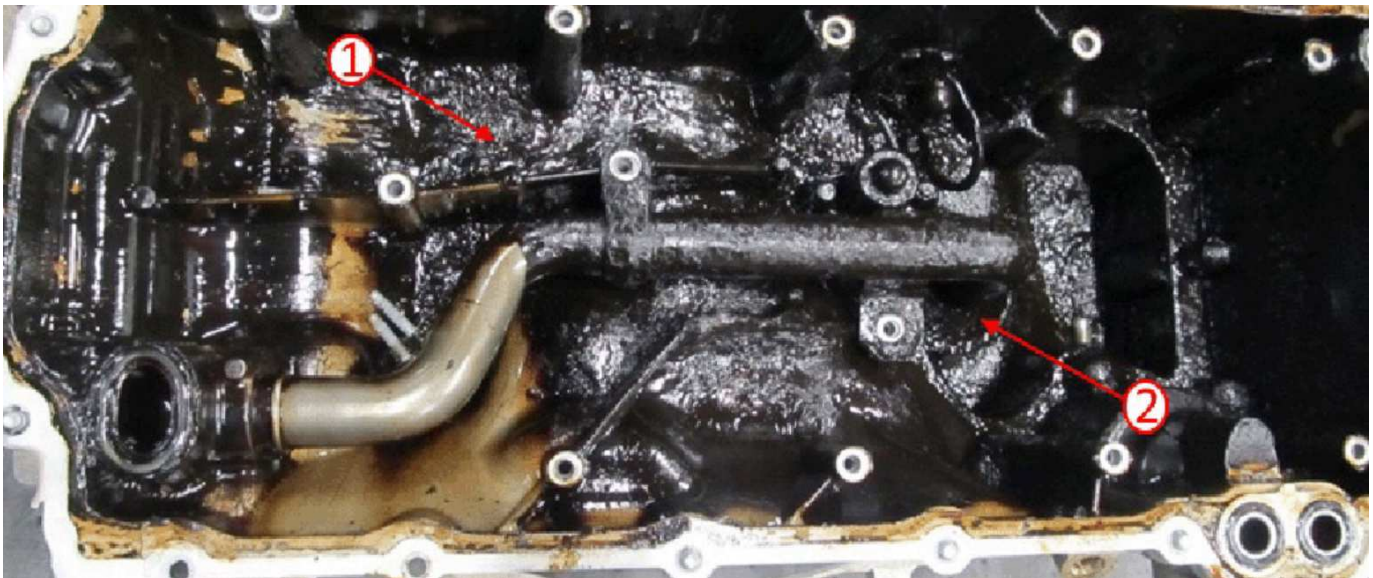
4543483

### Sludge build up in the bottom of the oil pan.

- Sludge (1) or debris found in the bottom of the pan blocking the pick up tube (2) screen.
- Light debris in the oil pump pick-up tube screen is normal, from normal engine wear.
- Some determination must be used to validate what is or what is not considered normal wear.

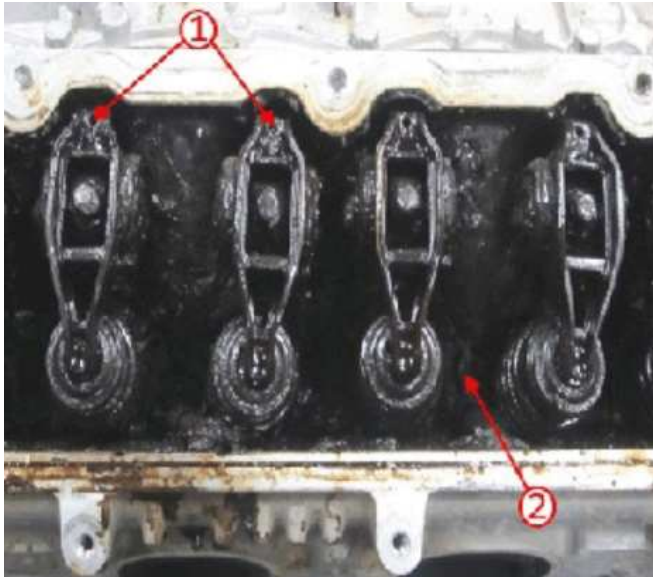
4543670

- Sludge build up on the camshaft (2) and camshaft caps (1).
- Scratches or gouges on the journals or lobes (3) of the camshaft causing a low or loss of oil pressure condition.
- Lack of oil on the lifter tappet creating ticking noise.

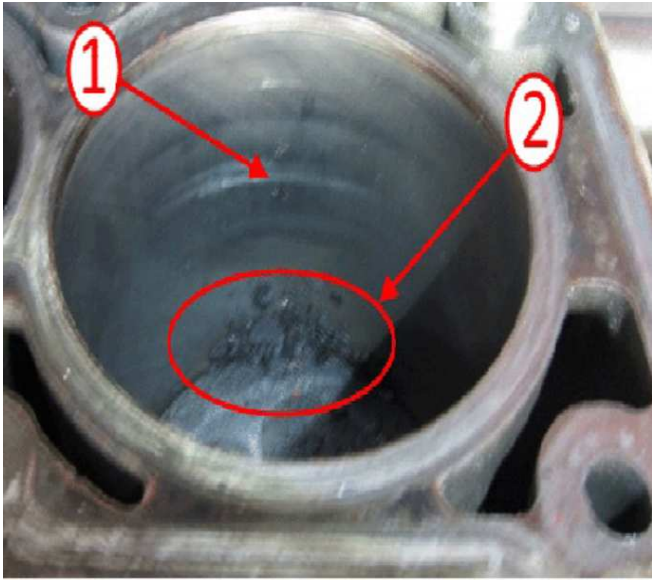
4543465

Conditions that May Result From Improper Service  
Improper installation of the air filter into the air filter housing or the use of aftermarket air filter.

- Foreign debris bypassing the air filter and/or the air filter housing outlet ducts.
- Faulty installation of the air filter in the air box housing causing the dirt and debris (2) to enter the combustion chamber.
- Damage to the piston and the piston cylinder wall (1).

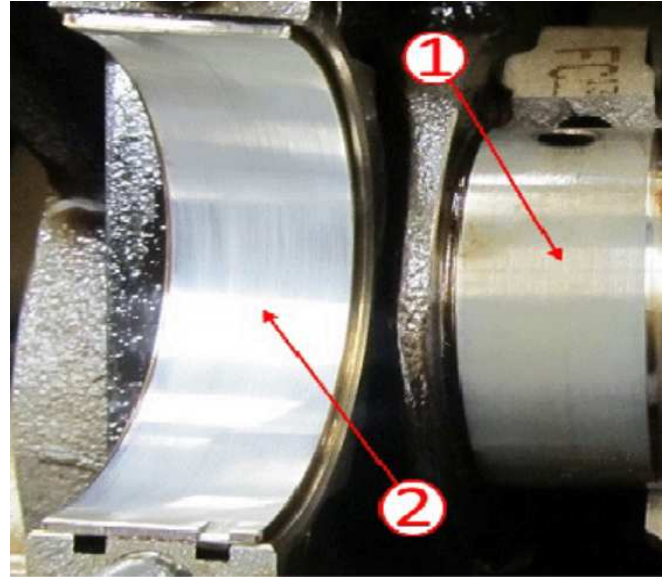
4543396

Main and rod bearing damage caused by foreign debris.

- Dust and debris on the crankshaft, crankshaft bearings, rods (1) or rod bearings (2) caused the chrome finish of the journals to prematurely wear away causing the clearance to increase, possibly causing low oil pressure or a knocking noise.
- Scratches or gouges on the journals result in low or loss of oil pressure condition.
- Possible previous engine repair may result in some debris entering the engine through open ports that are normally sealed or closed off.

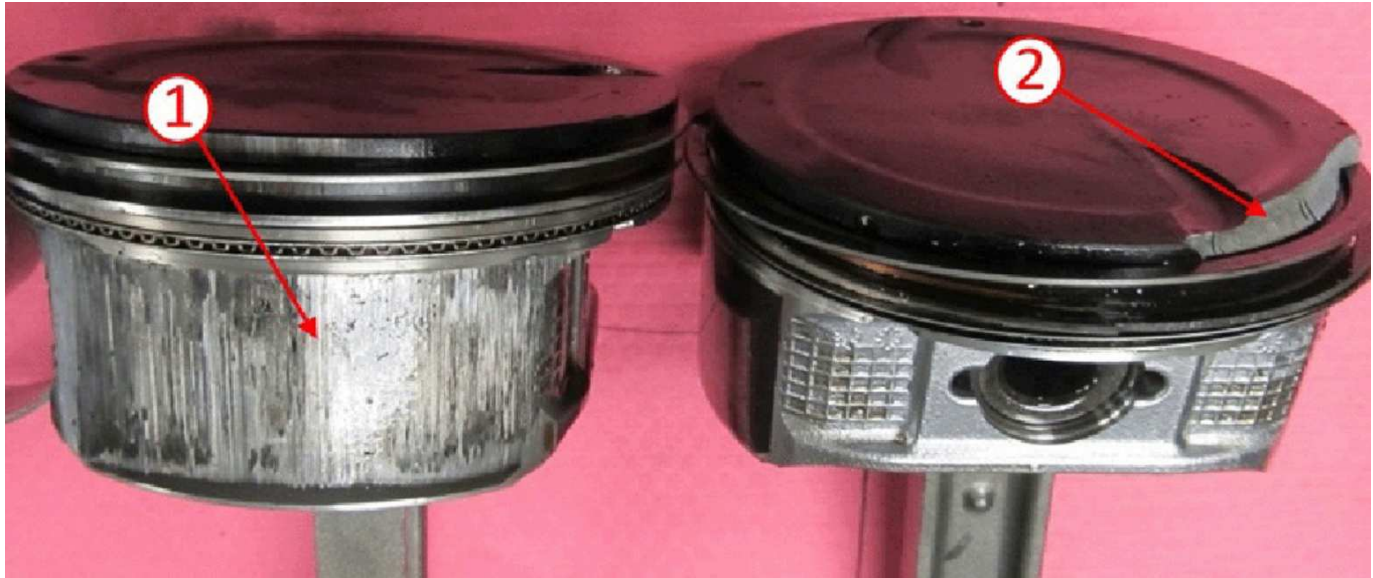
4547308

**Incorrect calibrations or modifications that may cause engine damage.**

- Piston damage (1) caused by a pre-detonation lean event.
- Improper engine warm up creates excessive heat to the piston causing them to seize to the cold cylinder walls cracking the piston lands (2).
- Aftermarket cold air filter, air filter housing and intake system not allowing proper engine warm up.
