Service Bulletin

Bulletin No.: 17-NA-114

Subject: Oil Leak from Turbocharger Inlet or Outlet Duct

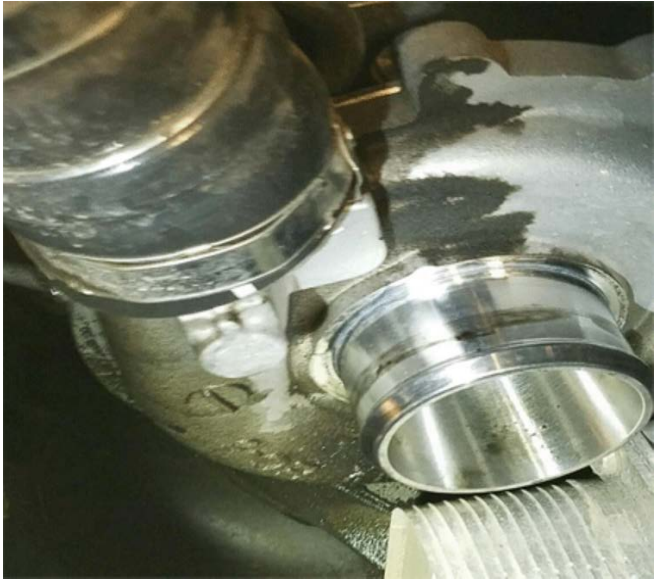
<p style="text-align: right; margin-right: 20px;">4754826</p>

<p style="text-align: right; margin-right: 20px;">4754827</p> <p>Some customers may comment on an oil leak originating from either the inlet or outlet duct of the turbocharger.</p> </div>
Cause	This may be due to the charge air cooler pipe clamp not being tightened properly.
Correction	If you encounter a vehicle with the above concern, do not replace the turbocharger for this condition, instead tighten the charge air cooler pipe clamp.

Refer to *Charge Air Cooler Inlet/Outlet Duct Replacement* in SI for the procedure to gain access to the clamps needed to be tightened.
