Service Bulletin

Bulletin No.: 18-NA-069

Date: January, 2022

Subject: Poor Engine Performance in Extremely Cold Weather Conditions for LFV Engines, Charge Air Cooler Icing - Malfunction Indicator Lamp (MIL) Illuminated - DTC P0299, P0236, P2227 and/or P00C7 Set

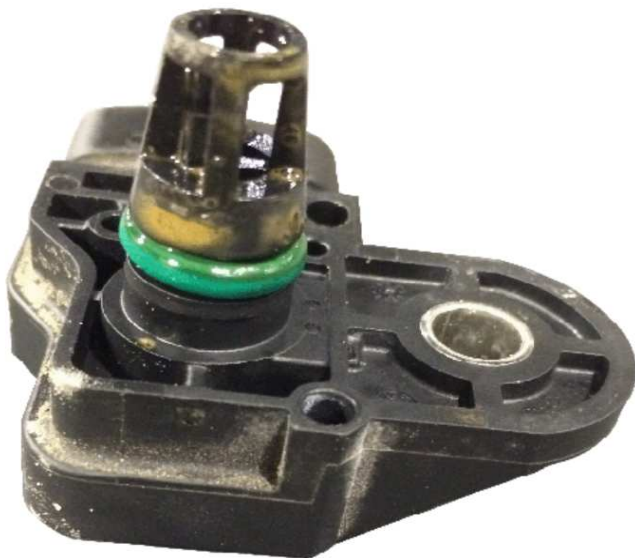
4910683

4. Inspect the sensor of any contaminants.

Important: Due to the sensitivity of the sensor, **Do Not** use any chemical cleaners including water and **Do Not** use compressed air to remove contaminants.
