Service Bulletin

Bulletin No.: 18-NA-098

Subject: Diagnostic Tip for Coolant Leak, Coolant Consumption and/or Low Coolant Message Being Displayed On the Driver Information Center (DIC)

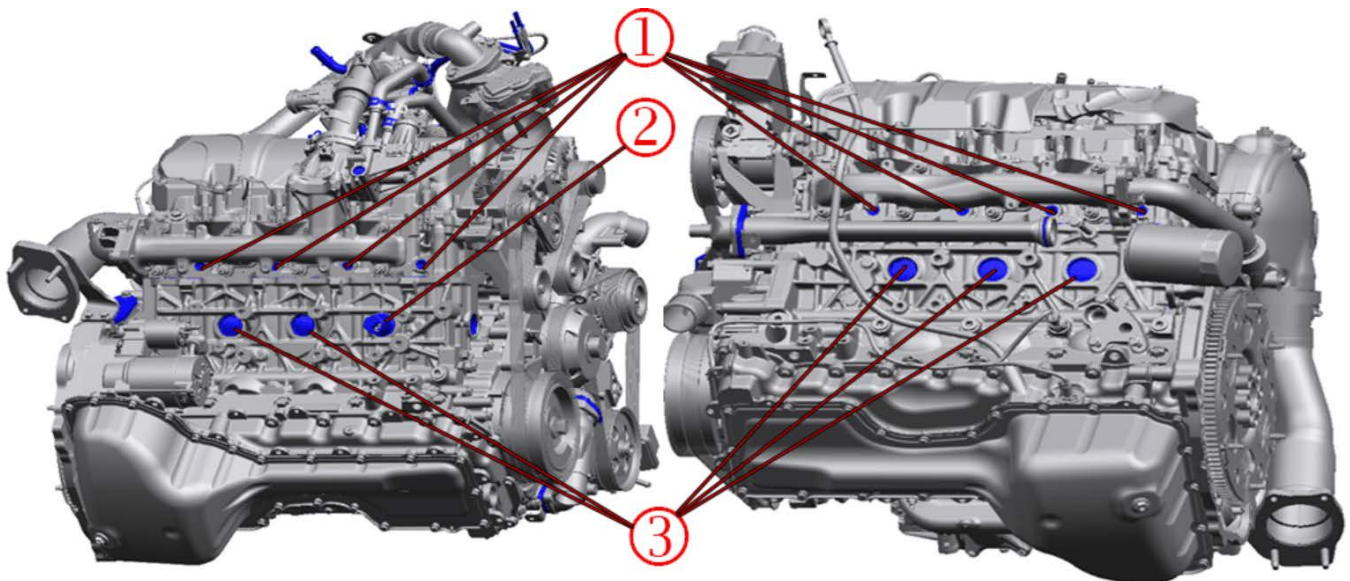
5027608

1. Plugs in Cylinder Head (PLUG, CYL HD CORE HOLE) (Qty 8)
2. Block Heater (HEATER, ENG COOL)
3. Cup Plugs in Block (PLUG, ENG BLK COOL DRN HOLE (OD=40MM) (Qty 5)

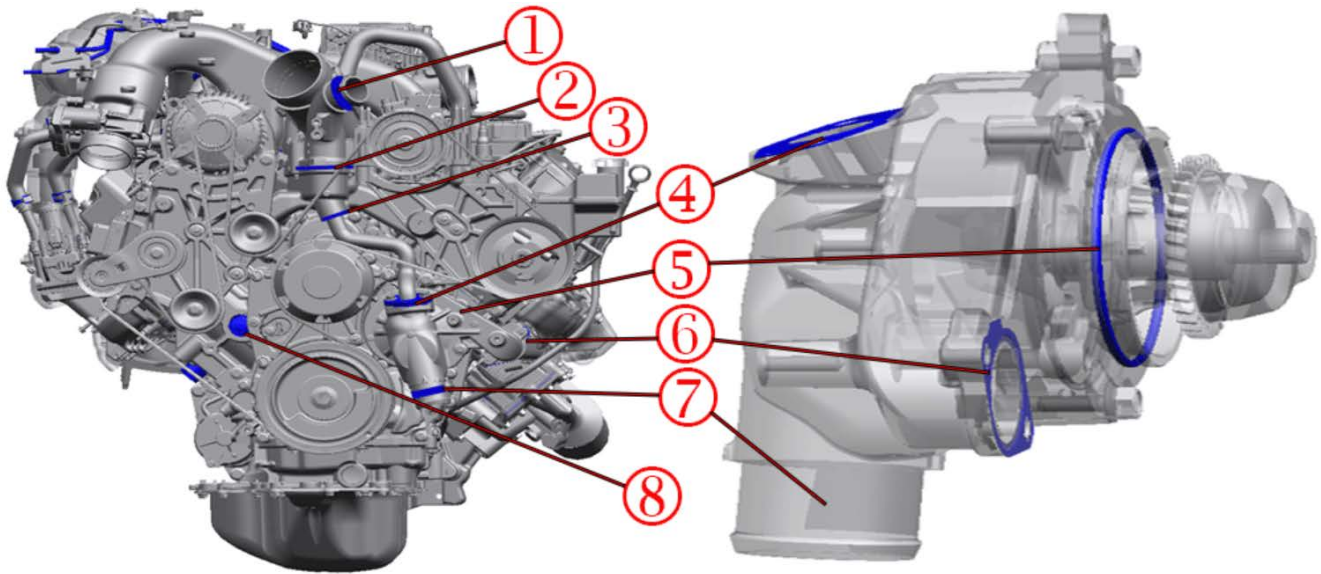
5027641

1. Coolant Hose and Clamp
2. Thermostat Housing (SEAL, ENG COOL THERM (O RING))
3. O-Ring for Bypass Pipe (SEAL, THERM BYPASS PIPE (O RING))
4. Flange with Gasket for Bypass Pipe (GASKET, THERM BYPASS PIPE)
5. O-Ring Seal (Front Cover to Water Pump) (SEAL, W/PMP CVR)
6. Seal-Water Pump to Pipe (GASKET, W/PMP OTLT PIPE)
7. Coolant Hose and Clamp
8. Cup Plug on Block (PLUG, ENG BLK COOL DRN HOLE)

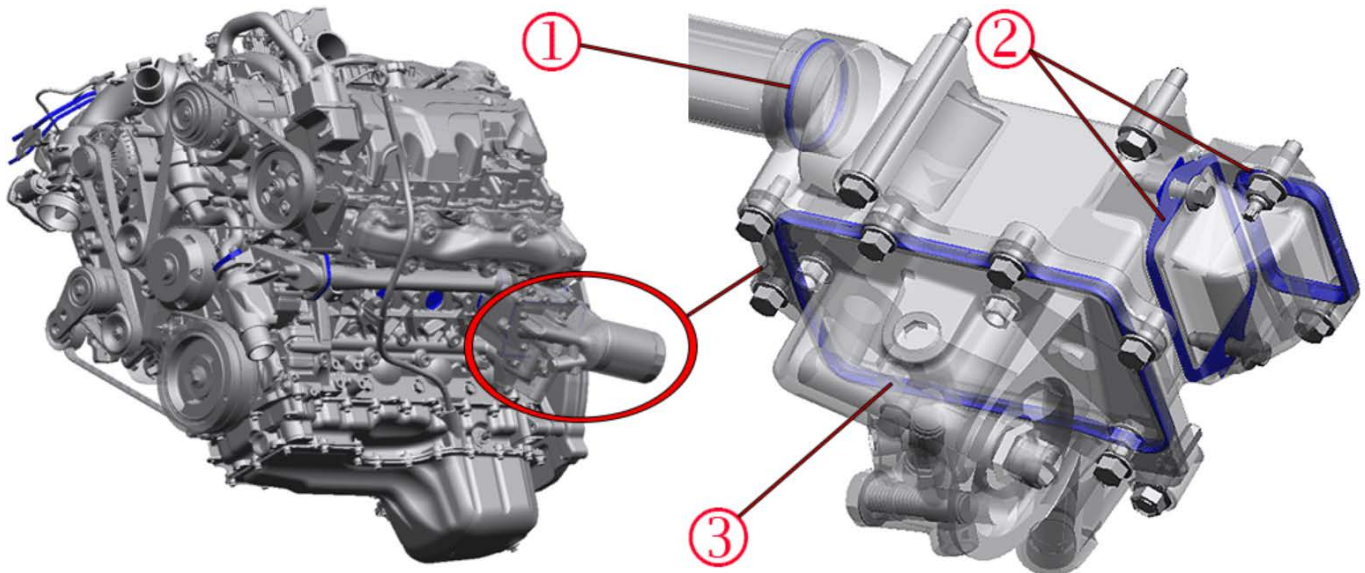
5028324

1. O-Ring (Water Pipe to Oil Cooler) (SEAL, W/PMP OTLT PORT)
2. Either end of the Oil Cooler Adapter (Elbow) (GASKET, ENG OIL CLR ADAP)
3. Seal in the Oil Coolerlet (GASKET, ENG OIL CLR)

Note: Ghost view of the Oil Cooler to reveal O-ring and cover gasket and 2 adapter gaskets (Oil Filter not shown).

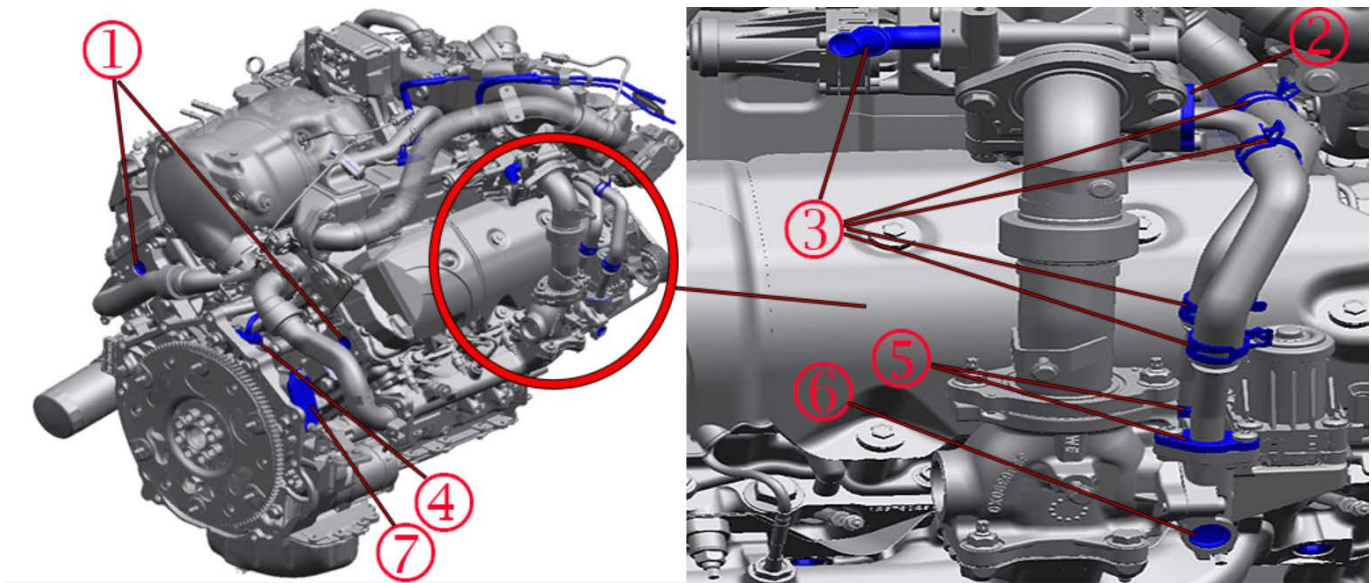
5028590

1. Cup Plugs (Qty 2)(One per side in rear of Cylinder Head) (PLUG, CYL HD CORE HOLE)
2. Gaskets under Flange, 1 location on EGR Bypass Valve (Serviced with VALVE, EGR VLV CLR BYPASS)
3. Hose Clamps, 5 locations
4. Turbo Coolant Feed Pipe (GASKET, TURBO COOL FEED & RTN PIPE)
5. Gaskets under Flange, 2 locations on EGR Valve (Service with VALVE, EGR)
6. Cup Plug in Bypass Valve (Service with VALVE, EGR)
7. Cover on Flywheel Housing (GASKET, FLYWHL HSG CVR)

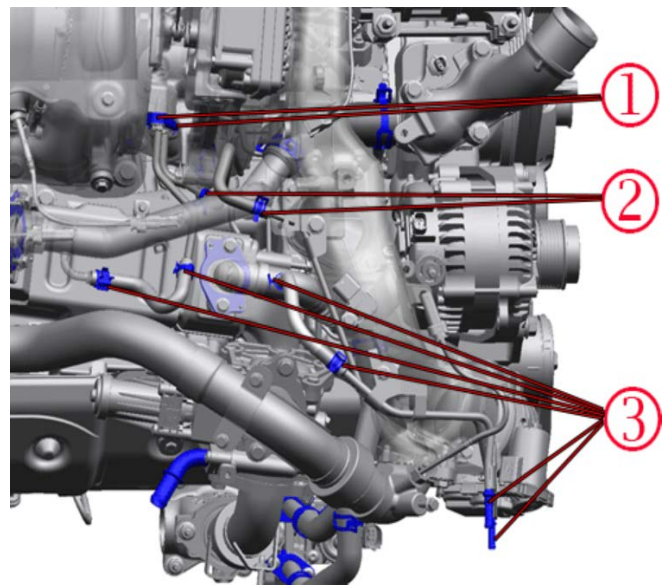
5028593

1. Gasket for Turbo coolant pipes (GASKET, TURBO COOL FEED & RTN PIPE) (Qty 2)
2. Ghost view of Upper Intake Manifold and EGR Coolant Pipe. Inlet Adapter removed to reveal EGR Coolant Return Pipe.
3. Hose Clamps for Turbo Coolant Pipes and DEF Coolant Pipe (Qty6)

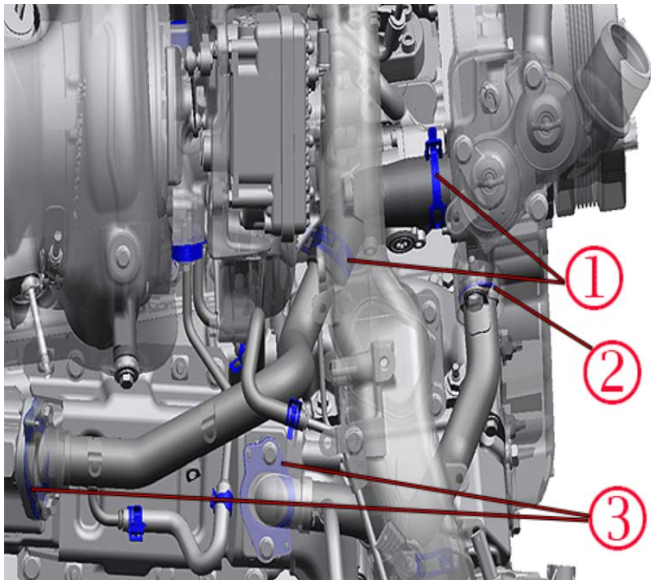
5028604

1. Hose Clamps on the EGR Coolant Return Hose (Qty 2)
2. O-Ring for EGR Coolant Return Pipe (SEAL, EGR COOL FEED PIPE) (Qty 2)
3. Gaskets under Flanges for EGR Coolant Feed and Return Pipes (SEAL, EGR COOL FEED PIPE) (Qty 2)

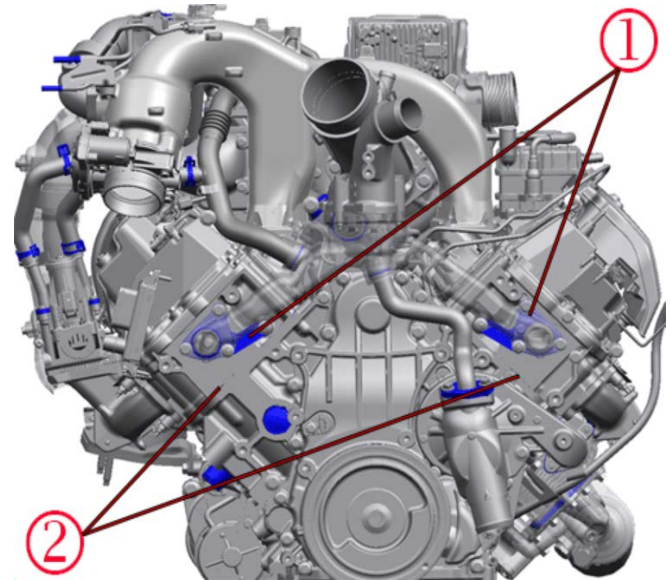
5028676

Note: A leak on the top of the engine will trail down the back of the engine and appear as a rear cover leak.

1. Gaskets between Cylinder, Heads and Water Crossover Housing (GASKET, ENG COOL THERM HSG) (Qty 2)
2. Head Gaskets (GASKET, CYL HD)
