Service Bulletin

Bulletin No.: 22-NA-003

Subject: Instrument Panel Cluster (IPC) Warning Lamps, Malfunction Indicator Lamp (MIL) Illuminated, Diesel Exhaust Fluid (DEF) Message Displayed - Various DTCs Set

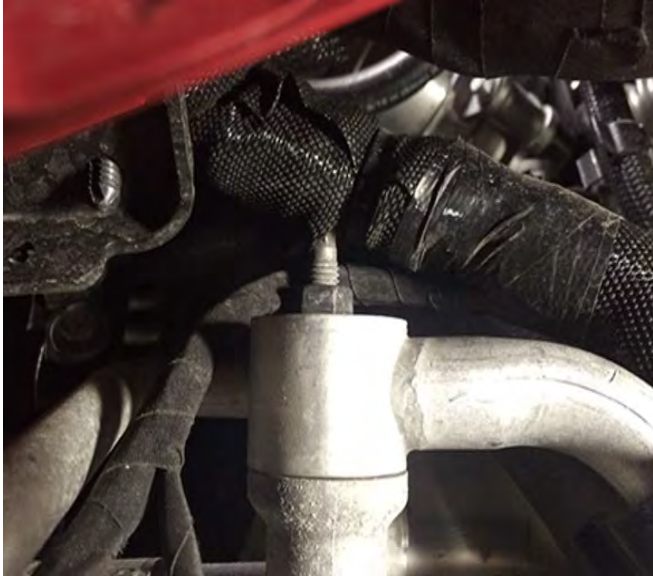
4573211

- Air Conditioning (AC) compressor, AC compressor suction and discharge line manifold, AC line and AC compressor clutch.

Concerns in the area of the AC compressor, lines or suction/discharge pipes may cause:

- The MIL to illuminate.
- The Driver Information Center (DIC) may display a reduced power message or service power steering message.
- The engine to run rough.
- The Service Four Wheel Drive (4WD) Light or Stabilitrak light may illuminate.
- A possible extended crank or a crank no start.
- The oil pressure gauge may read erratically or read no oil pressure.
- The Air Conditioning (AC) may not cool or blow hot air.
- An open fuse in the Underhood Bussed Electrical Center (UBEC).

DTCs associated with chaffing in this area include:

- B127E, C0306, C0321, C0398, C0800, P0071, P0072, P0117, P0119, P0340, P0341, P0406, P0483, P0522, P0628, P0641, P06A3, P0700, P20BB, P20BF, P227E, P24B1, U0073, U0077, U0121, U0131, U0140, U0151, U0415, U2099, U0401, U0415 and U0420.
- Serpentine Belt. The fan clutch wiring harness support bracket may be out of position allowing the harness to rub on the belt.

If you encounter these scenarios, inspect, repair (as necessary) and route the wiring harness away from these possible chafe points.

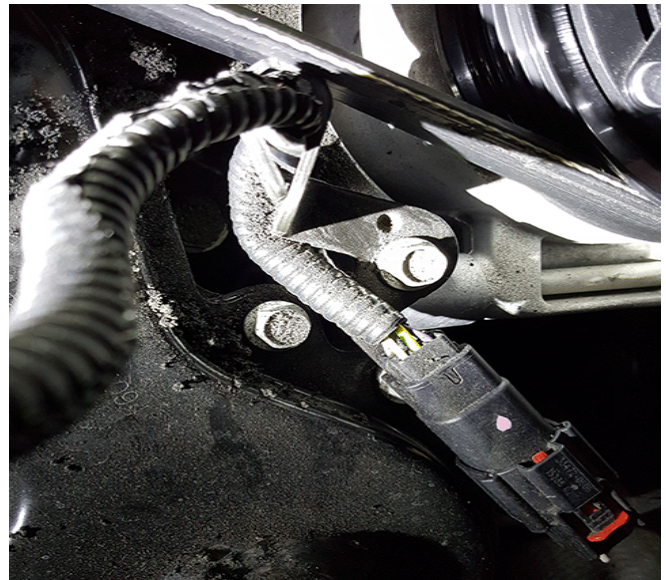
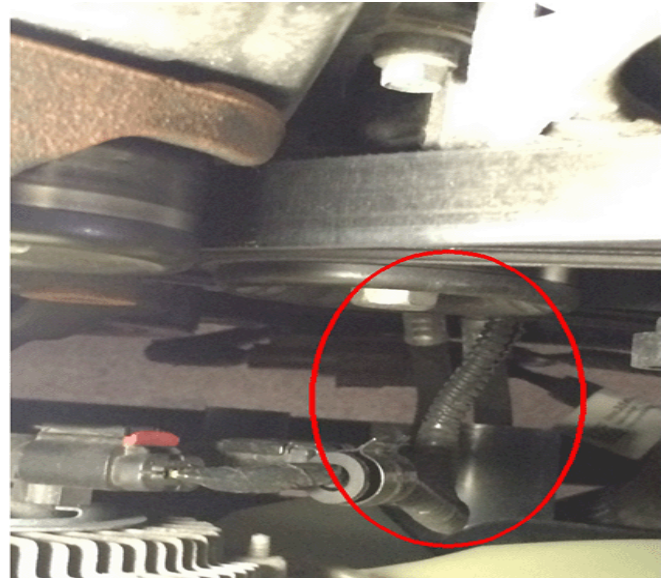
Concerns in the area of the serpentine belt may cause:

- Various IPC warning lights to illuminate.
- A crank no start concern.
- The MIL to illuminate.
- The engine may run rough or misfire.
- The Service Four Wheel Drive (4WD) light may illuminate.
- The Stabilitrak light may illuminate.
- The Air Conditioning (AC) may not cool or may blow hot air.

DTCs associated with chafing in this area may include:

- C0273, P0526, P0480, P0336, P0526, P0641 and P0651.
- Right rear of engine. Check for harness damage on the exhaust heat shield as described in the latest version of bulletin 16-NA-081.

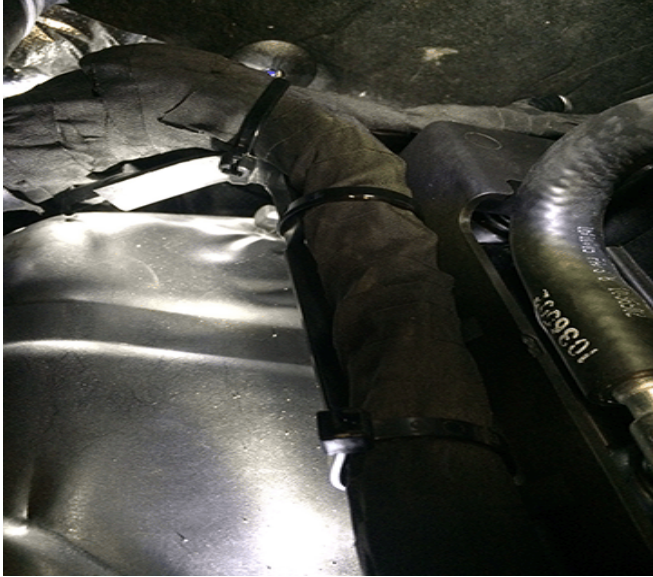
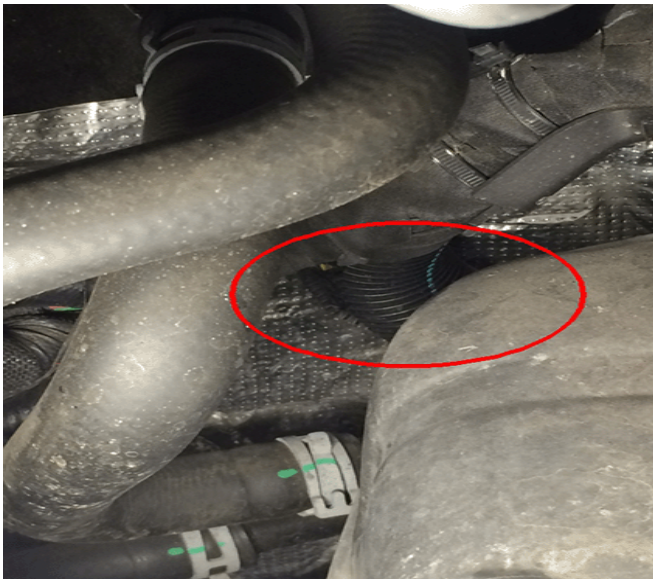
Concerns in the area of the right rear of engine / exhaust heat shield may cause:

- Various IPC warning lights to illuminate.
- The Service Four Wheel Drive (4WD) light may illuminate.
- The Stabilitrak light may illuminate.
- The check engine light to illuminate.

- The Driver Information Center (DIC) may display a reduced power message.
- An open fuse in the Underhood Bussed Electrical Center (UBEC)

DTCs associated with chafing in this area may include:

- B1011, C0306, P0201, P0202, P0203, P0204, P0410, P0575, P062D, P0697, U0073, U0100, U0121, U0140, U0415 and U0420.
- Transmission bell housing bolt/stud.

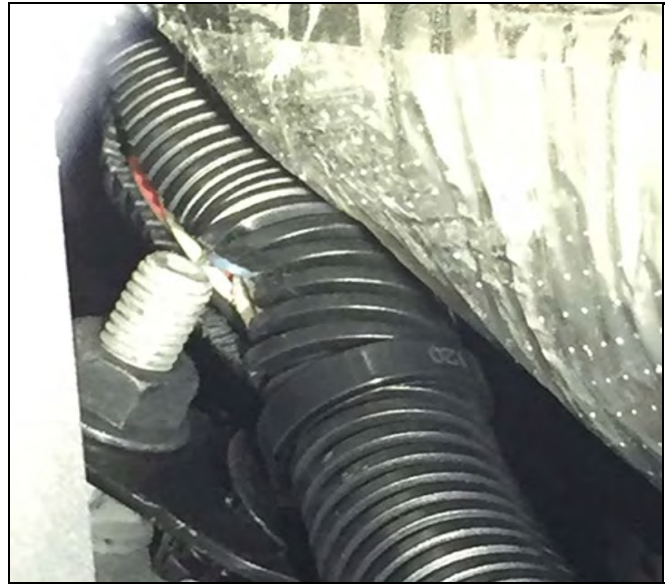
4573244

Concerns in the area of the rear of engine / transmission bell housing bolt/stud may cause:

- Various IPC warning lights to illuminate.
- The Service Four Wheel Drive (4WD) light may illuminate.
- The Stabilitrak light may illuminate.
- The MIL to illuminate.

DTCs associated with chafing in this area may include:

- P0201, P0202, P0203, P0204, P0392, P0401, P0420, P062D and U0073.
- Coolant pipe and clamp tabs between engine and cowl.

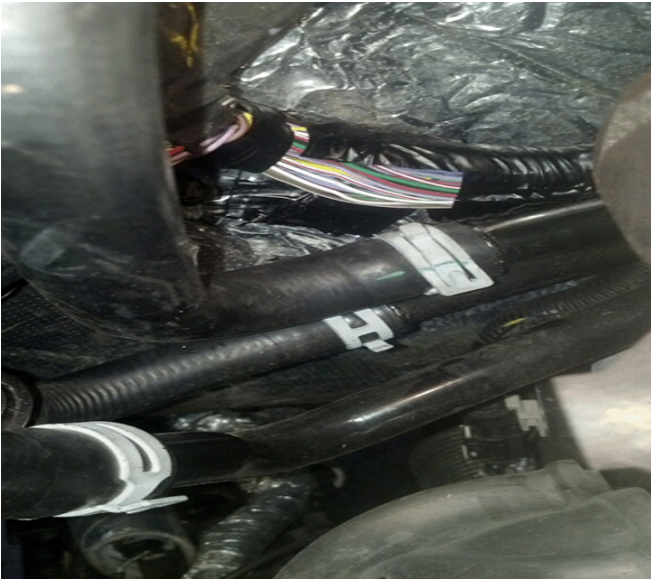
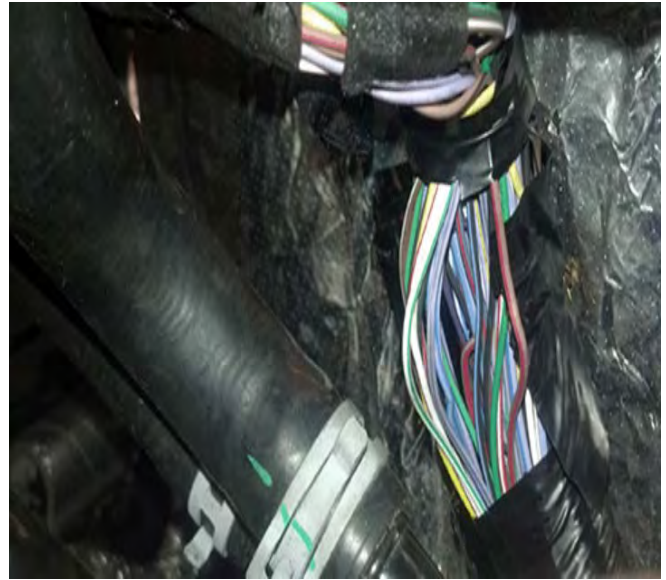
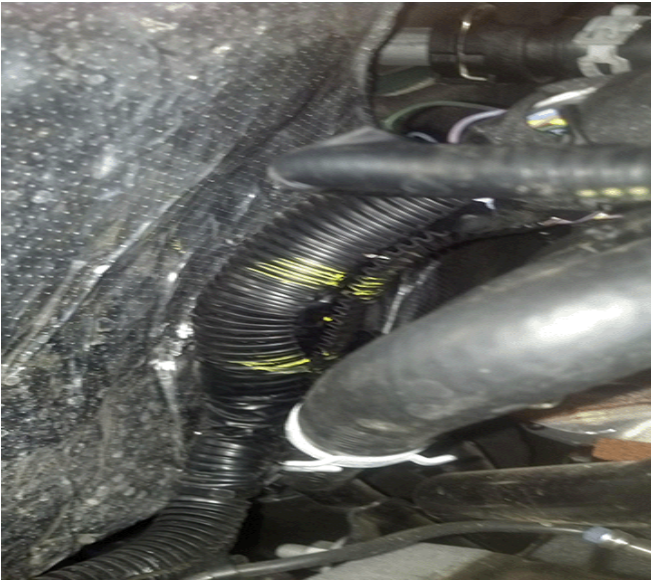
Concerns in the area of the coolant pipe / clamp / clamp tabs between engine and cowl may cause:

- Various IPC warning lights to illuminate.
- The Service Four Wheel Drive (4WD) light may illuminate.
- The Stabilitrak light may illuminate.
- The MIL to illuminate.

DTCs associated with chafing in the area may include:

- B1011, P0575, U0073, U0100, U0121, U0140, U0415 and U0420.
- Near the brake fluid level switch.

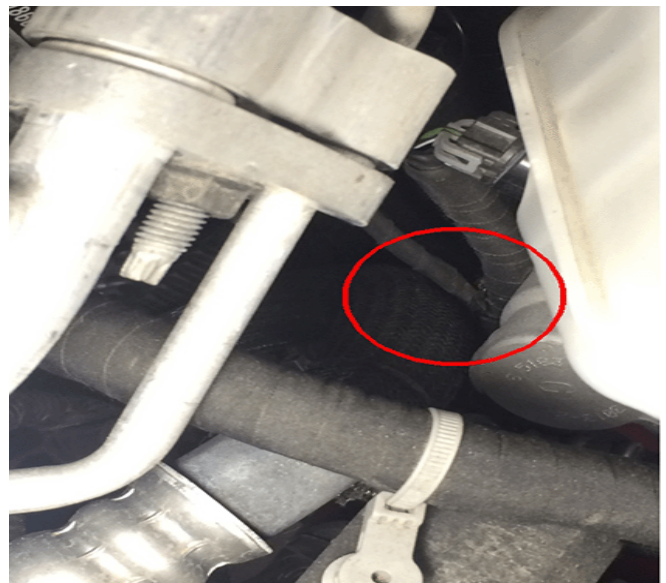
4573216

Concerns in the area near the brake fluid level switch may cause:

- The service brake light to illuminate.
- The DIC may display that the brake fluid is low.
- The check engine light to illuminate.

DTCs associated with chafing in this area may include:

- C0273 and P0641.
- Transfer case encoder motor.

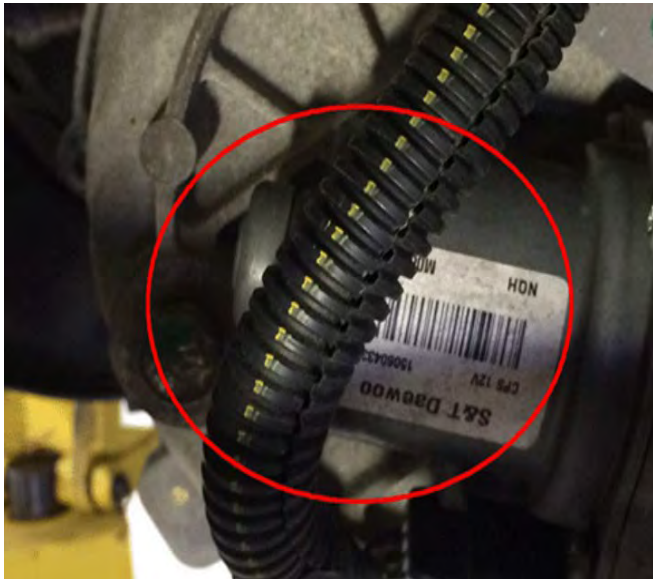
4573221

Concerns in the area near the encoder motor on the transfer case may cause:

- Various IPC warning lights to illuminate.

DTCs associated with chafing in this area may include:

- C0396.
- Turbocharger Vane Position Actuator Connector.

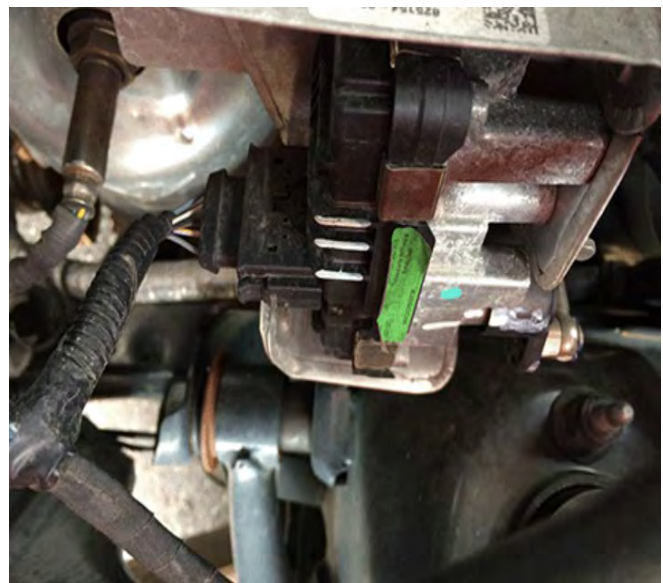
4575279

Concerns with loose terminals or connector not fully seated at the Turbocharger Vane Position Actuator may cause:

- The Check Engine Light to illuminate.
- The Driver Information Center (DIC) may display a reduced power message.
- The vehicle may have a low power concern.

DTCs associated with a loose connector or terminals include:

- P0045 or P2599.
- Additionally, there may be chafing of the wiring harness on the power steering pump pulley.
