# Service Bulletin

Bulletin No.: 22-NA-007

**Subject: Poor Engine Performance in Extremely Cold Weather Conditions for LE2 Engines, Charge Air Cooler (CAC) Icing - Malfunction Indicator Lamp (MIL) Illuminated, DTC P0299, P0234, P0236, P2227, P00C7 Set**

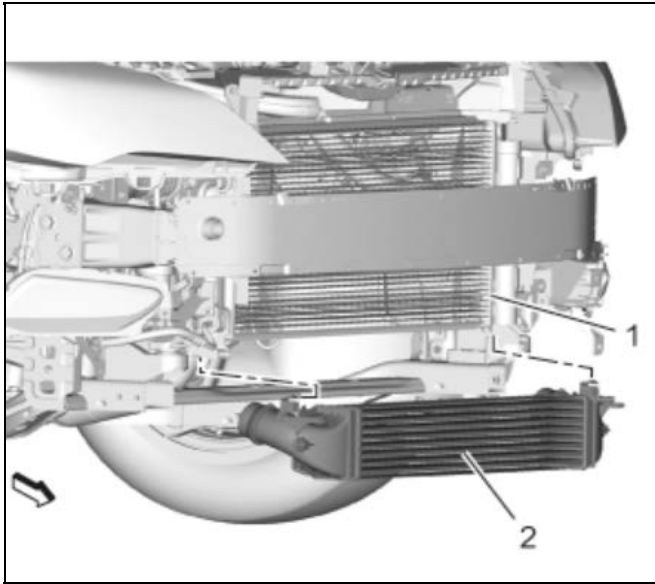
4171562

<b>Cause</b>	This condition may be caused by ice accumulation in the charge air cooler (CAC), restricting air flow to the throttle body.
<b>Correction</b>	<p>If any of the above conditions are present, allow time for possible ice build up in the CAC to melt by allowing the vehicle to thaw in a warm environment.</p> <p>If there is a check engine light with a P0234 or P0299 DTC during cold weather driving, refer to Turbocharger/Supercharger Boost Sensor Inspection below.</p> <ul style="list-style-type: none"> <li>– Frozen oil/water contaminant in the Turbocharger Wastegate Regulator Solenoid Valve (TCV) is often concurrent with vehicle operating conditions that cause CAC freezing. If either DTC P0234 or P0299 is set, refer to PIP5812C for Turbocharger Wastegate Regulator Solenoid Valve Inspection. Cleaning or replacing the TCV solenoid should be performed in addition to CAC protection measures specified in this bulletin.</li> </ul> <p>Follow the Service Procedure below once the vehicle has had time to thaw.</p>

1. Remove the CAC (2) and drain any moisture built up. Refer to *Charge Air Cooler Replacement* in SI.
